RE: Proposed Compliance Commitment Agreement from
Koppers Inc
Violation Notice A-2021-00217
I.D. 031300AAJ

**Re: Violation Notice A-2021-00217
ID: 031300AAJ**

Unit: U-03
Equipment: V-101 & V-201
Description: TAR FRACTIONATOR
Serial Number: 74-413B National Board: N/A

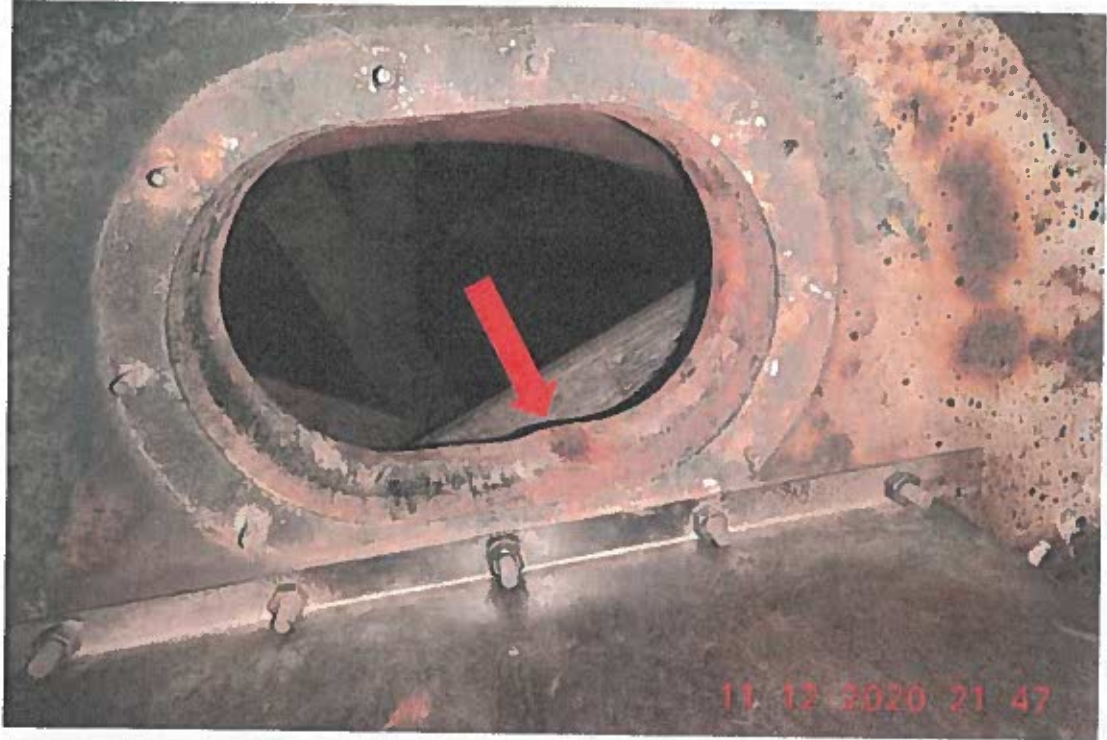
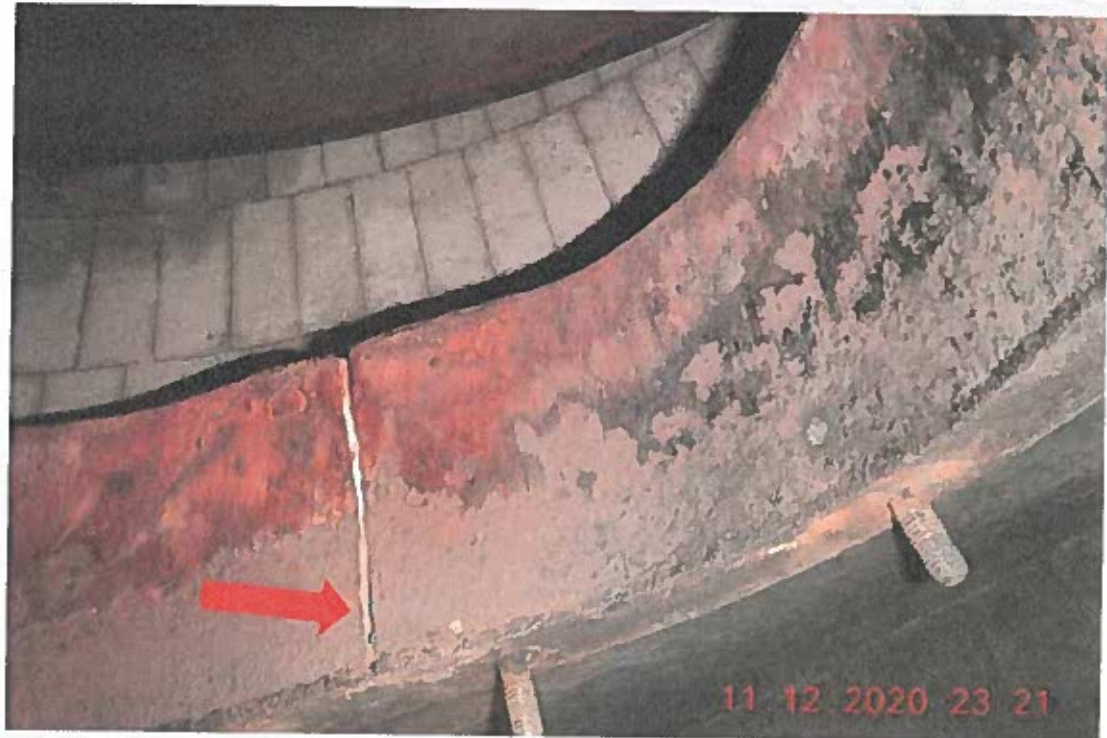
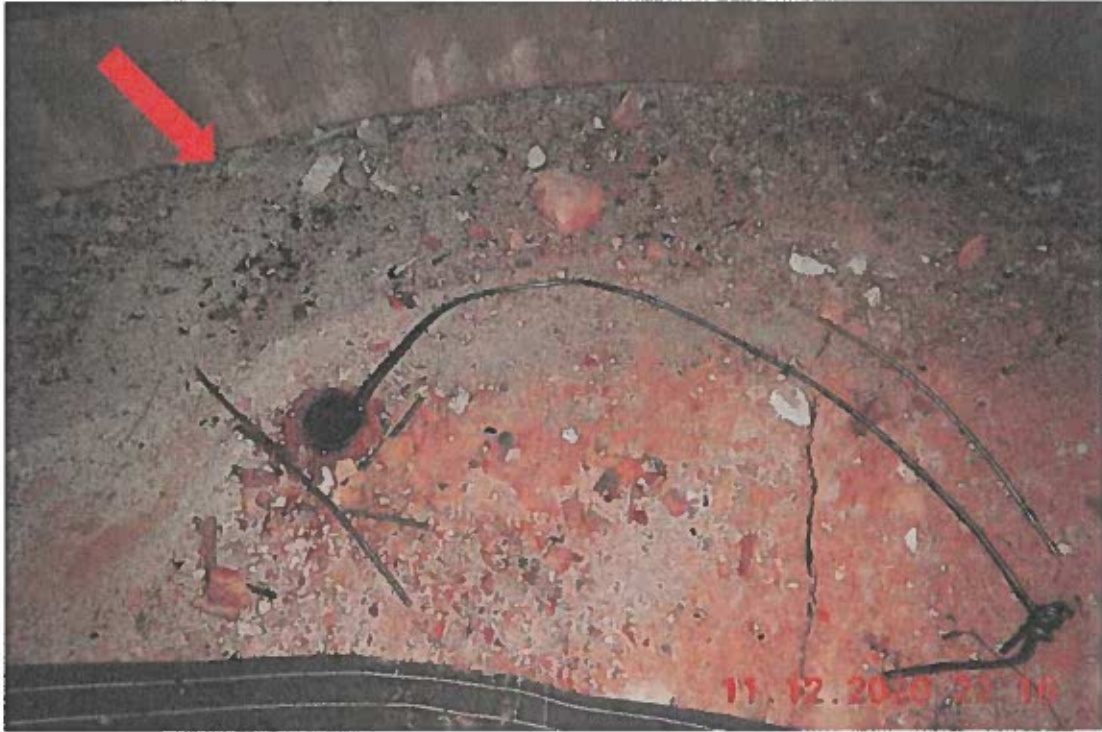
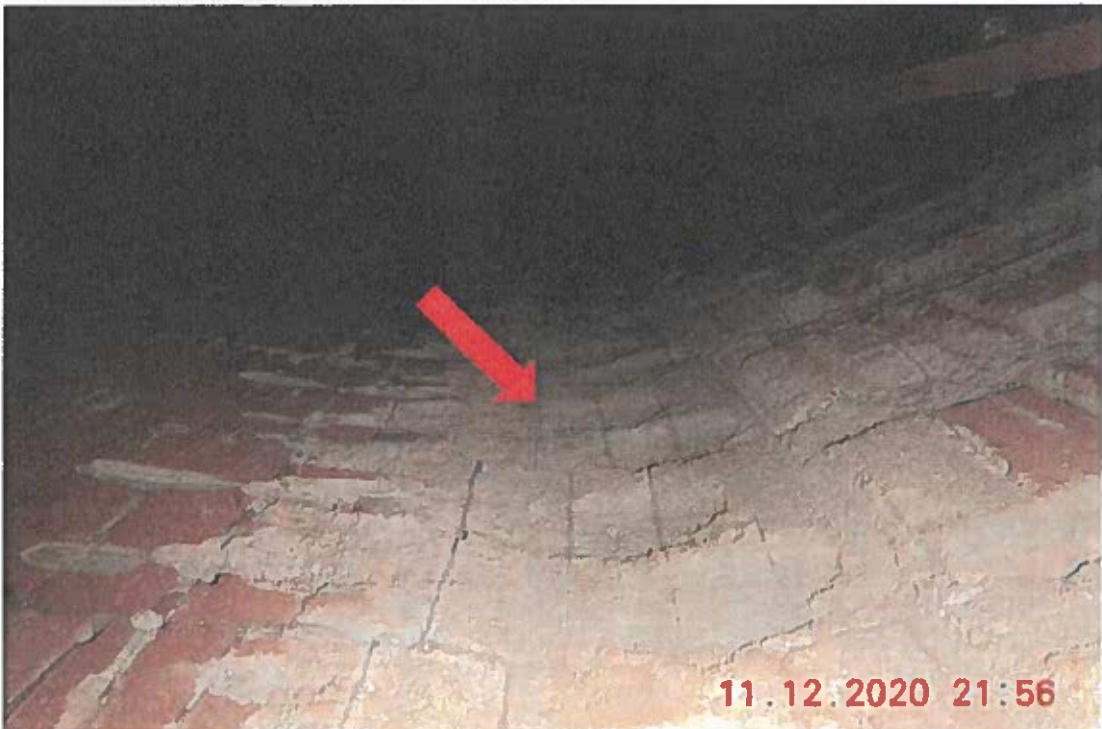
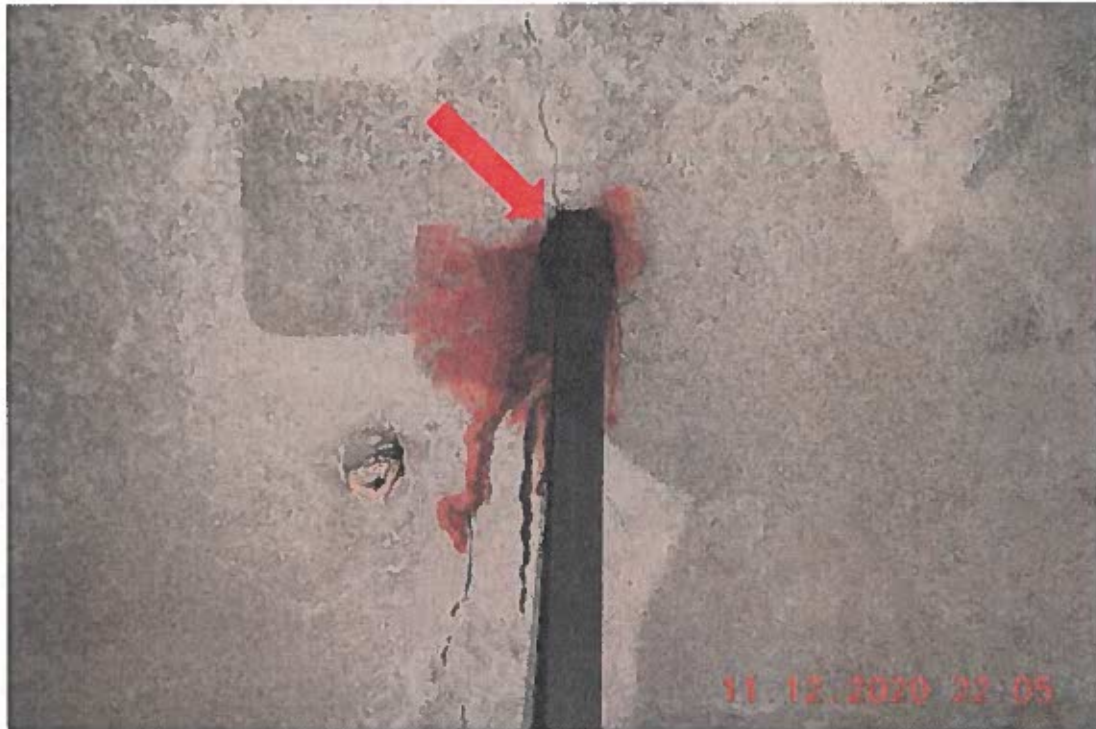
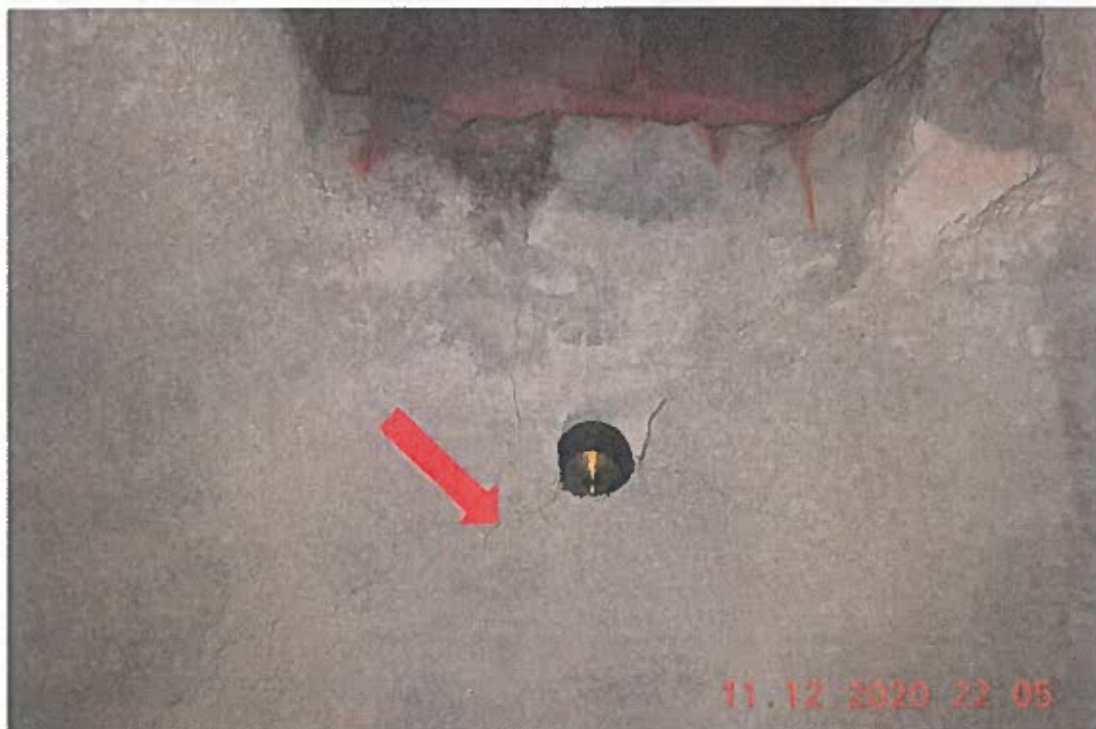
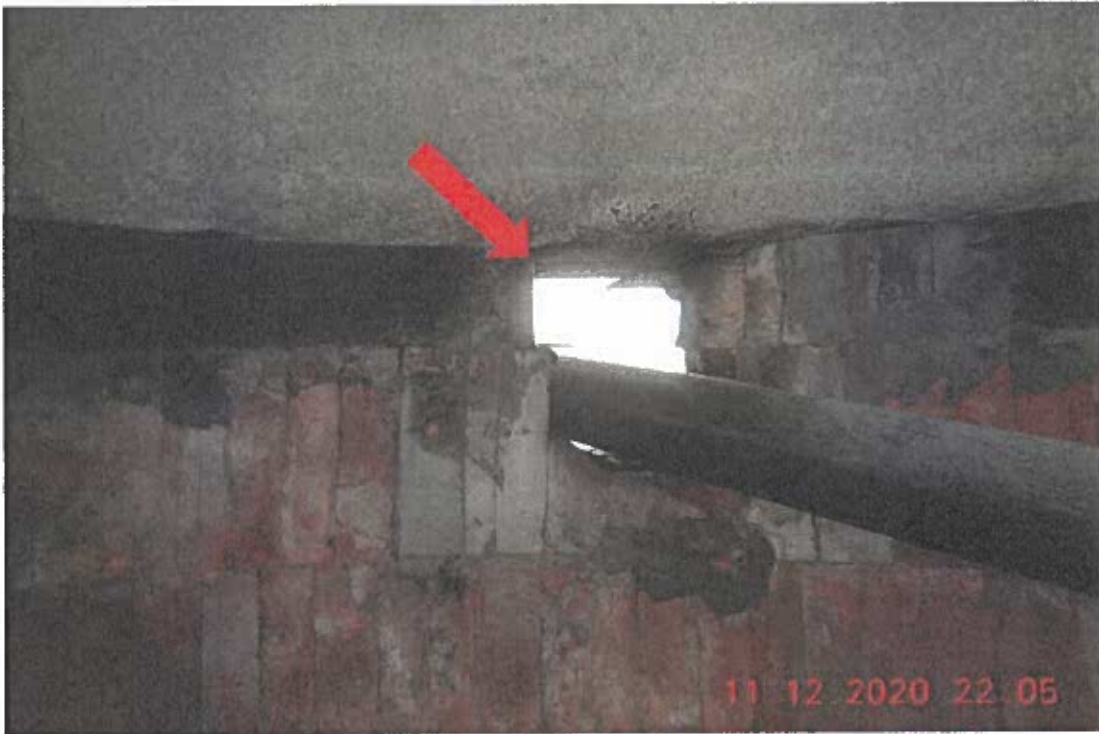
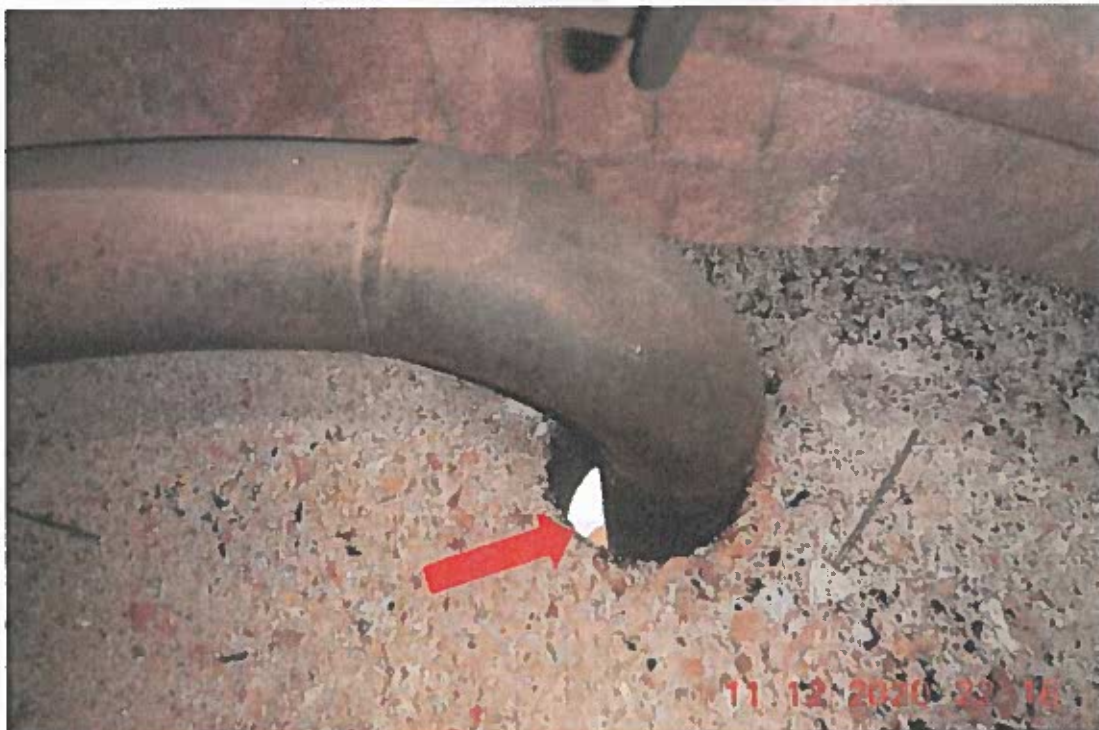
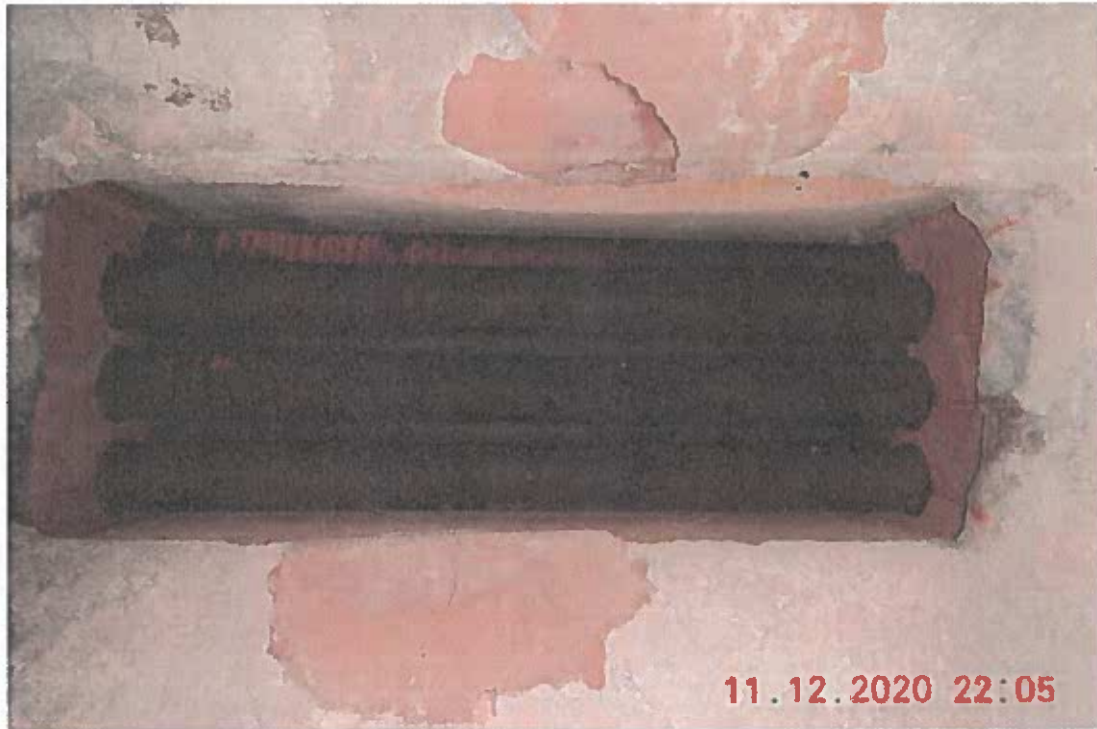
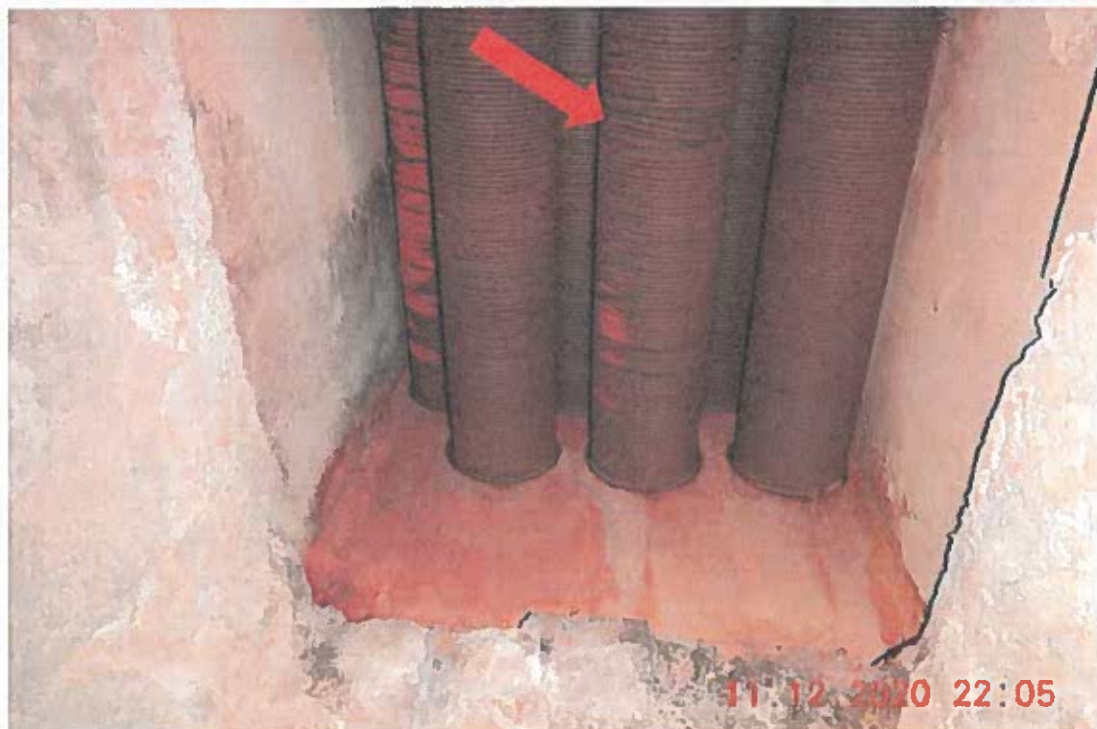
The following ten (10) photos show the internal condition of the reboiler. A crack and warping in the manway metal ring were observed. Areas of water staining were observed in the refractory around top head attachments. Areas of eroded or scrapped away shell refractory was noted. Light cracking and spalling were noted in the top refractory. Openings were observed in the reboiler at the coil inlet and outlet. Light general corrosion and bent fins were noted on the accessible economizer tubes.

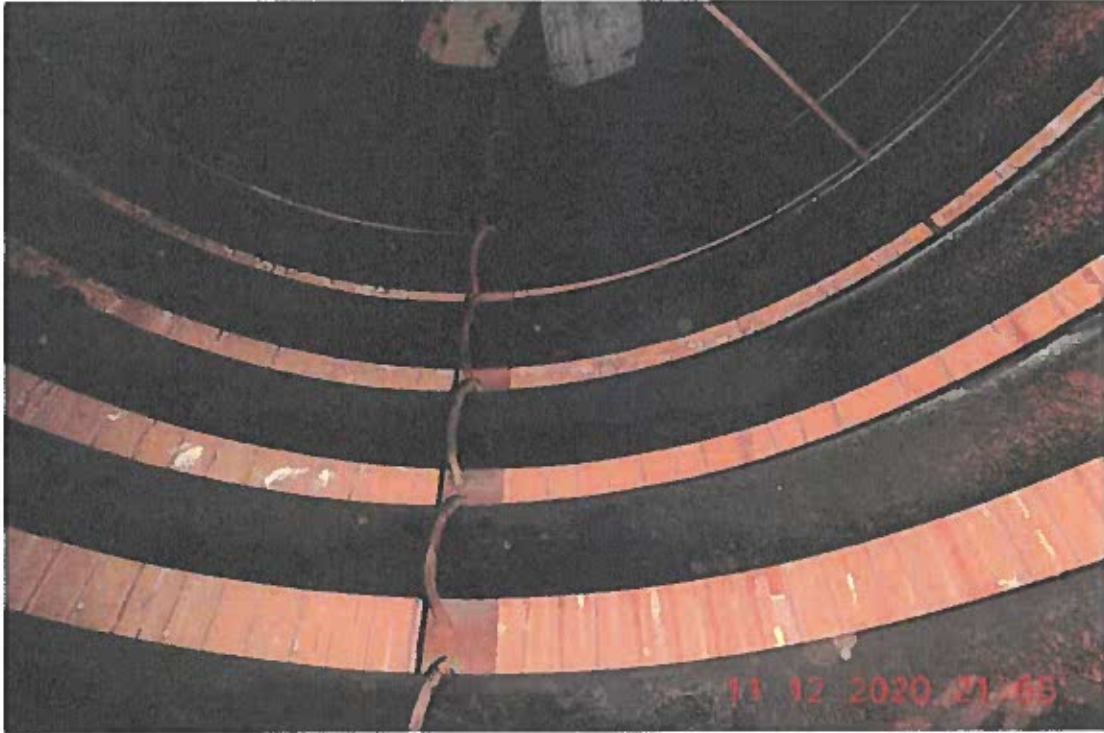
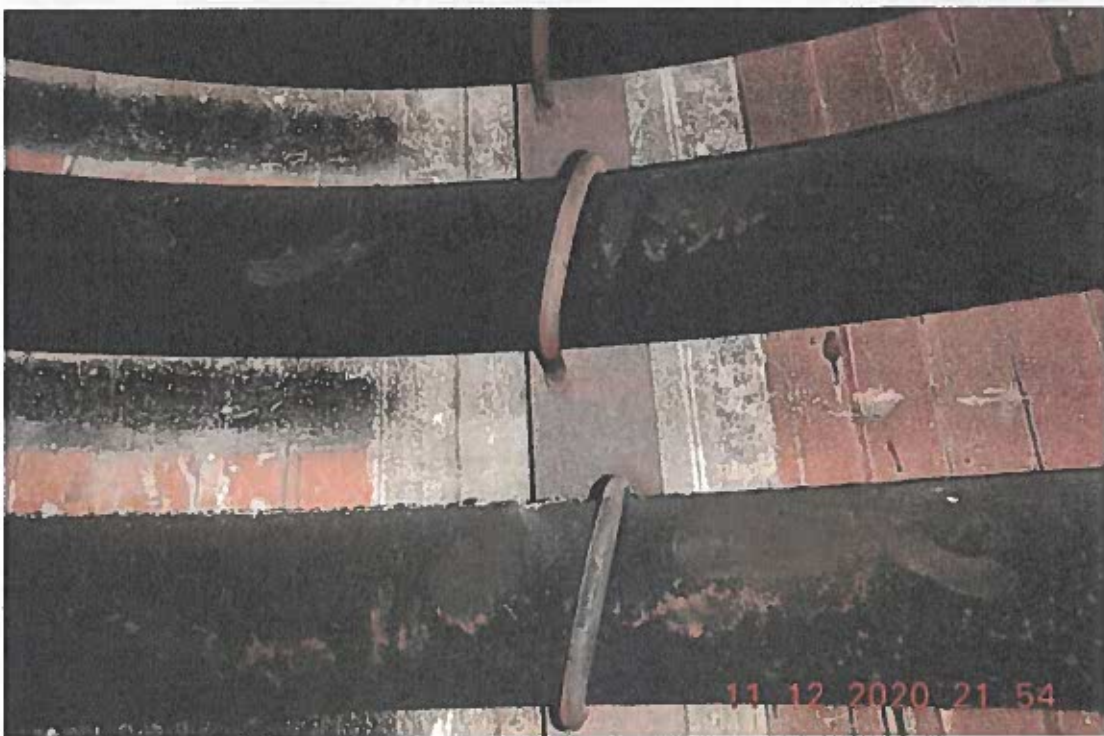
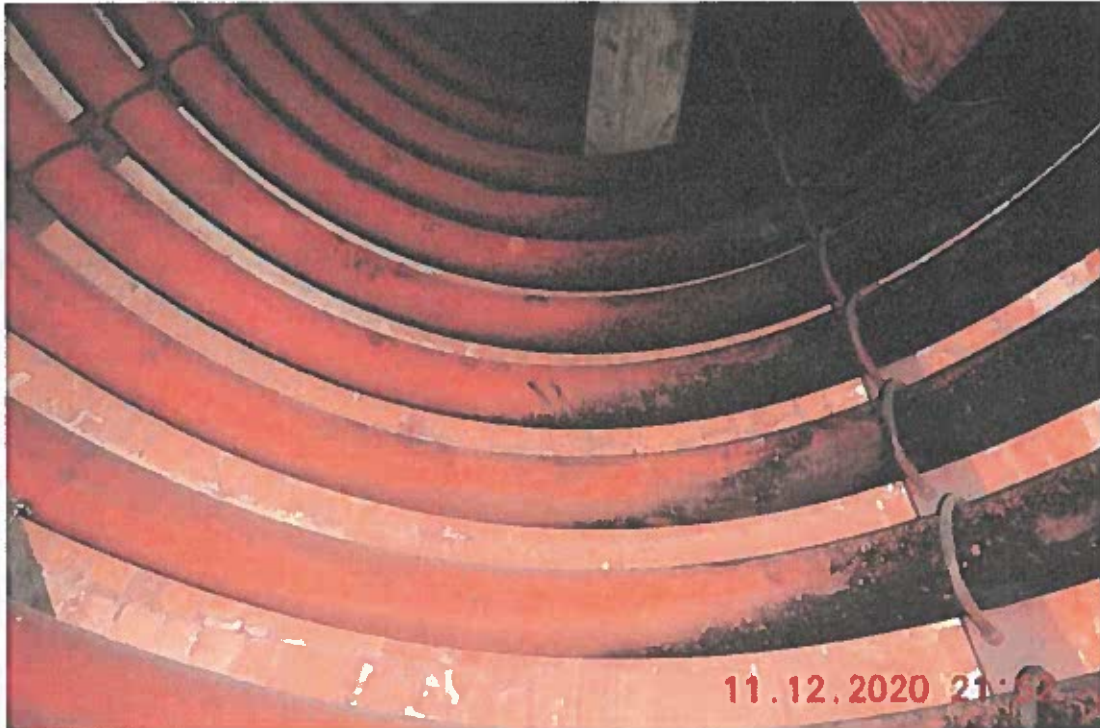
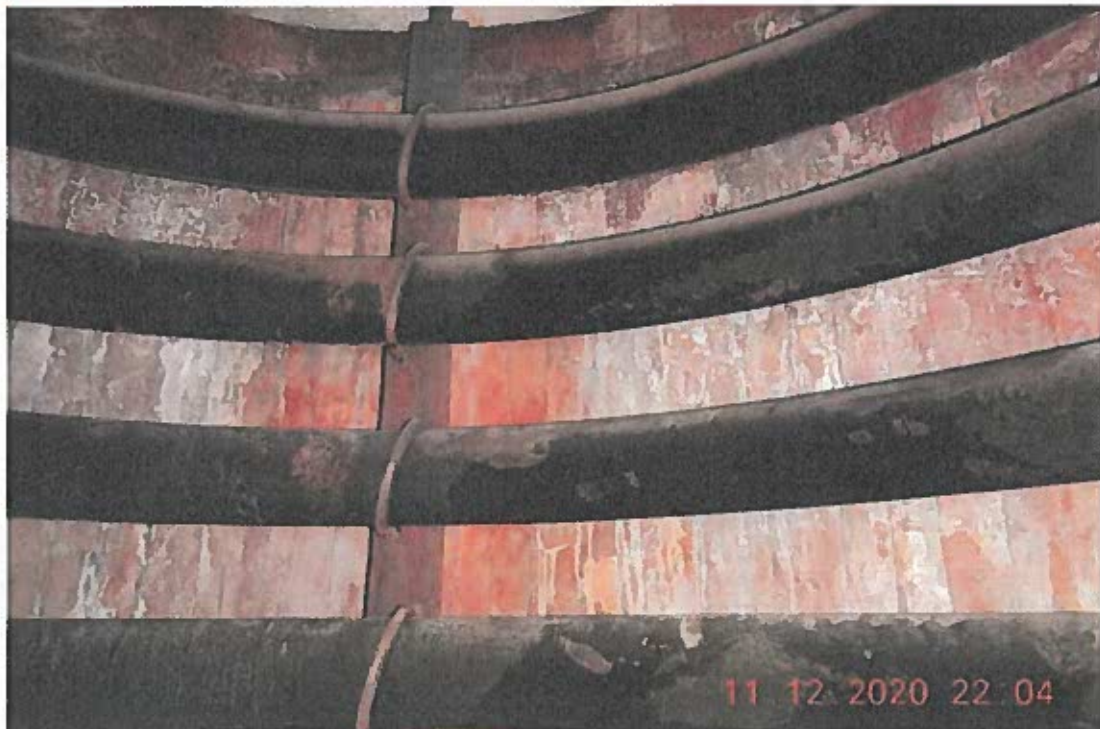
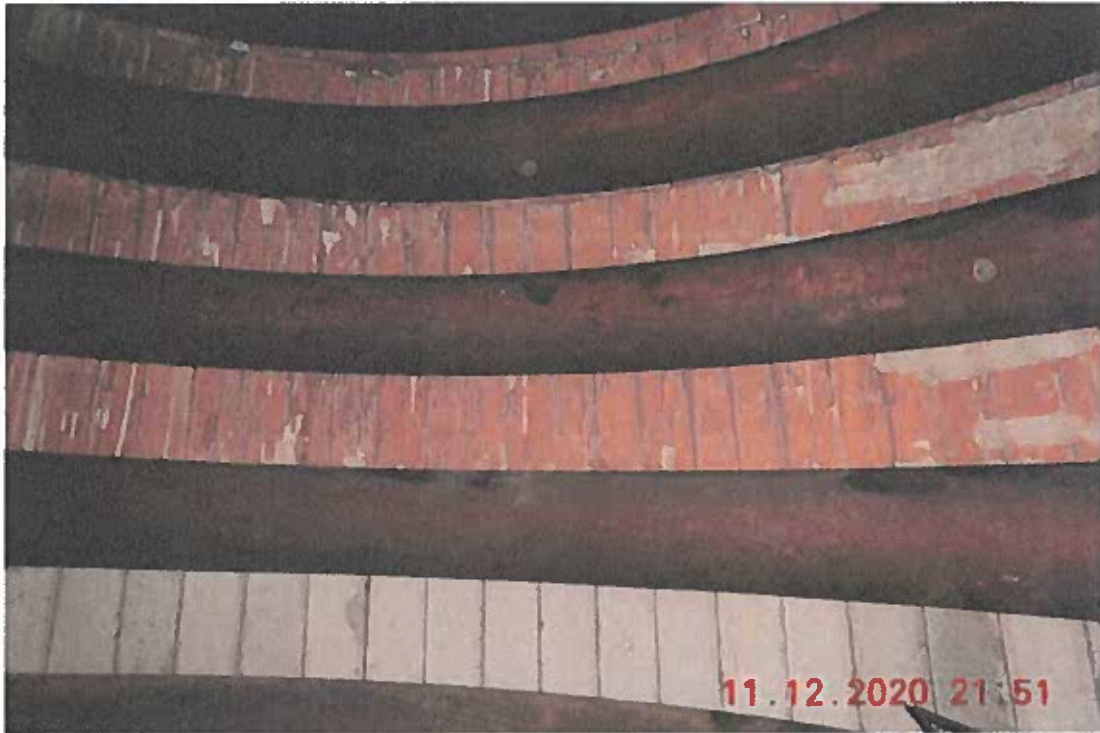
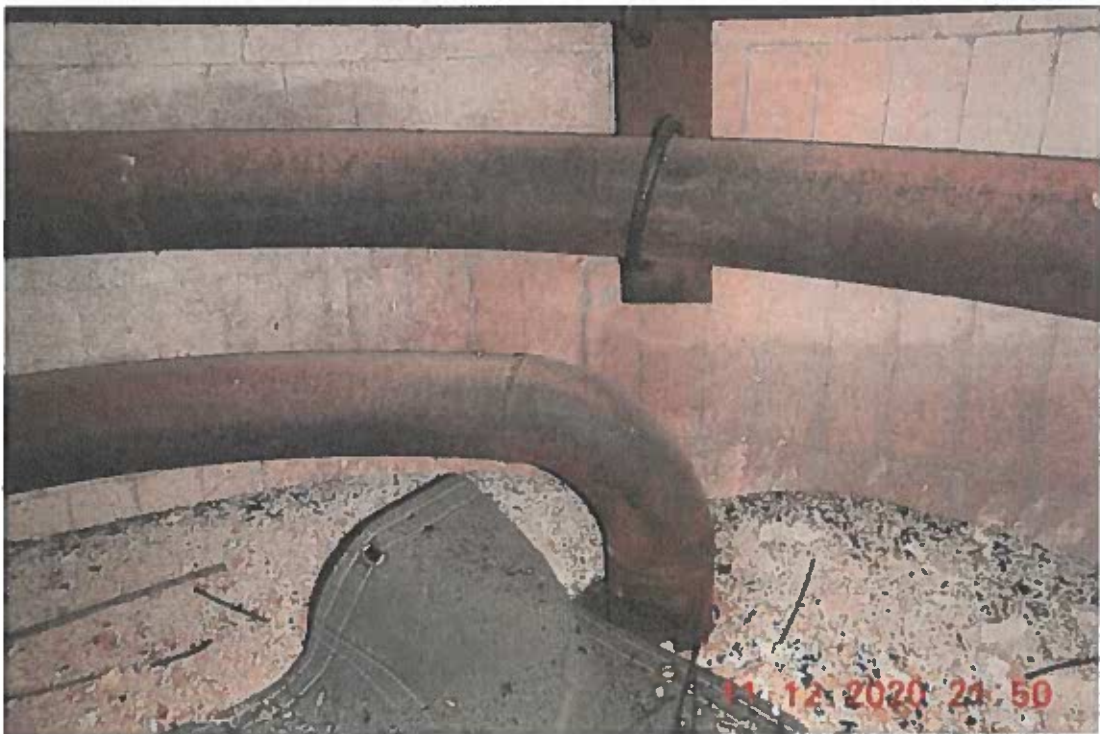
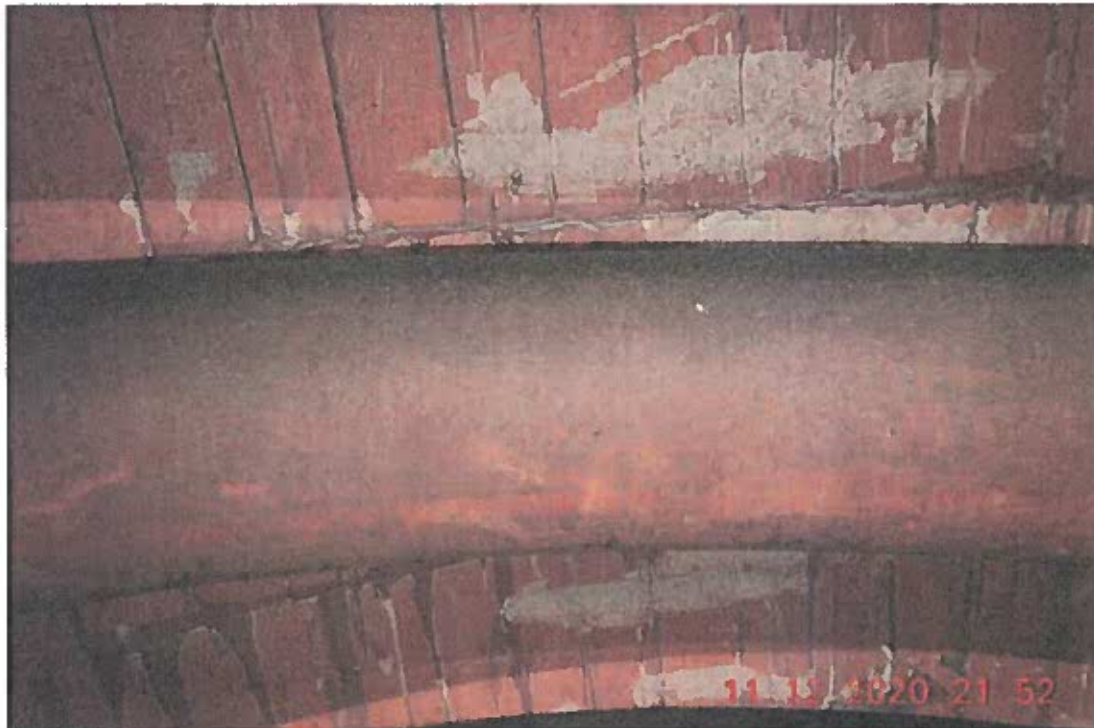
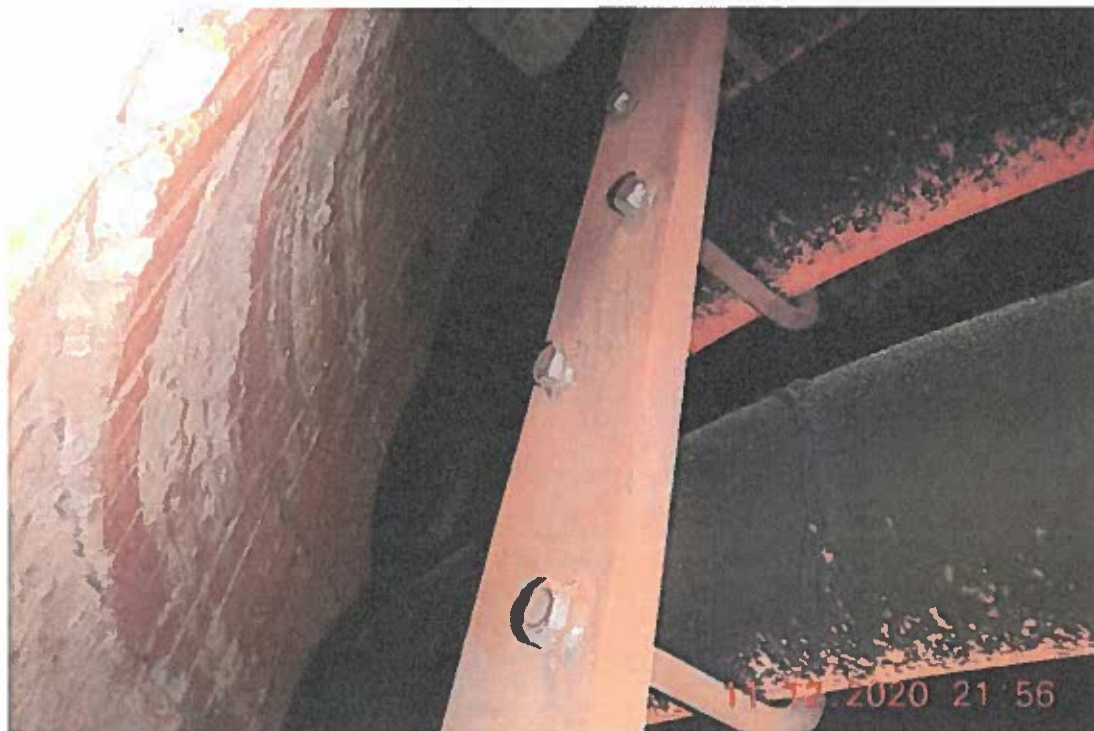
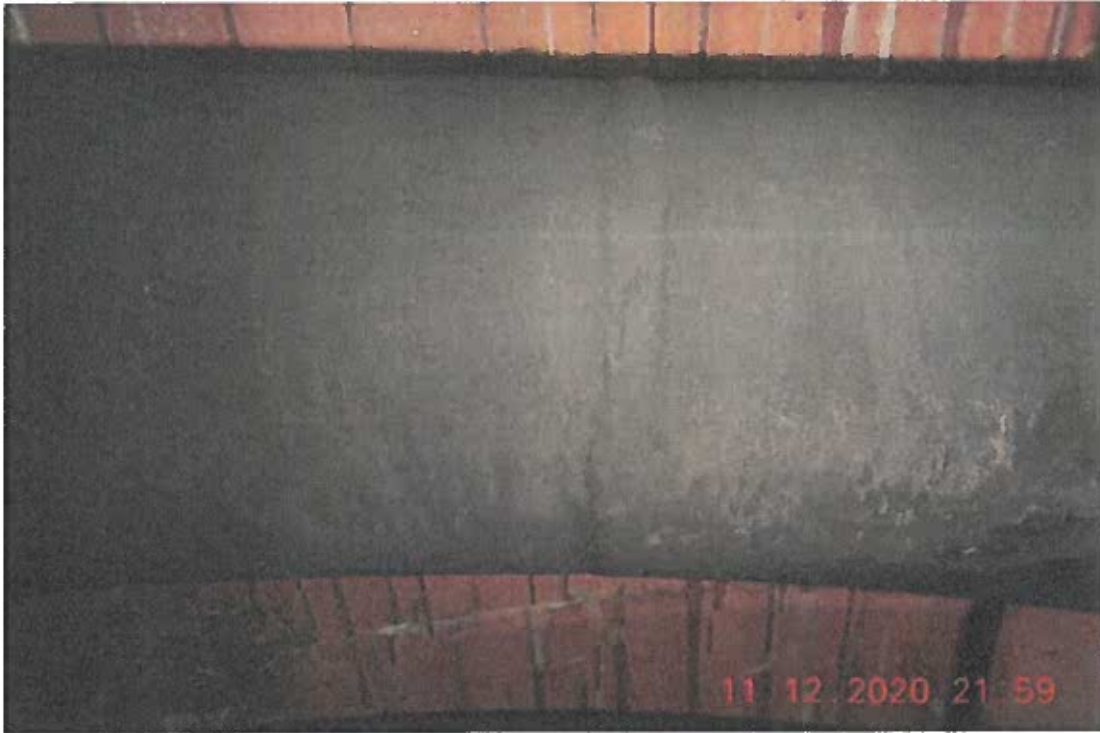
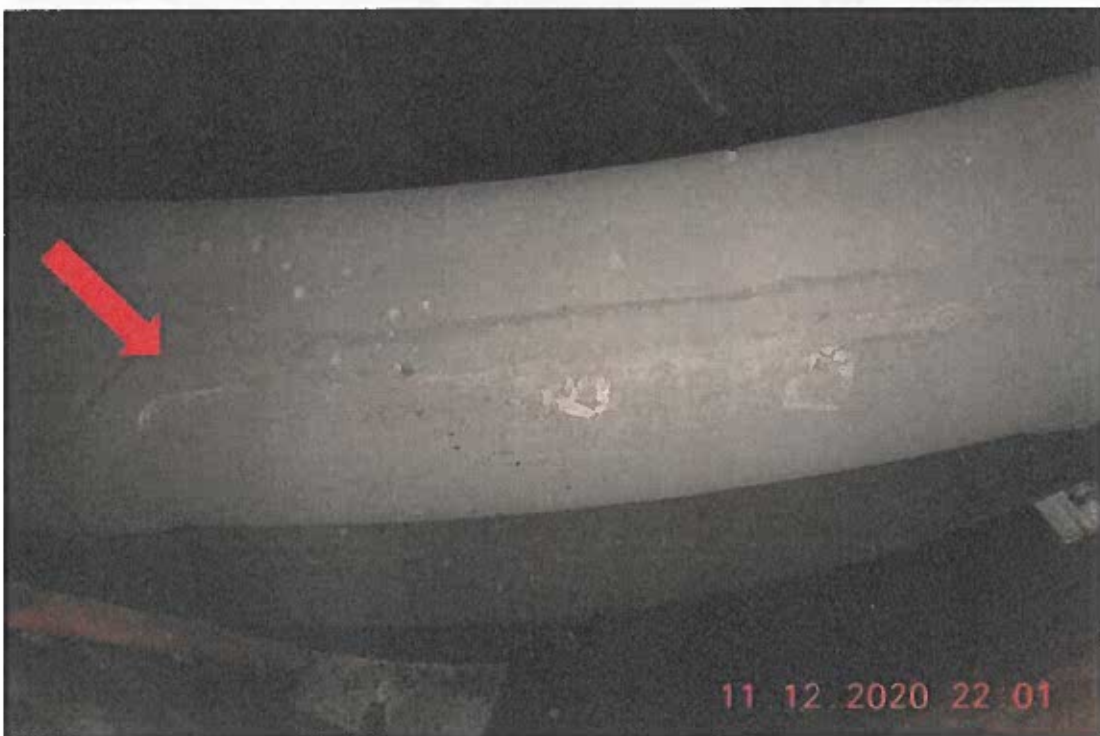
The following ten (10) photos show the condition of the coil tubes and U-bolts. No indications of significant corrosion or erosion were noted on the coil. Repair window welds were observed on tubes 36 and 38. Light staining and moderate black discoloration (soot) were noted on the coil throughout. No broken U-bolts were observed.

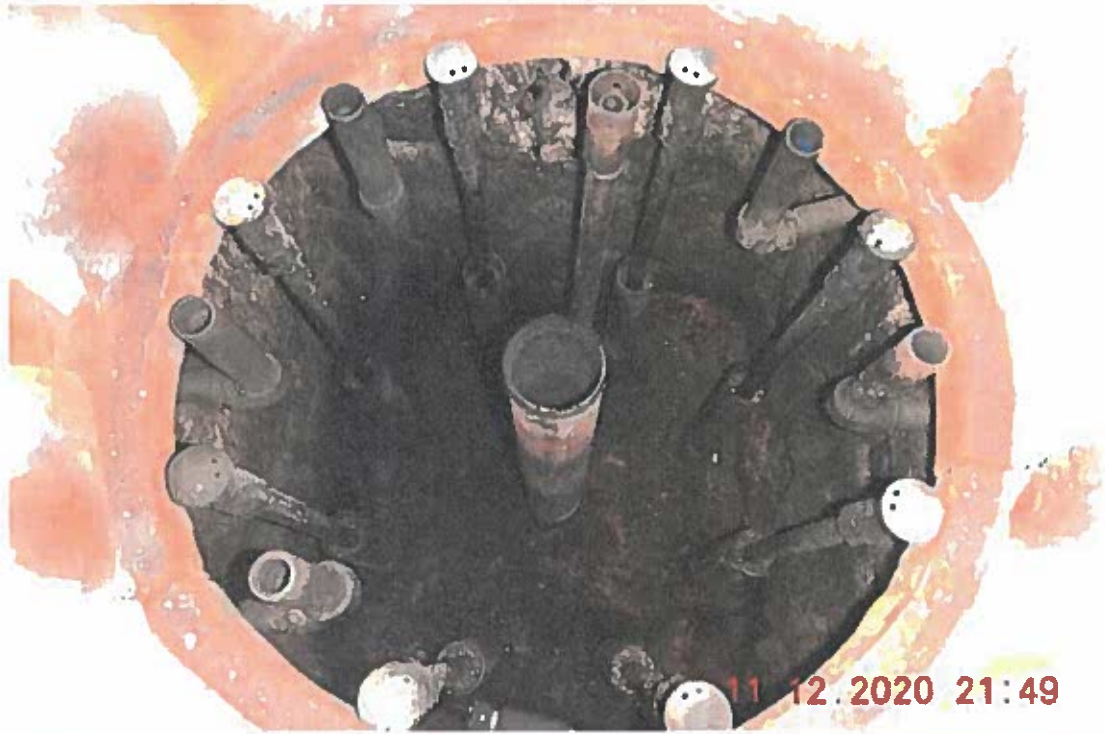
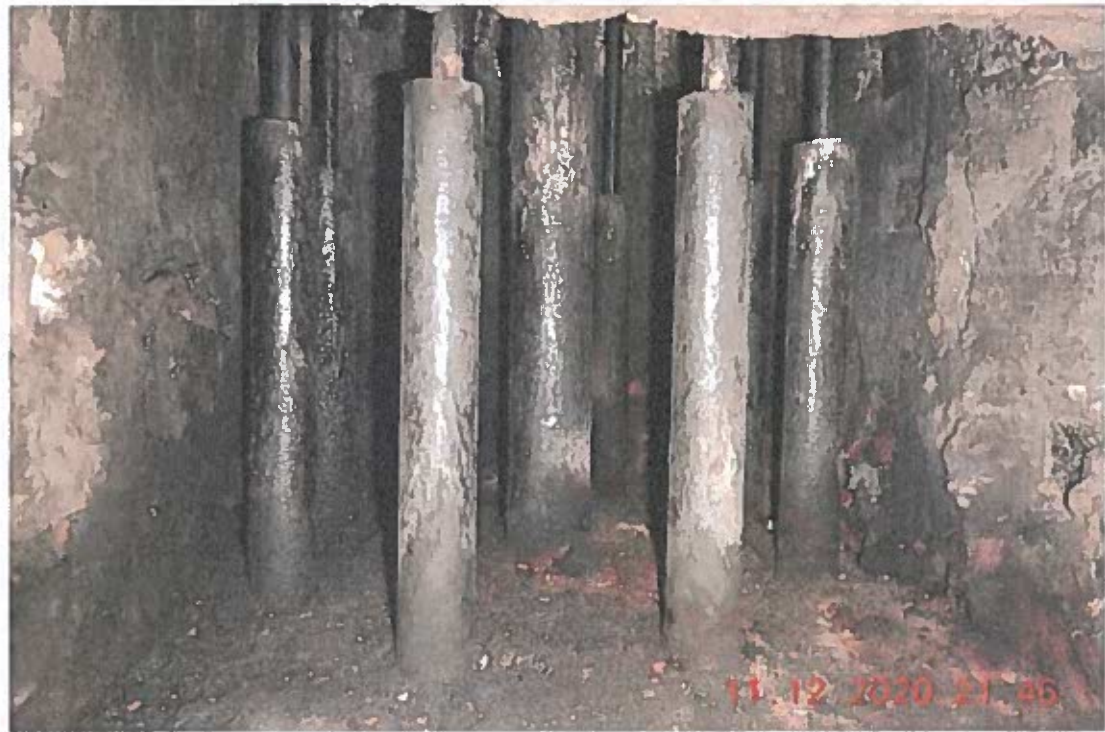
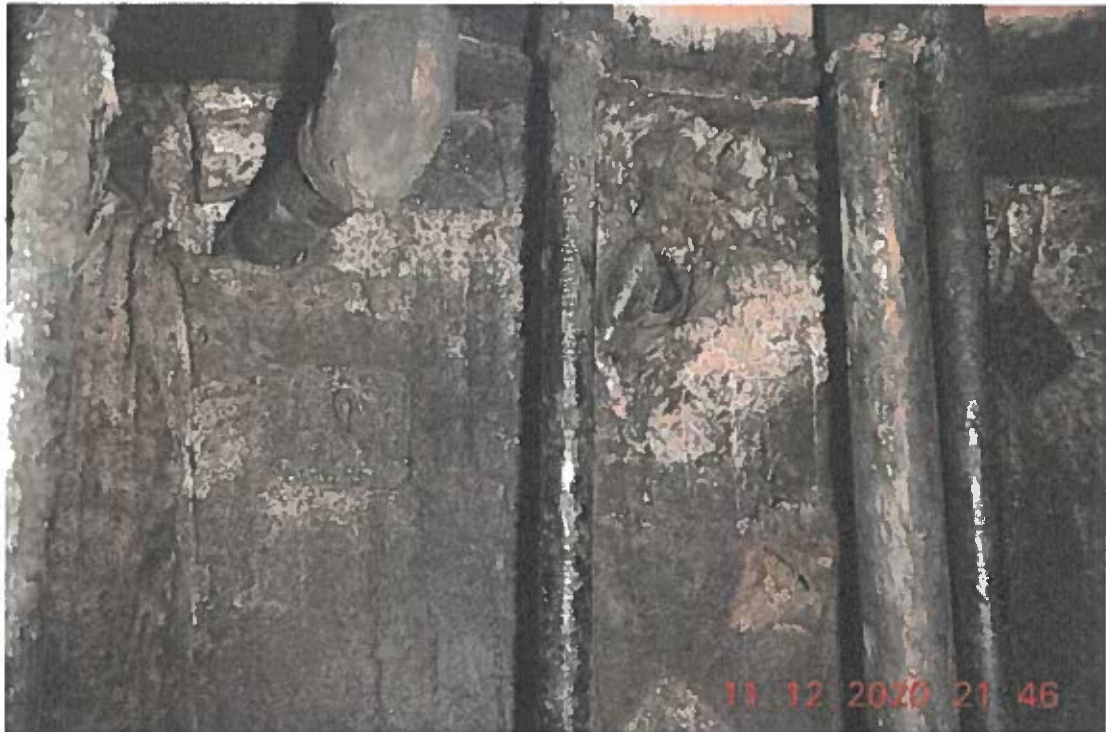
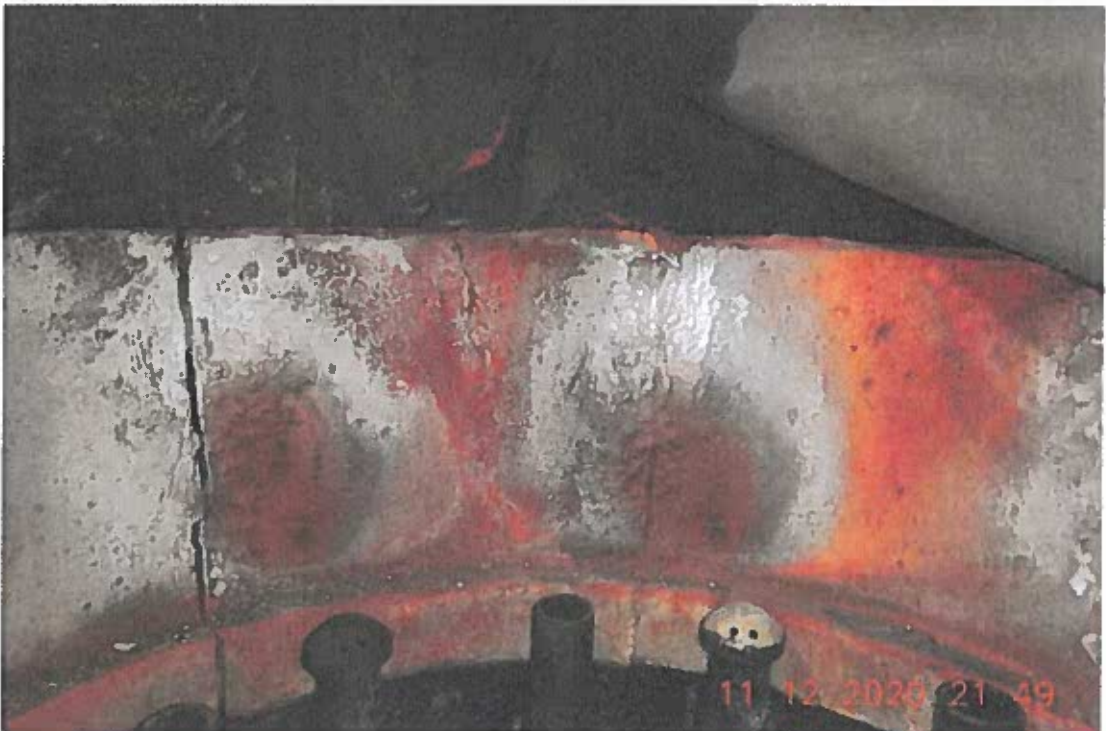
The following four (4) photos show the internal condition of the burner and burner box. The burner and burner box appeared to be in satisfactory condition for continued service; however, accumulation of loose insulation and debris were observed.
