RE: Proposed Compliance Commitment Agreement from
Koppers Inc
Violation Notice A-2021-00217
I.D. 031300AAJ

**Re: Violation Notice A-2021-00217
ID: 031300AAJ**

Unit: U-03
Equipment: V-101 & V-201
Description: TAR FRACTIONATOR
Serial Number: 74-413B National Board: N/A

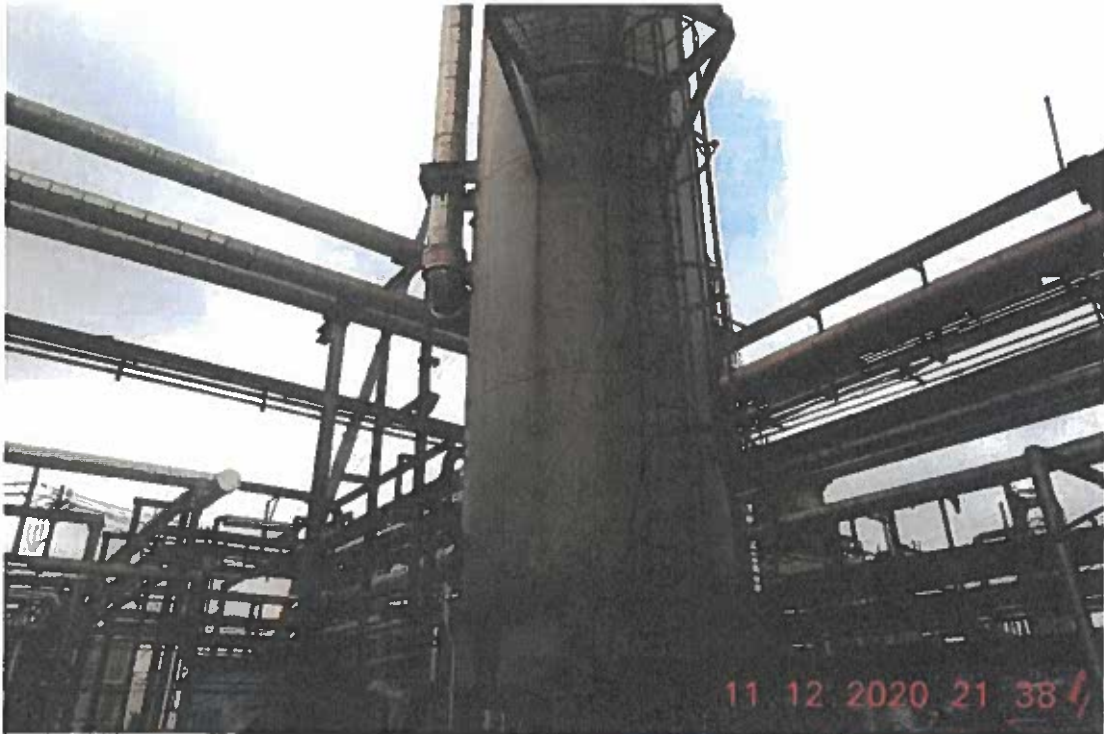
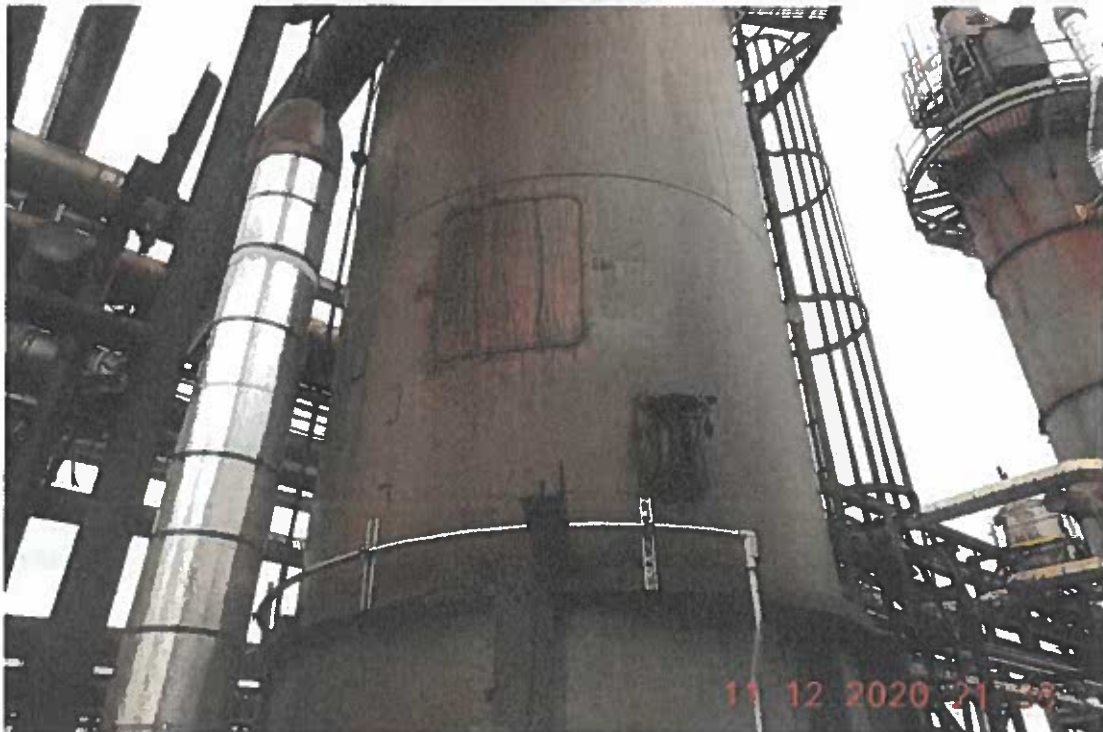
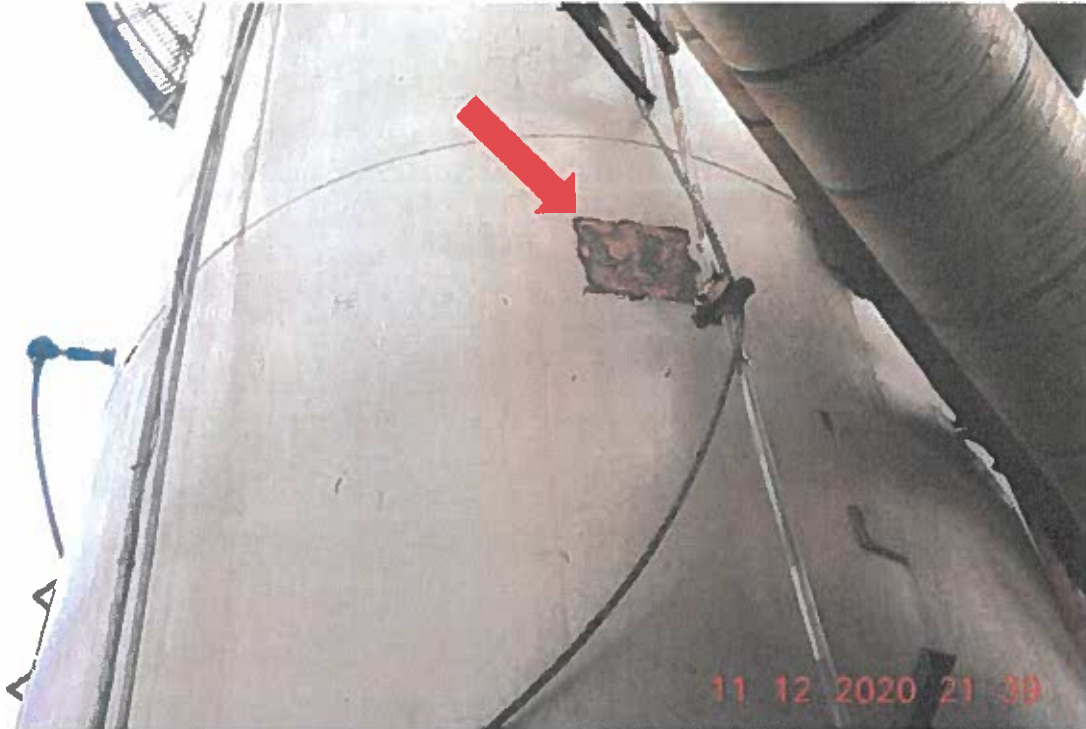
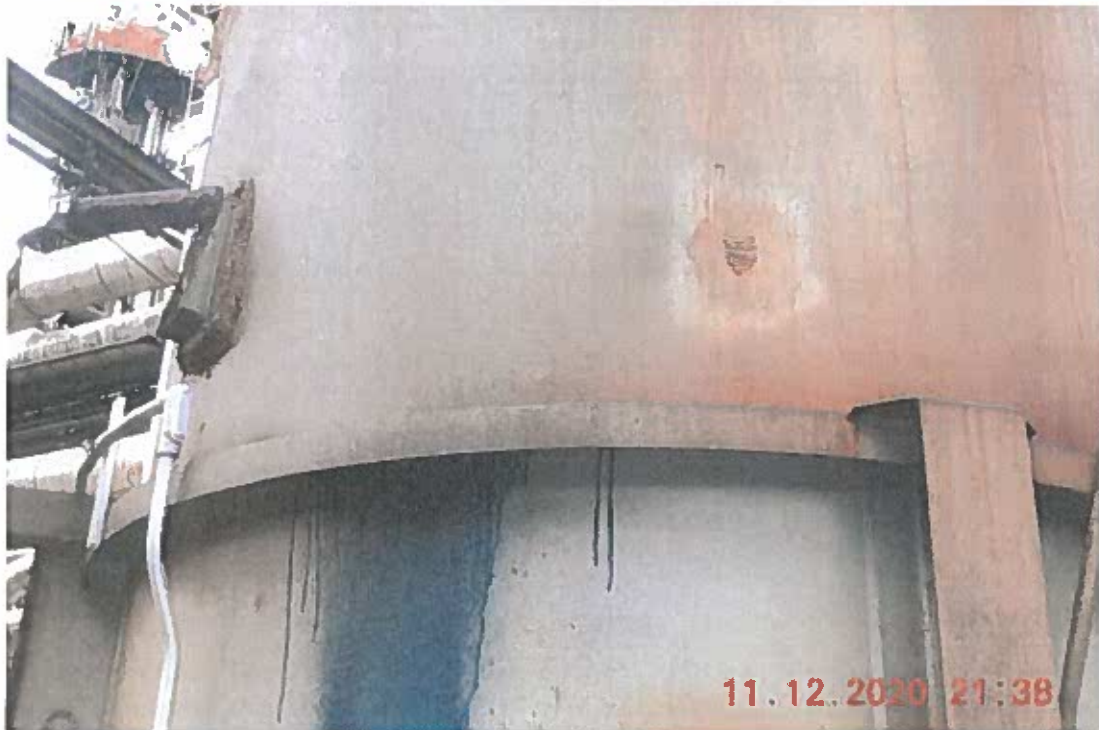
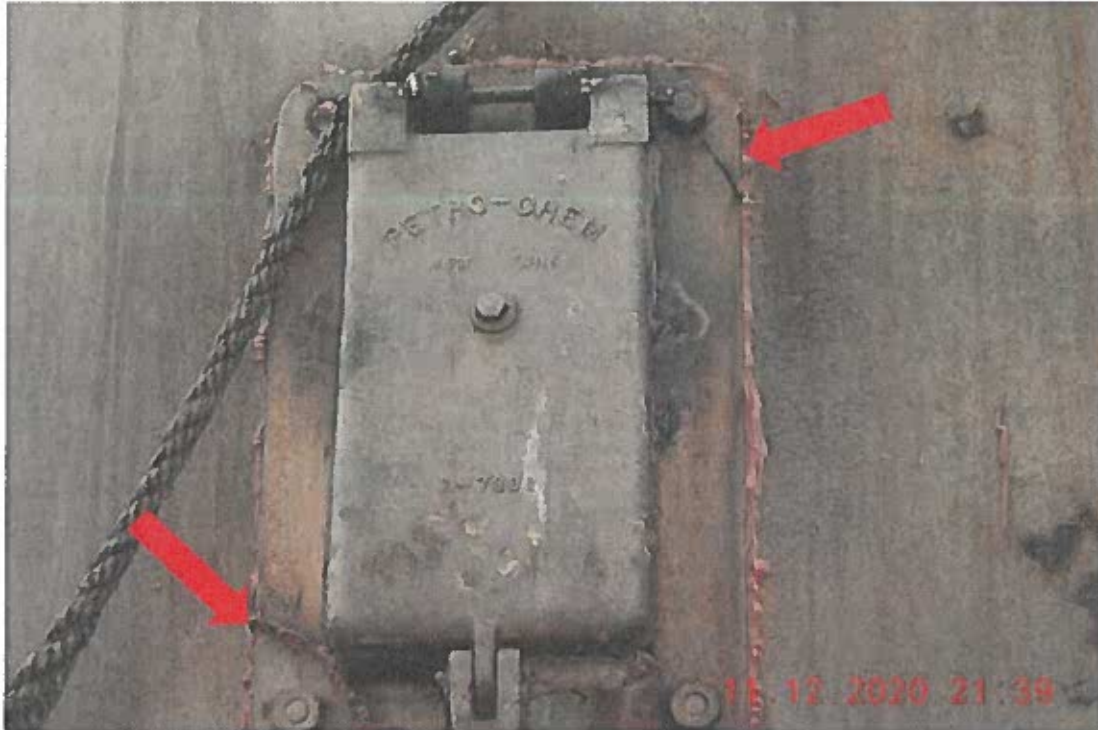
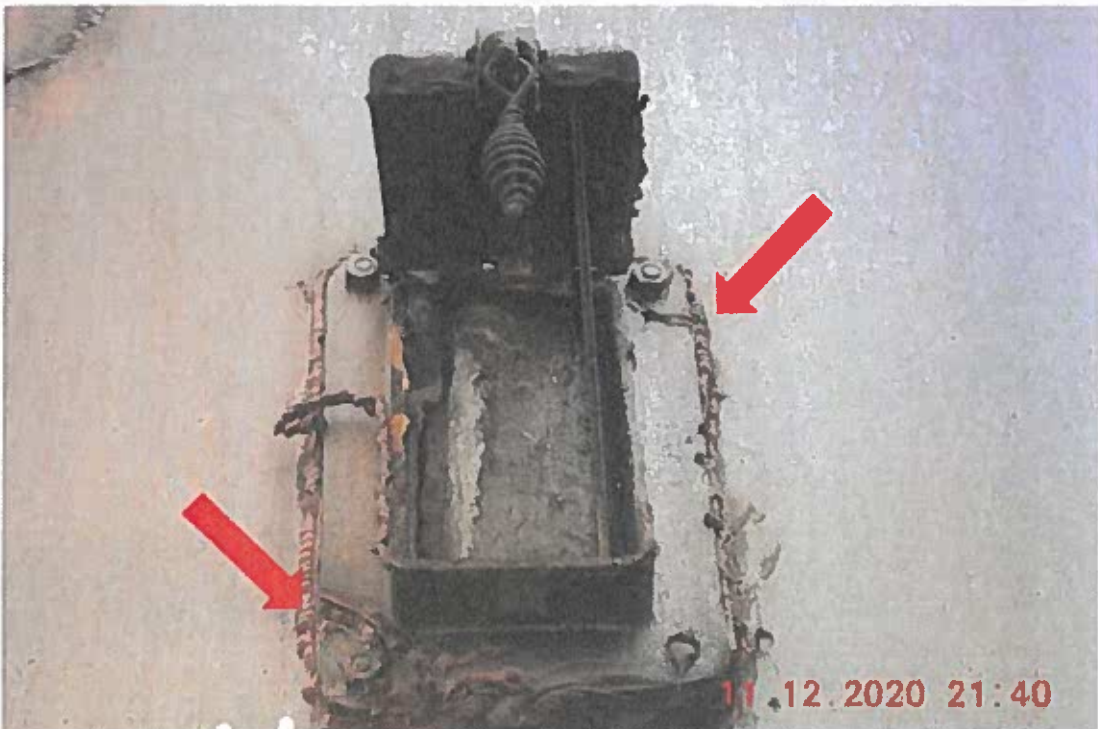
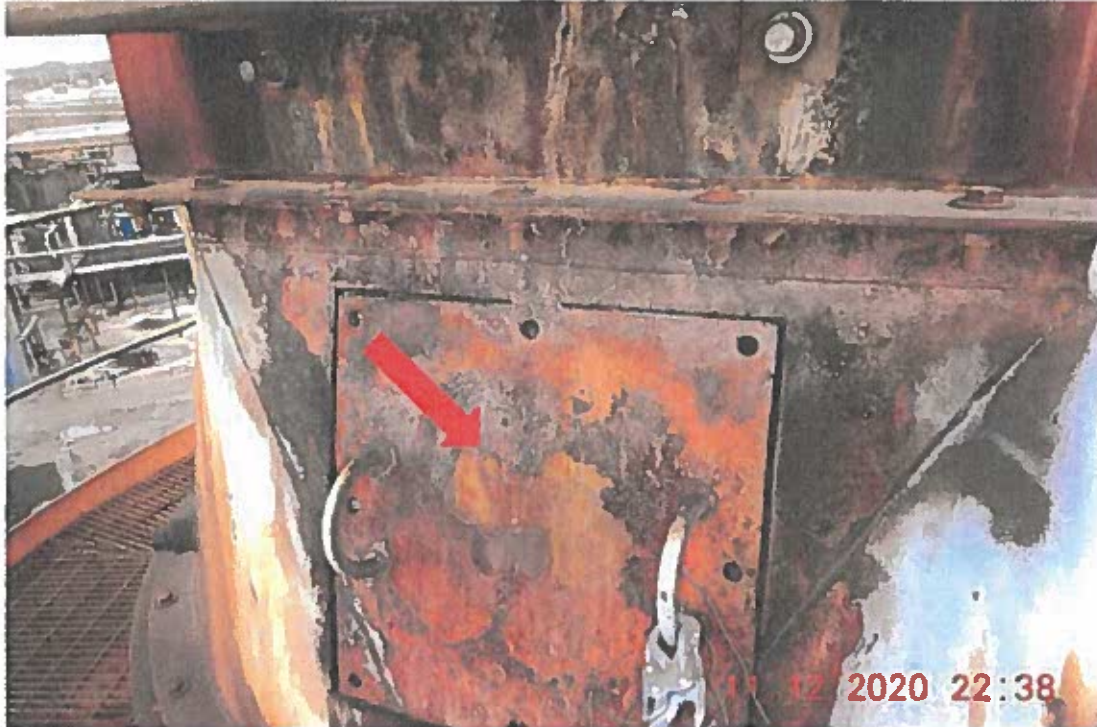
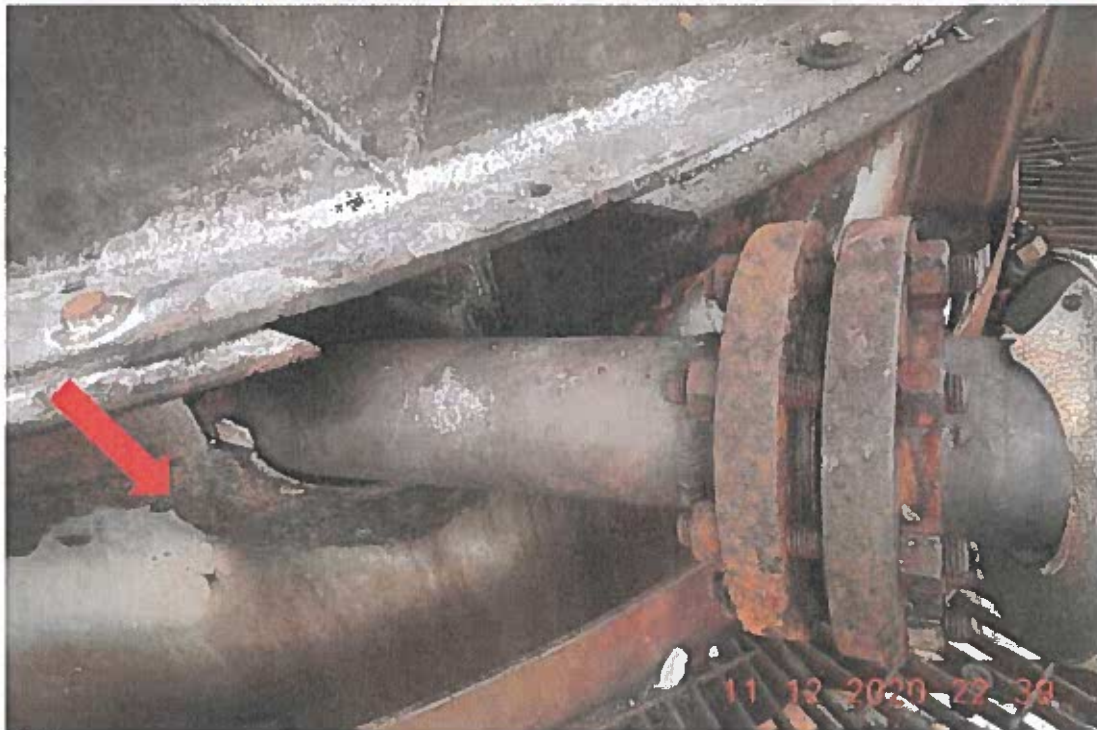
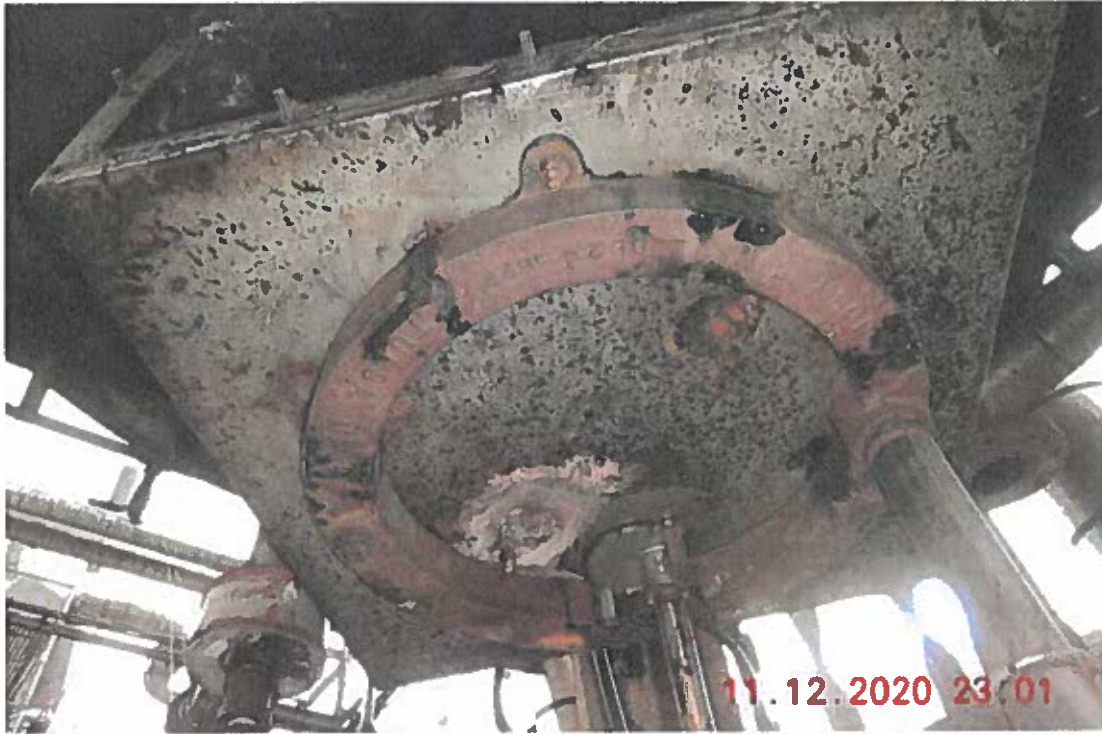
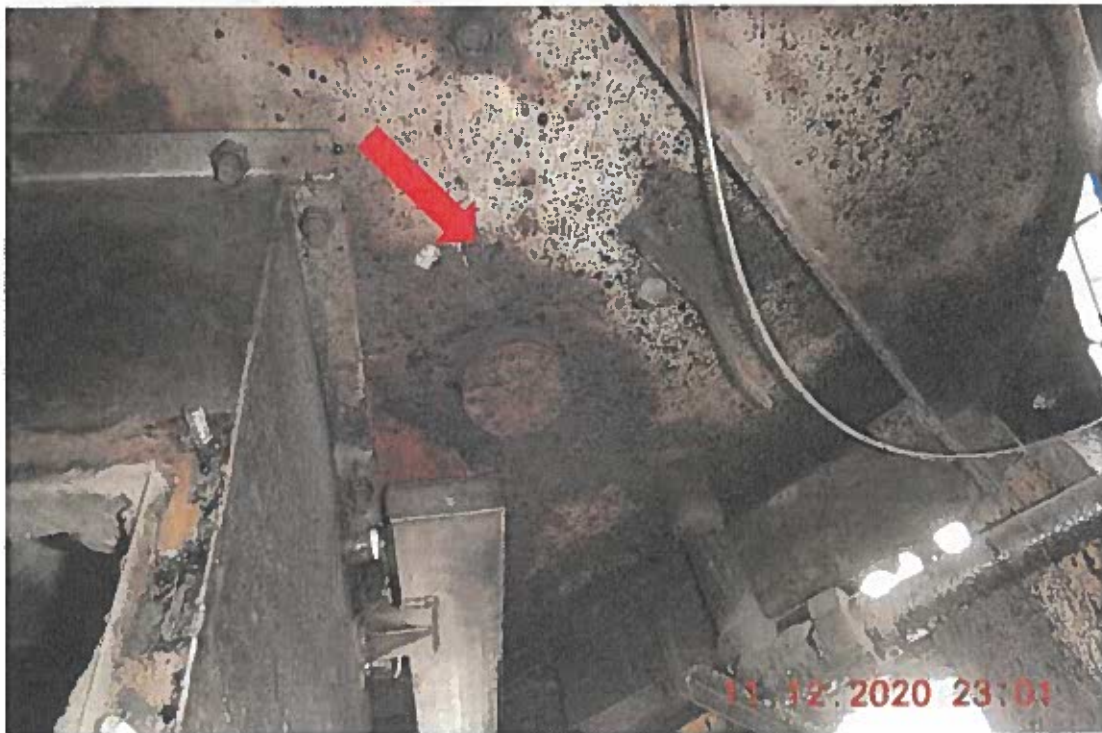
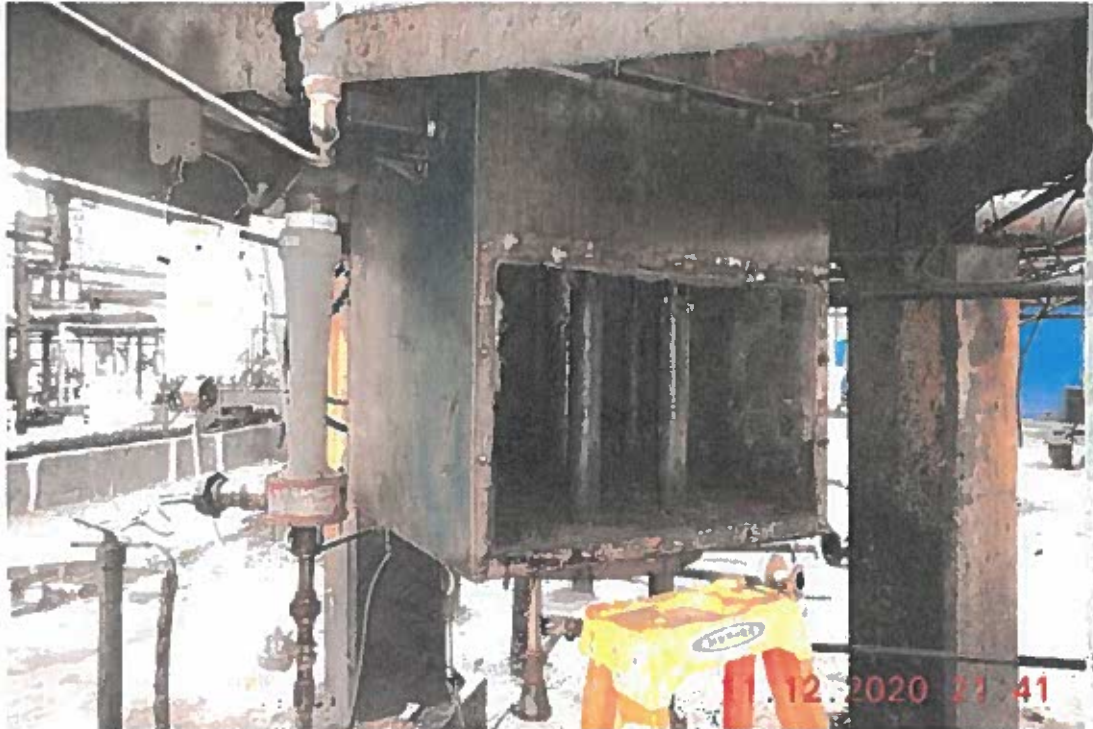
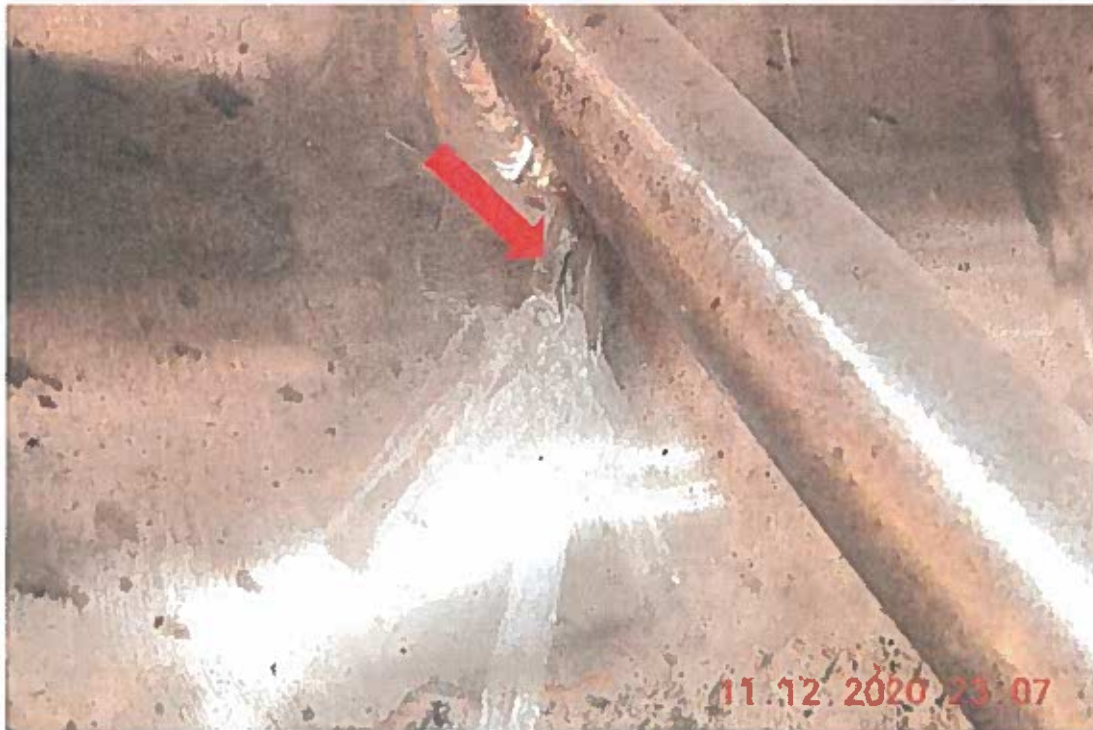
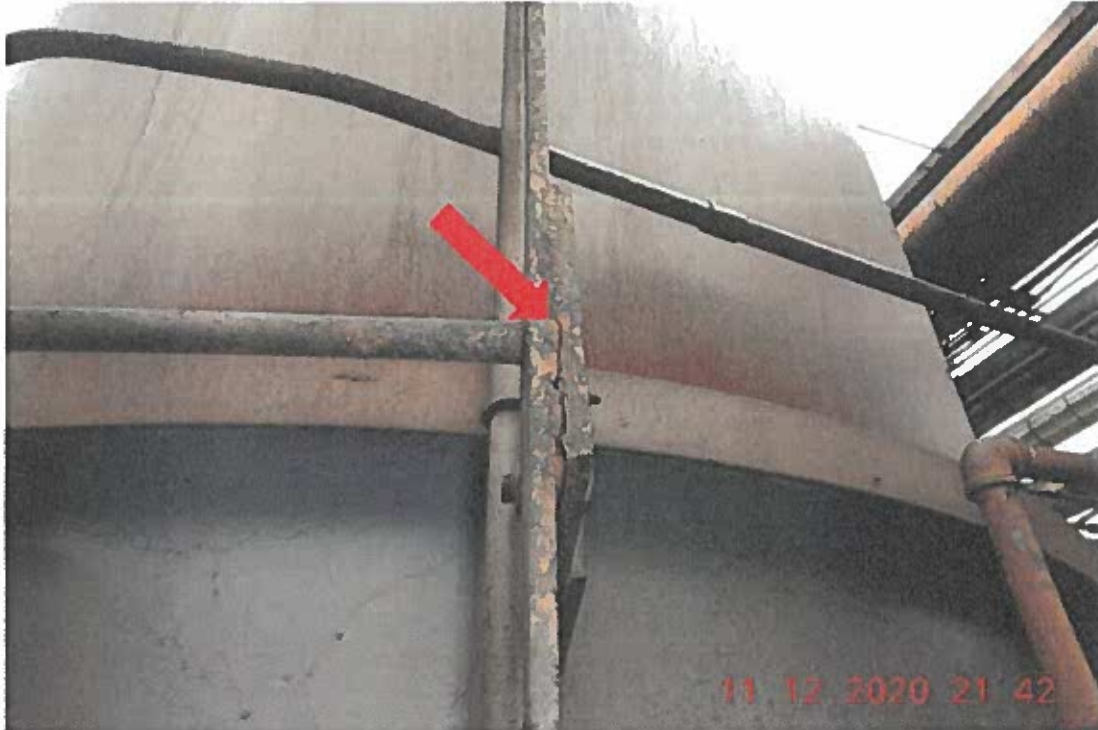
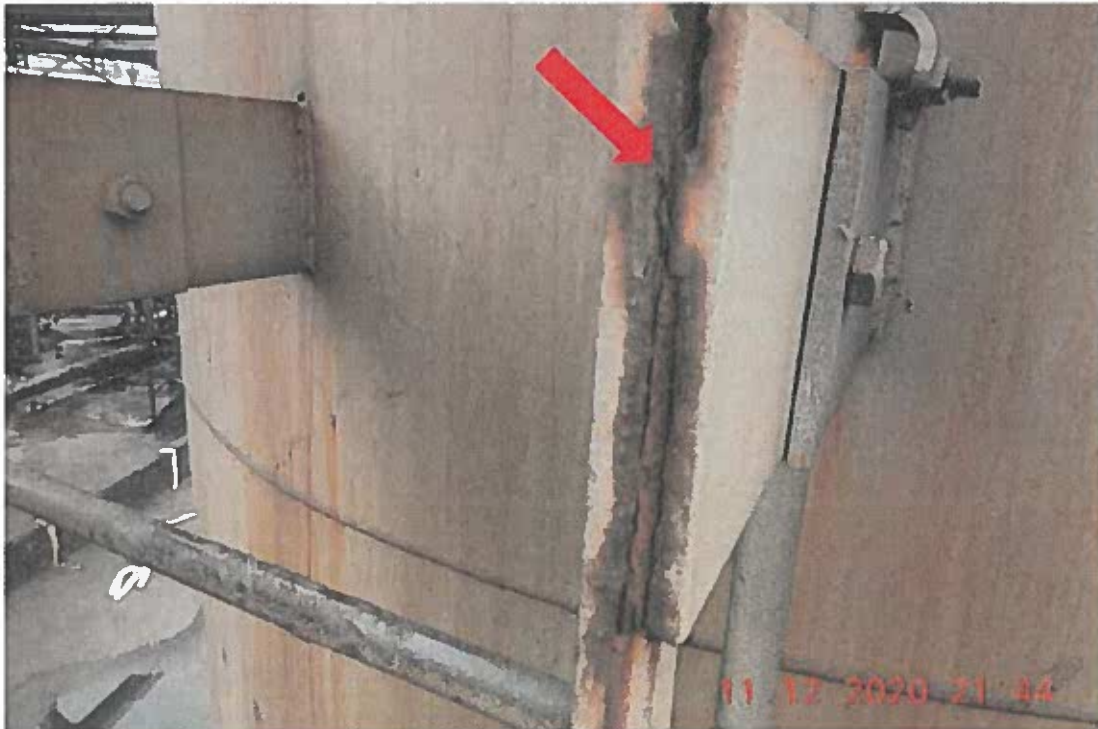
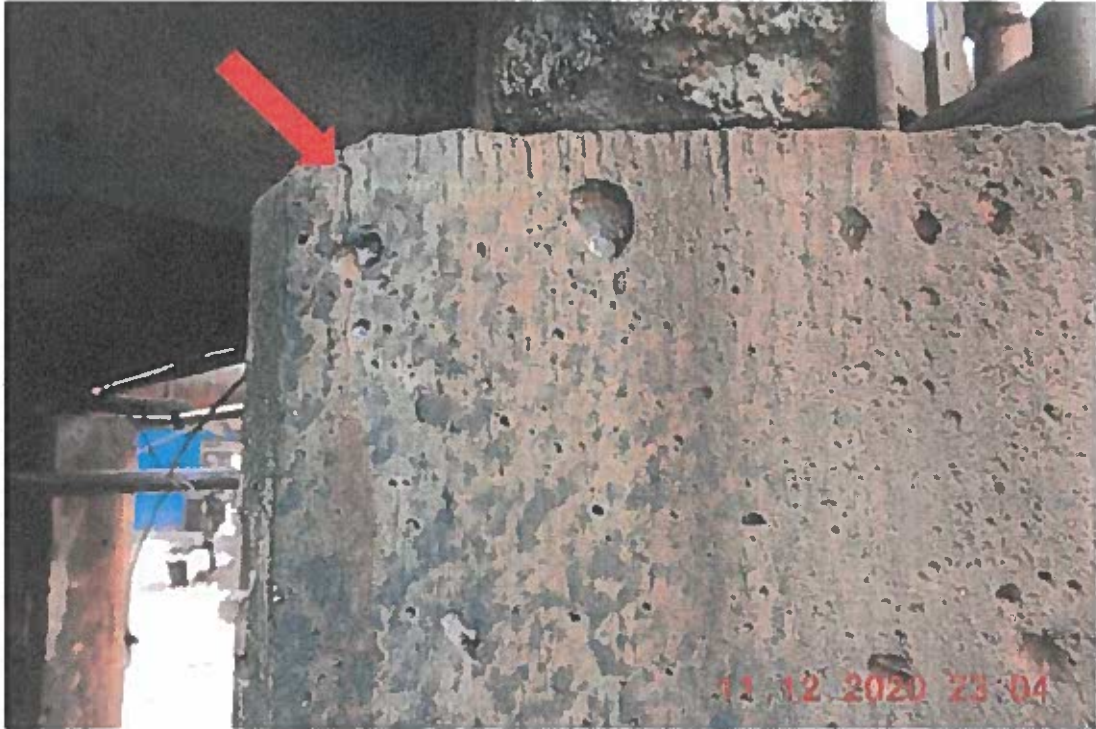
The following sixteen (16) photos show the external condition of the reboiler. Areas of general corrosion were observed on the exterior of the reboiler. A crack in the southeast side of the burner box was observed. Cracks were noted around the bolts of the inspection ports. Light cracks were noted in the concrete pillars of the support legs. Significant cracks and separation in the ladder support welds were noted.

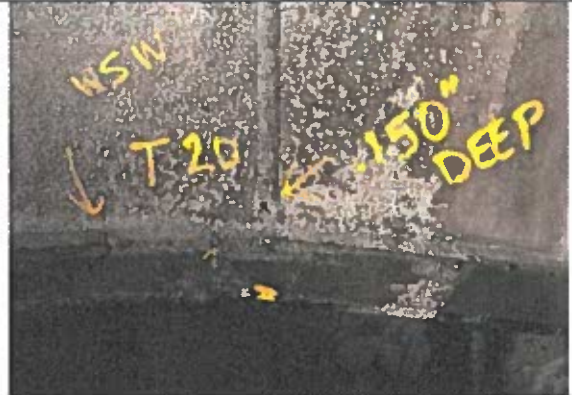
Reference ID: 10

Description: Tray ring 20 vertical weld seam has .150 x .200" pin hole and tray ring splice has a crack and pin hole in the attachment weld (unknown depth of crack)

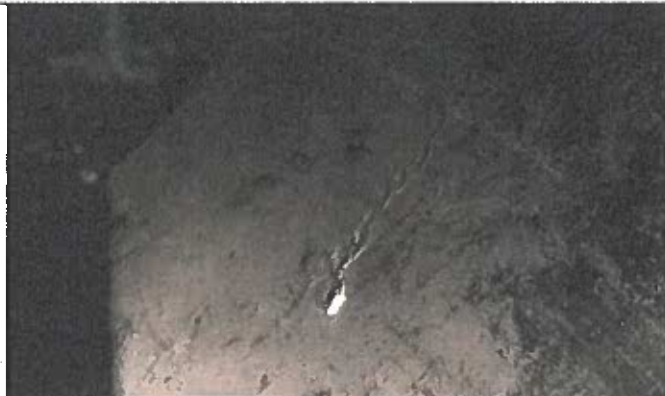
Reference ID: 11

Description: Manway Nozzle 1E mechanical damage and arc strike

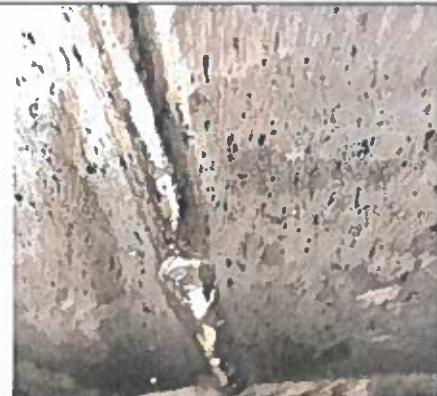
Reference ID: 12

Description: Vertical seam near bottom head of dehydrator. Undercut/weld defect .040" deep

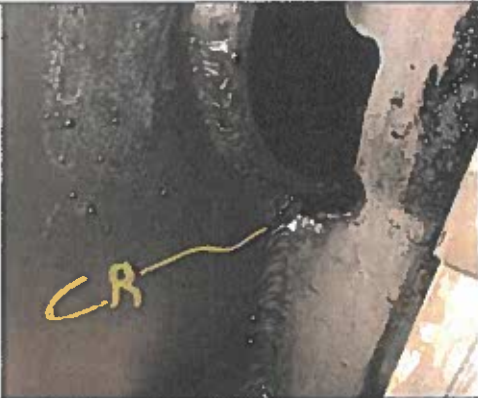
Reference ID: 15

Description: Baffle bracket attachment weld below tray 21. Crack developing at the top of the weld. Weld quality issues, arc strikes, undercutting, buckshot.

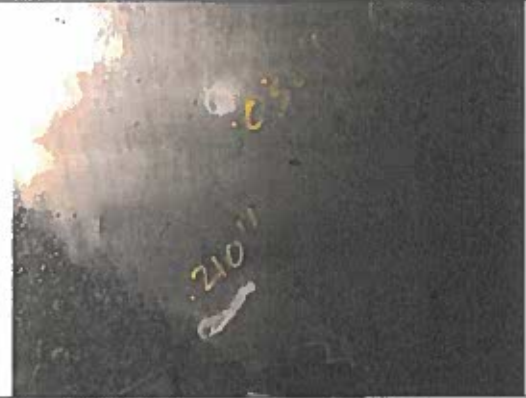
Reference ID: 16

Description: Shell defect areas above tray 21 @ xxx degrees

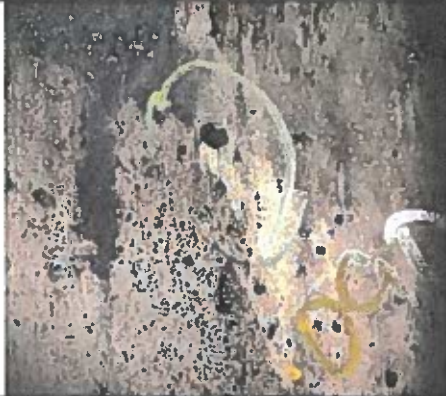
Reference ID: 17

Description: Shell defect areas above tray 22@ xxx degrees. .090 x .325". Arc strikes.

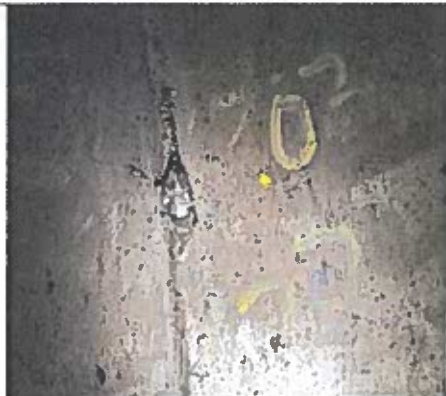
Reference ID: 19

Description: Vertical seam above tray 22. Undercut/weld defect .030" deep, pin hole.

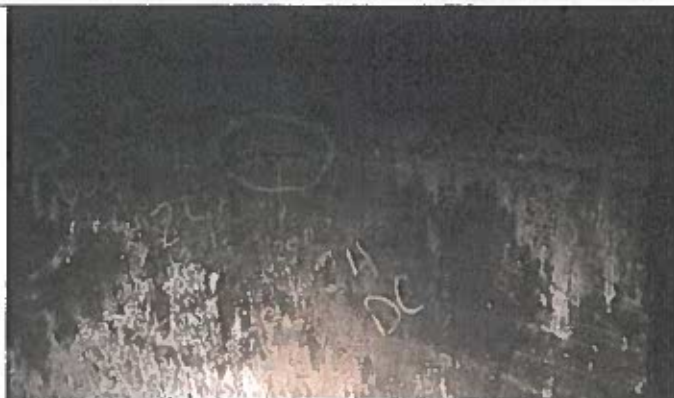
Reference ID: 27

Description: 3 arc gouged areas at tray level 24. Depth as marked

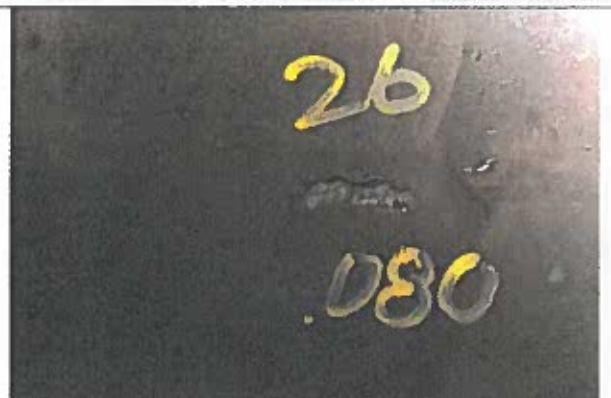
Reference ID: 28

Description: Arc gouged area at tray level 26. .080 x 1.5"

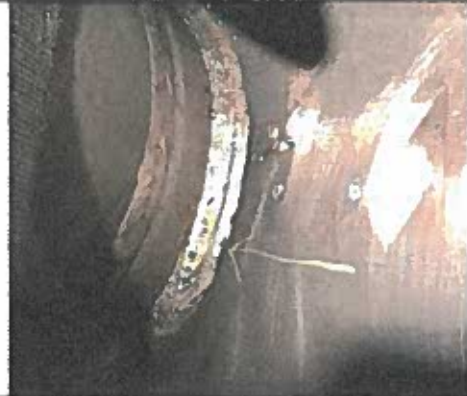
Reference ID: 34

Description: Dehyd Vapor nozzle N 4 fillet weld crater crack, arc strikes

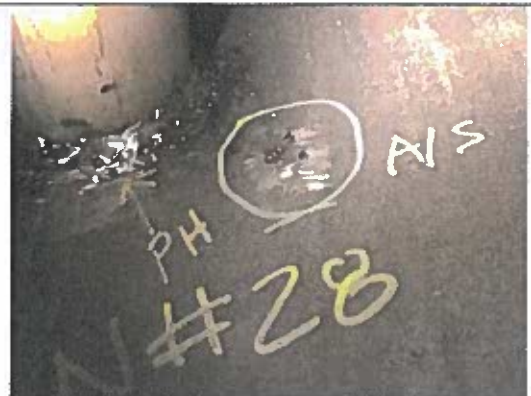
Reference ID: 36

Description: N28 pin hole with crack and arc strike area. .030" depth of arc strikes

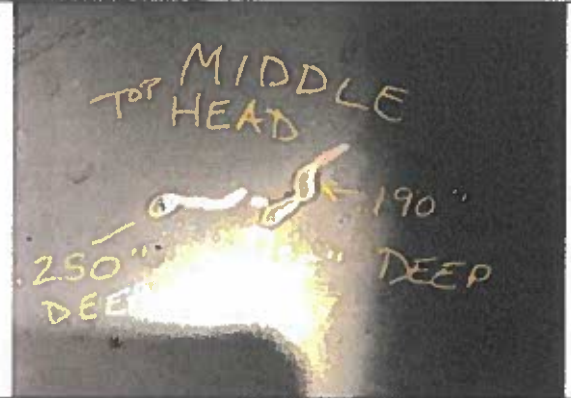
Reference ID: 38

Description: Indications in top head of dehyd (inside of flash drum). Depths as noted

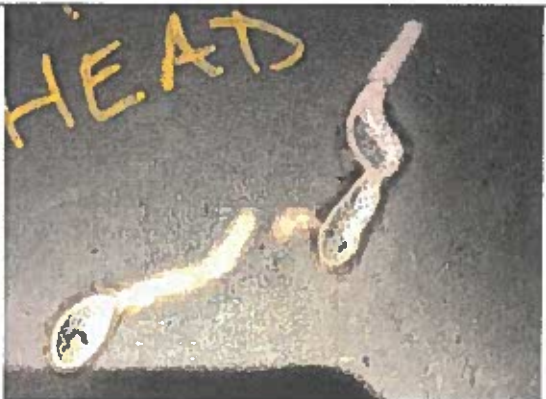
Reference ID: 39

Description: Close up view of item 38

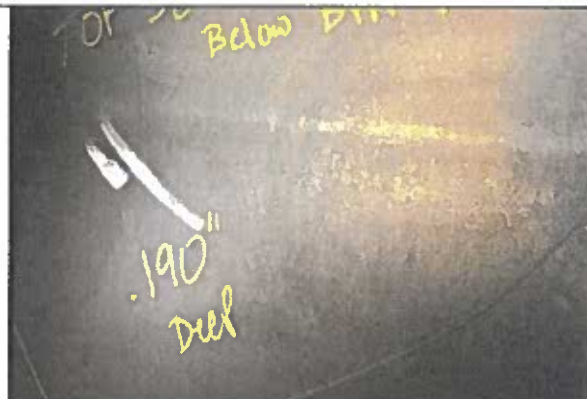
Reference ID: 40

Description: Indication in wall of flash drum. .190 x 2"
