AERIAL ASSESSMENT OF DUTCHMAN CREEK JOHNSON COUNTY, IL December, 2004

Prepared by Wayne Kinney for Illinois Department of Agriculture

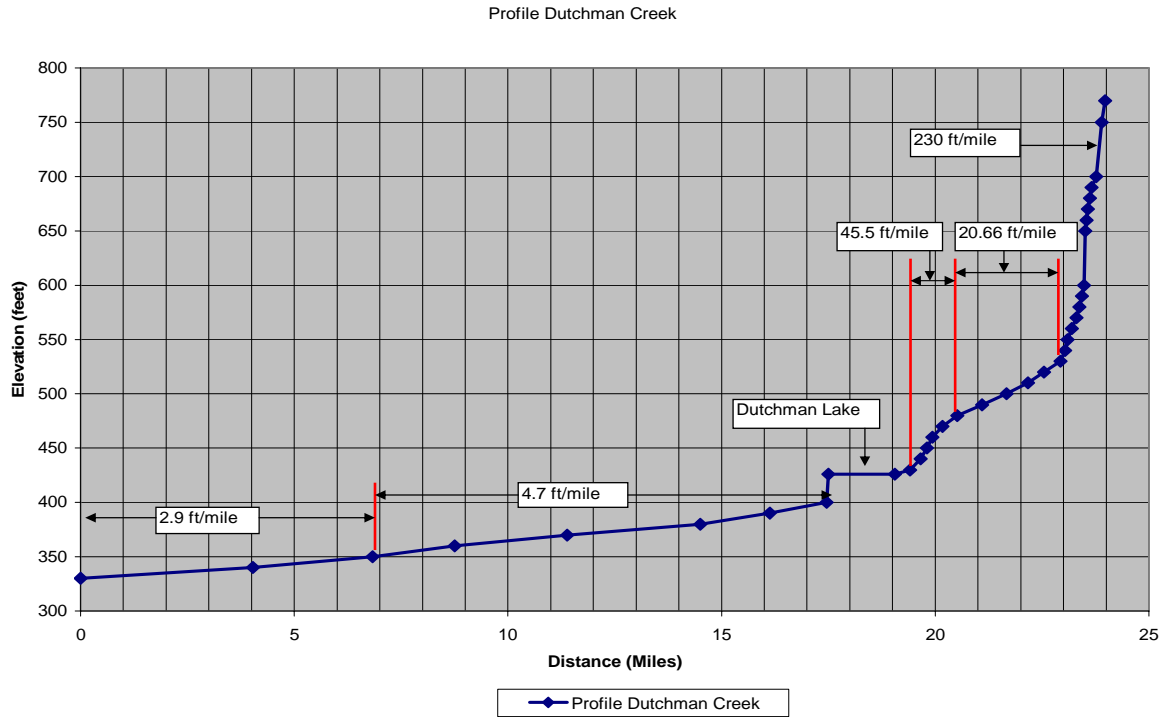
Figure 1. Valley Slope along Dutchman Creek from USGS Topographic Maps

There is a significant difference in the character of Dutchman Creek above Dutchman Lake as compared to Dutchman Creek below Dutchman Lake. First, the valley slope in Dutchman Creek reduces from 45 ft./mile immediately above Dutchman Lake to less than 5 ft./mile below the Lake. (Fig. 1)

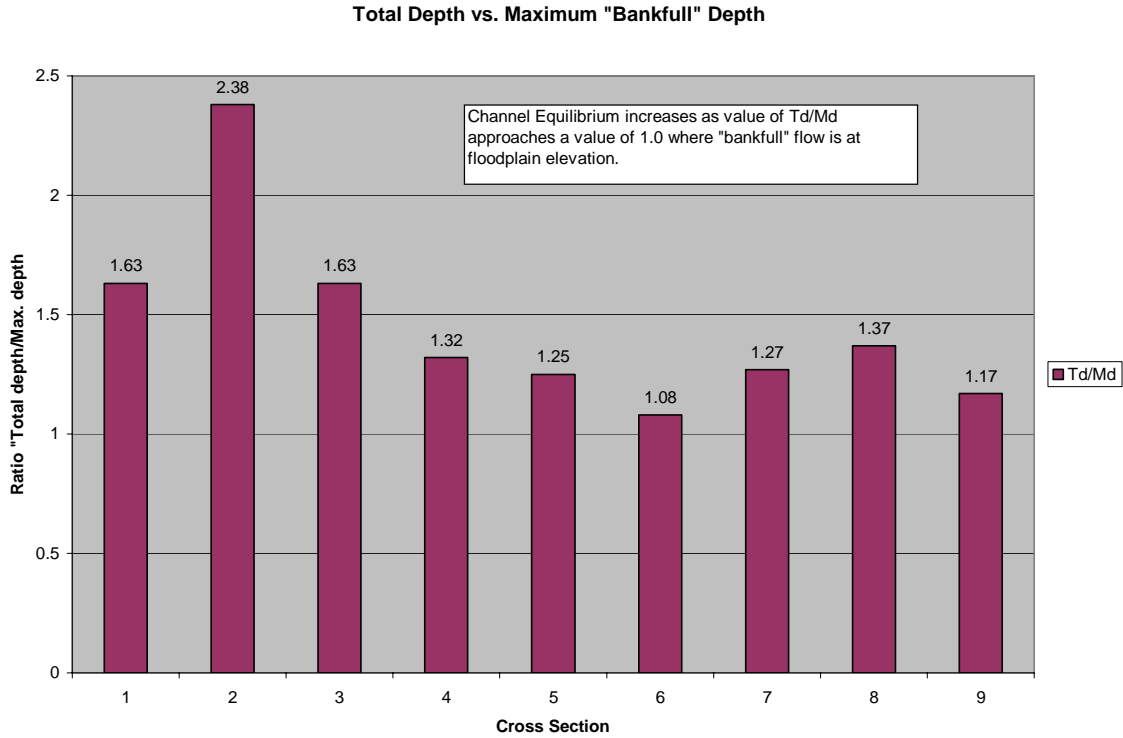
Figure 6. Total Depth at Top Bank compared to Maximum “Bankfull” Depth

Figure 6 shows the greatest incision, at 2.38 times bankfull depth occurs at Cross Section 2. It reduces at subsequent sections downstream to a value of 1.08 times bankfull until reaching Sections 7 and 8 where the incision increases somewhat to 1.27 and 1.37 respectively, before it reduces to 1.17 at Section 9.

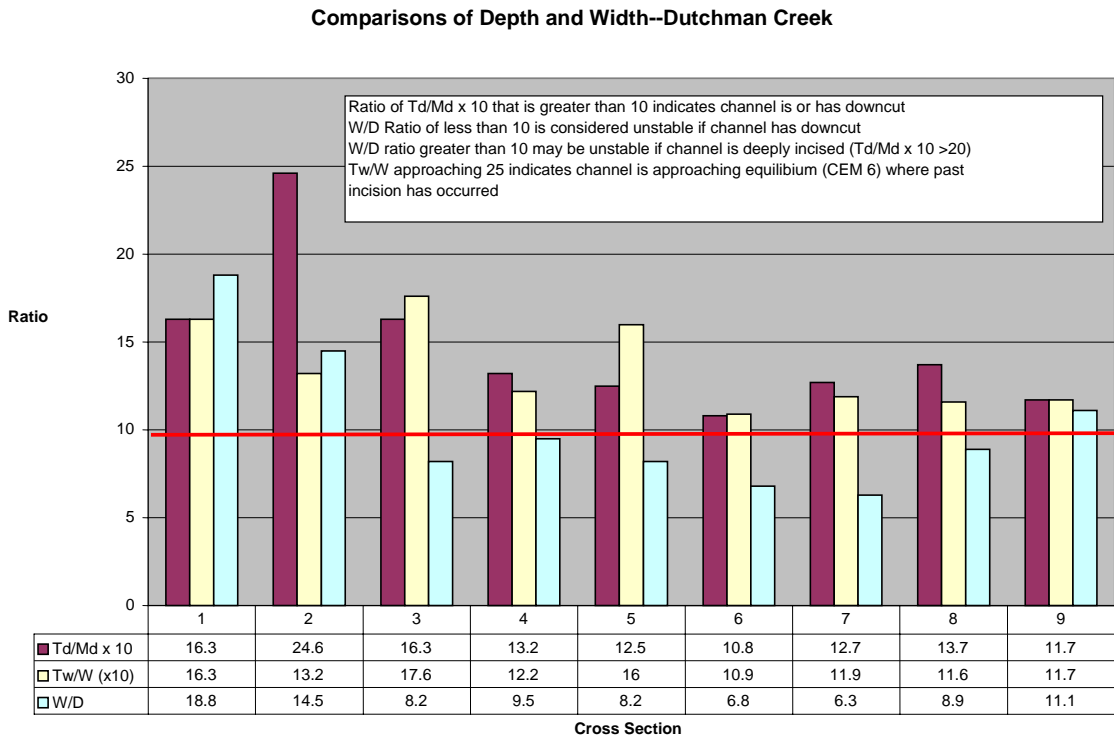
Figure 7. Comparisons of Depth and Width Computations on Dutchman Creek at Cross Section Locations

Although there is insufficient data analysis to assign a CEM stage to this combination of measurements, the following observations can be made. First, values of Td/Md greater than 10 indicate the channel has downcut, with higher values indicating more downcutting and increased separation from the floodplain.

Second, W/D ratios of less than 10 indicates the channel should be considered unstable and widening if the value of Td/Md indicates downcutting has occurred. W/D ratios of more than 10 may also be widening if Td/Md indicates that downcutting has been severe (W/D ratio greater than 20). Third, the Tw/W value indicates the amount of “floodplain” development that has occurred as the channel adjusts to past downcutting. A value of 25, meaning the active floodplain is 2.5 times the bankfull width has been suggested as approaching equilibrium (CEM stage 6).

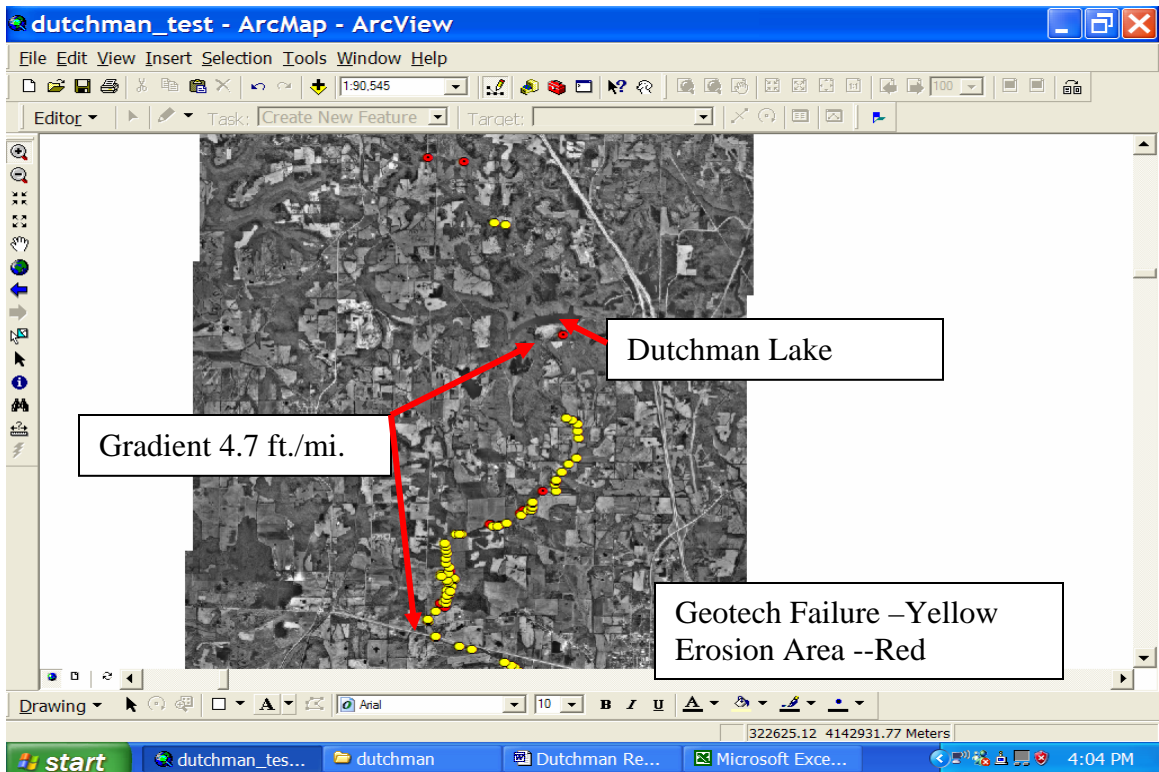
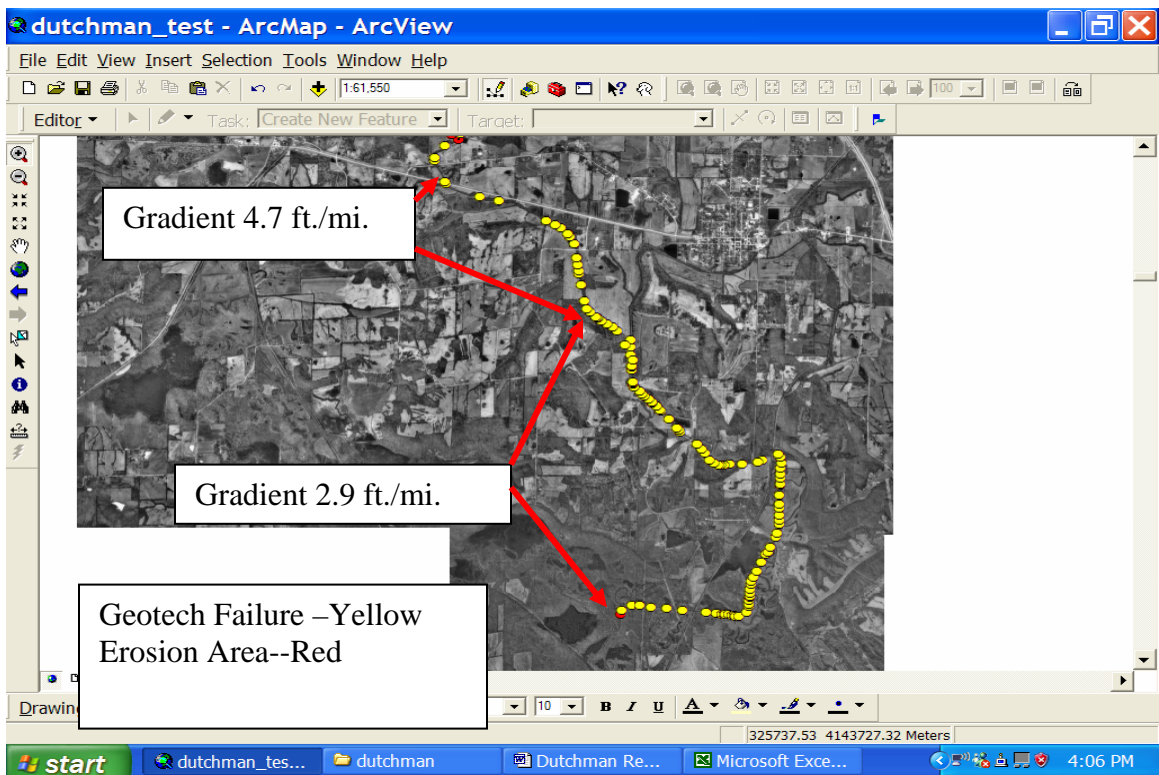
Although Cross Section 9 was also determined to be stable by analysis, it does not agree with the USGS review of the DVD. This discrepancy is probably due to the fact that Section 9 was taken at the only “riffle” location in the lower portion of Dutchman and the field investigation found that this site has been channelized by excavating through a ridge that contained enough large stone and cobble to armor the bed. See Figures 8 and 9.

Fig. 8 Upper Dutchman Creek, above Illinois Route 146

Fig. 9 Lower Dutchman Creek, below Illinois Route 146

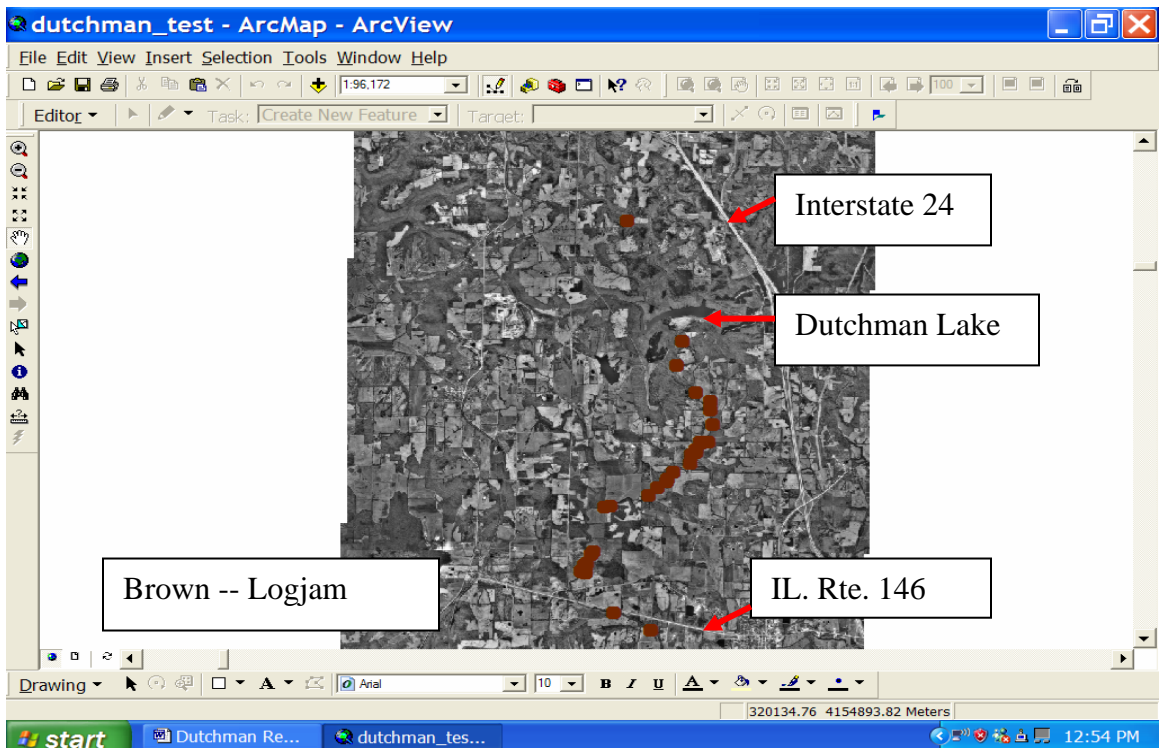
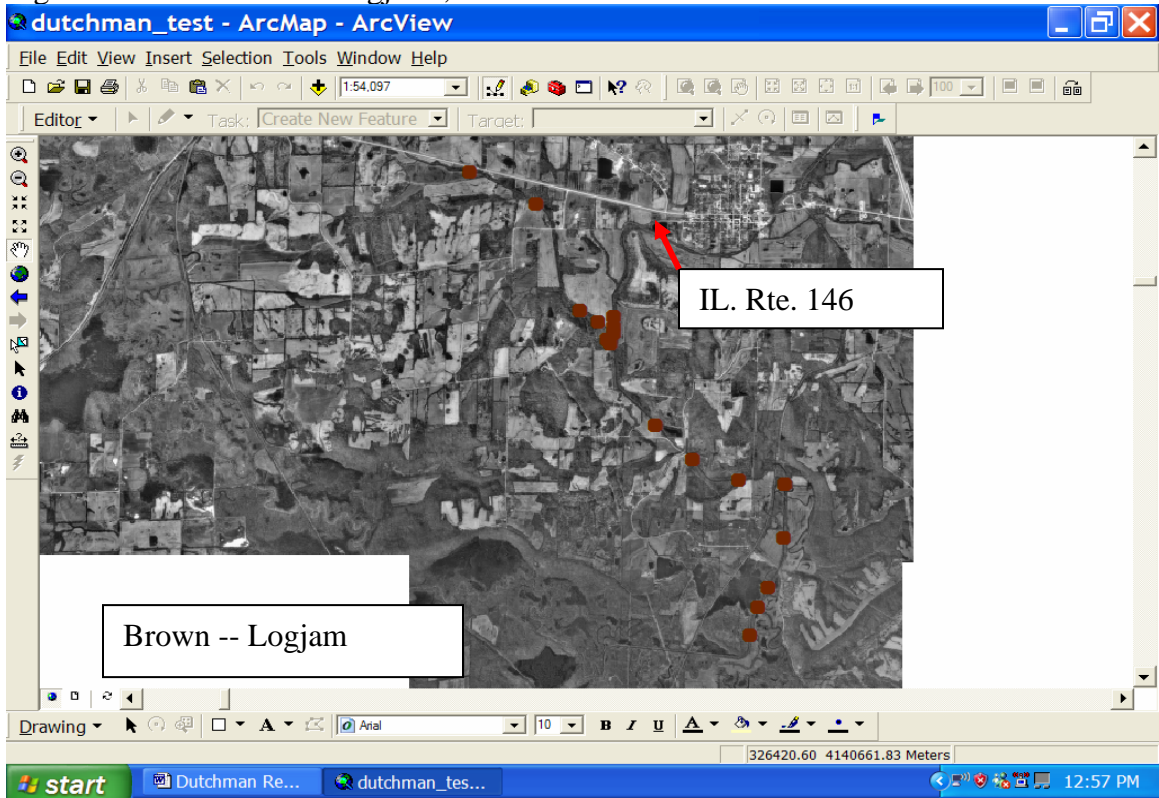
The large bank failures and numerous logjams below Dutchman Lake are presumed to be due to the geotech failures that caused large trees to fall into the channel. See Figures 10 and 11.

Fig. 10 Dutchman Creek Logjams, above Illinois Route 146

Fig. 11 Dutchman Creek Logjams, below Illinois. Route 146

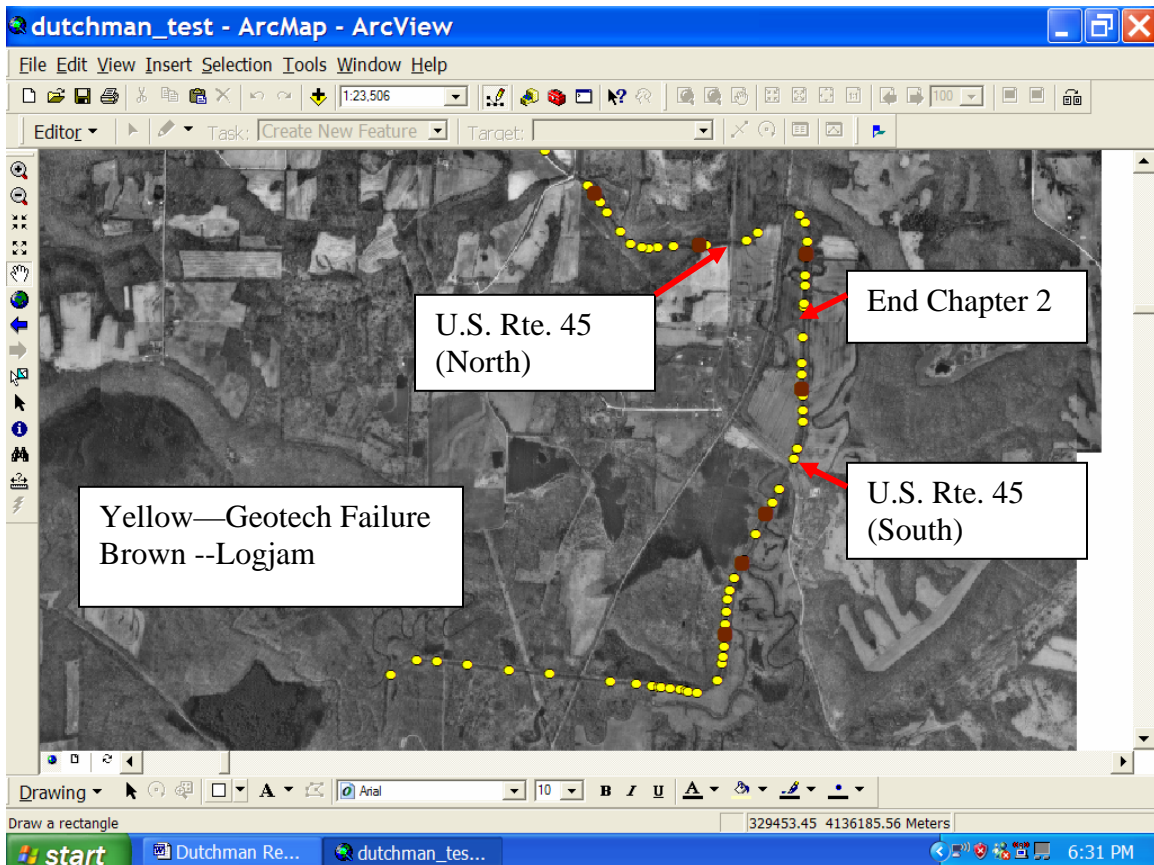
Figure 12. Chapter 2 Dutchman Creek

This section of Dutchman Creek begins at the confluence with the Cache River and continues upstream to a point above the U.S. Route 45 bridge and ends just below cross Section 9. The entire reach has been channelized and has a gradient of about 2.9 ft./mile. There are over 30 geotech failures identified in this reach. They are located all along the channel with no specific area of concentration. There are no grade breaks or riffles in this reach as it is one long slow moving pool about 2.4 miles long.

The bank failures appear to be the result of oversteepened banks, possible due to downcutting, although the pool depth in this reach prevented an accurate cross section from being collected. Downcutting has been identified in the Cache River immediately downstream and Newberry type Rock Riffle Grade Controls have been installed.

A series of Rock Riffle Grade Control Structures is recommended for treating this reach. The height and location of each structure will depend on a design survey and calculations that cannot be made at this time. However, there is only approximately 7 feet of fall in this entire reach, so for re-aeration purposes the structures cannot have a total drop of more than 7 feet plus any increase in water surface profile that can be achieved without causing flood damages.

For estimating purposes, assume 8 Newberry type structures three feet high with a net drop of 1 foot per structure. Each structure will require approximately 650 tons of stone at a cost of \$40 per ton installed. Therefore, each structure is estimated to cost \$26,000 for a total estimated cost of \$208,000. Fig. 13 is an example of a Newberry style rock riffle near Bloomington, Illinois.

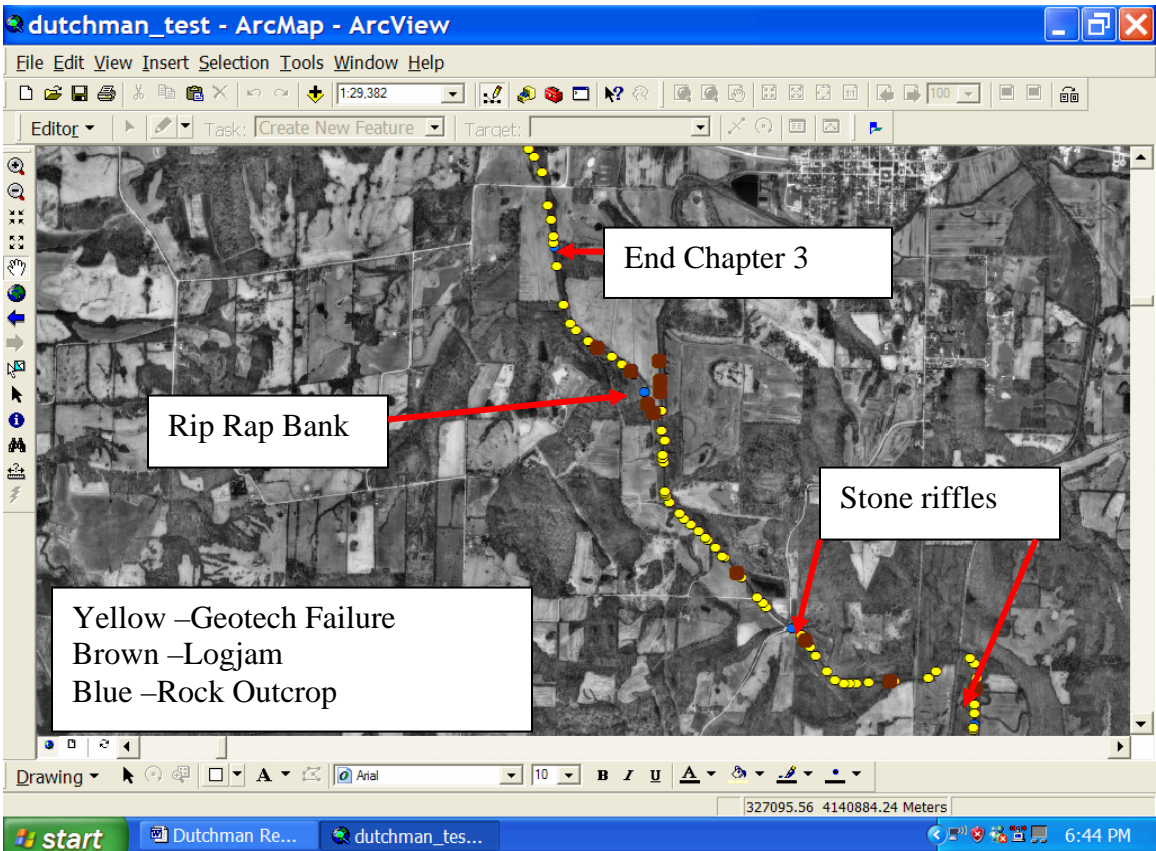
Fig. 15 Chapter 3, Dutchman Creek

This section begins approximately halfway between the two U.S. Route 45 bridges and continues upstream to approximately 0.5 mile below Old Cypress Road. This reach is very similar to Chapter 2 with the addition of two existing riffles where there is some re-aeration occurring. Both of these sites are stone cobble riffles that appear to be stable. Figure 15 shows the location of Chapter 3 and the identified features of geotech failure, logjams and rock outcrops.

This reach has over 40 identified geotechnical failures and at least 8 logjams. The recommended treatment for this 3.25 mile reach is also to construct either Newberry Rock riffles or Rock Cross Vanes. This structure will increase the aeration, create a riffle pool sequence that will help stabilize the banks and reduce the volume of woody debris which is contributing to the logjams.

Unlike Chapter 2, this reach has cross sectional data that suggest the channel has degraded and is still downcutting. In the very upper reach of Chapter 3, the gradient increases from 2.9 to 4.7 ft./mile and the channel bed has exposed residual material that strongly suggest active downcutting. Using available cross section data, it is estimated that the riffles can be 3.0 feet above the existing channel bed without increasing flood elevations.

There is approximately 10 feet of gradient in this reach, therefore the estimate calls for the installation of 8 additional grade control structures around the two existing natural riffles. The channel begins to reduce in width in this reach, especially above the confluence with the Little Cache River, therefore the estimated stone requirements for each riffle in this reach is reduced to 375 tons at a cost of \$15,000. The total estimated cost for riffles in this reach is \$120,000.

There are two additional sites where the channel is migrating into adjacent cropland that can be treated with Stone Toe Protection (STP). Each site is approximately 600 feet long and will require about 750 tons of stone. The estimated cost of placing stone in this reach will be \$25 per ton due to easier access and placement. Therefore, each of these sites has an estimated cost of about \$18,750 for a total cost of \$37,500.

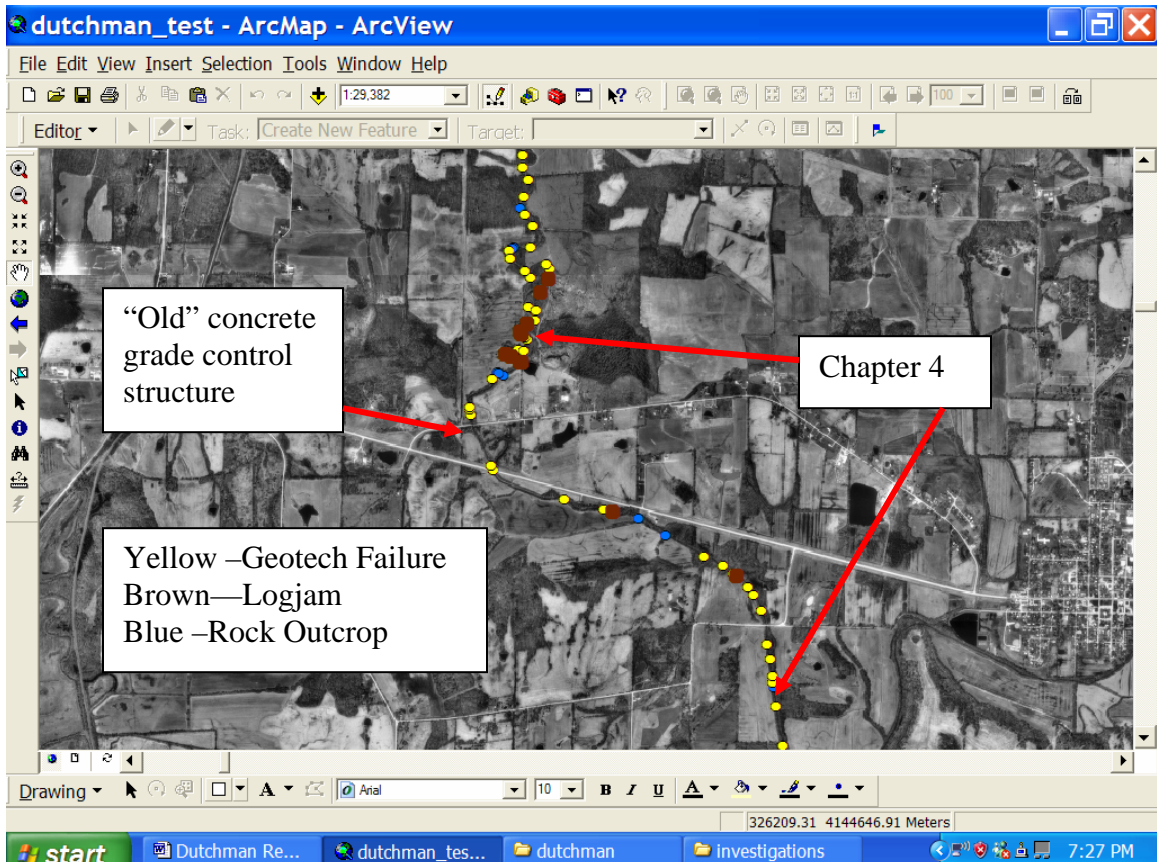
Fig. 16 Chapter 4 Dutchman Creek

This reach begins below Old Cypress Road and continues upstream about 0.75 miles above Old Route 146. The entire reach has a gradient of 4.7 ft./mile. There is a section of this reach below Illinois Route 146 that appears to be near equilibrium. The features of geotechnical failures, logjams and rock outcrops are shown in Fig. 16.

Chapter 4 has less than 20 geotechnical failures identified in 2.7 miles compared to 30 or 40 in chapters 2 and 3. The assessment suggests that the downcutting in Chapter 3 has not migrated as far upstream as Illinois Route 146, but is above Old Cypress Road. In addition there is an old concrete grade control structure just below the Old Route 146 bridge (DVD time 18:25). However, the structure is not in good shape and cannot be depended on to halt any downcutting. This structure demonstrates that with fine bedload, grade controls can be spaced farther apart without losing the ability to pass bedload.

The recommendation for Chapter 4 is to again install Newberry Rock Riffle Grade Control Structures or Cross Vanes to control bed instability and increase aeration. Even though the stream is near equilibrium below Route 146 the grade controls should be built along the entire reach to gain the maximum aeration possible.

There is about 12 feet of gradient in this reach so it may be possible to build 12 grade control structures with one foot of effective height. Since the channel is considerably smaller in this chapter, each riffle will require only about 250 tons of stone and cost an estimated \$10,000 each. The total estimated cost of treatment for Chapter 4 is \$120,000.

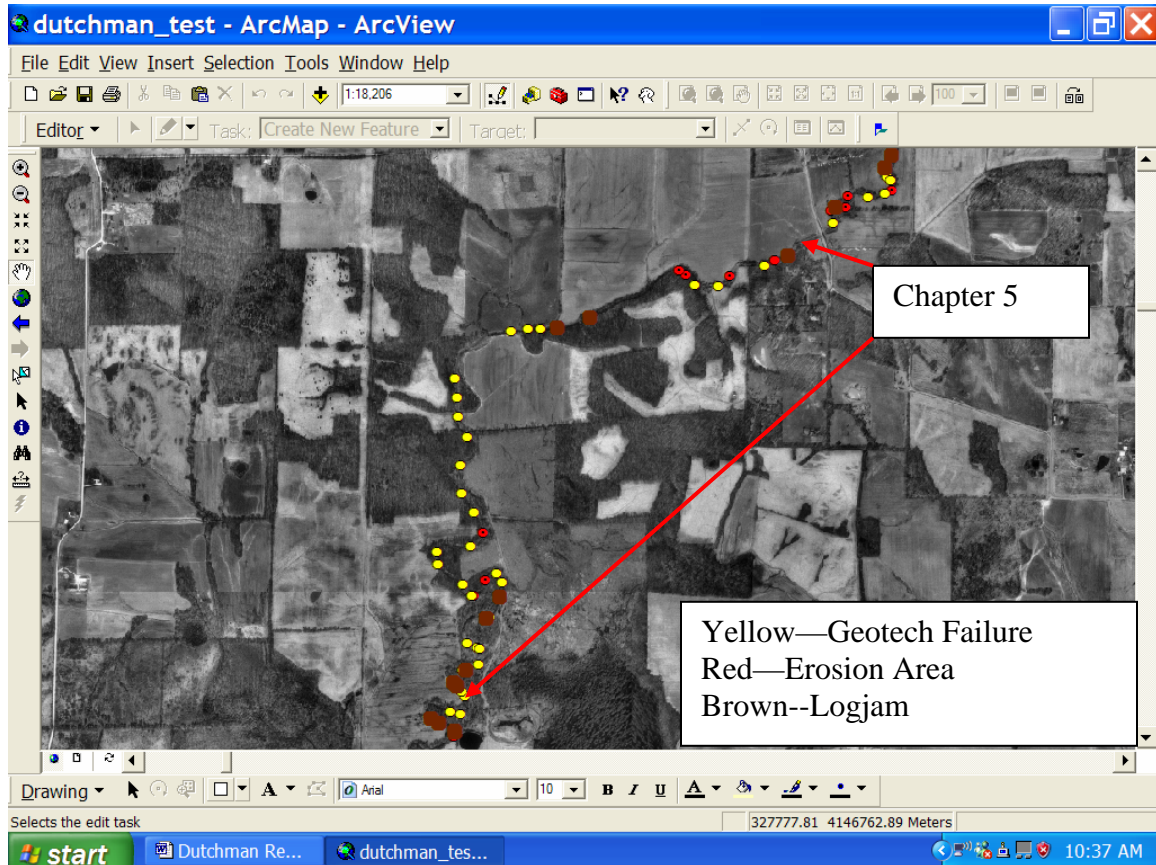
Fig. 17 Chapter 5 Dutchman Creek

This reach is approximately 2.25 miles long with 26 geotechnical failures and 6 erosion sites identified. Cross section 4 is located very near the upper end of Chapter 5 and there is a “knickzone” at this location. Therefore, the channel stability identified at Cross Section 5 below Illinois Route 146 is an isolated segment with downcutting occurring above and below.

Chapter 5 also has the first sites identified as erosion sites rather than geotechnical failures. The erosion sites are on outside bends and represent bank failure due to scouring action rather than soil conditions, although there is likely a component of both present at some sites. These erosion sites then become candidates for lateral bank stabilization and also present another opportunity to create turbulence and therefore re-aerate the flow. The recommendation for Chapter 5 will include grade control and bank protection.

The entire reach of Chapter 5 is recommended for grade control, and with a total of approximately 11 feet of gradient in this section there is opportunity to build 11 structures with each having a 1.0 foot of net overfall. Each riffle will require approximately 250 tons of stone at a cost per riffle of \$10,000. The estimated total cost for riffles will be \$110,000.

Potential Stream Barbs locations are found at DVD times of 20:19, 21:28, 23:19, 23:39, 23:48, 24:37 and 25:00. Each site is estimated to require an average of five Stream Barbs at 50 tons each for a total of 250 tons or \$7500 per site. The total estimated cost for Stream Barbs in Chapter 5 is \$52,500.

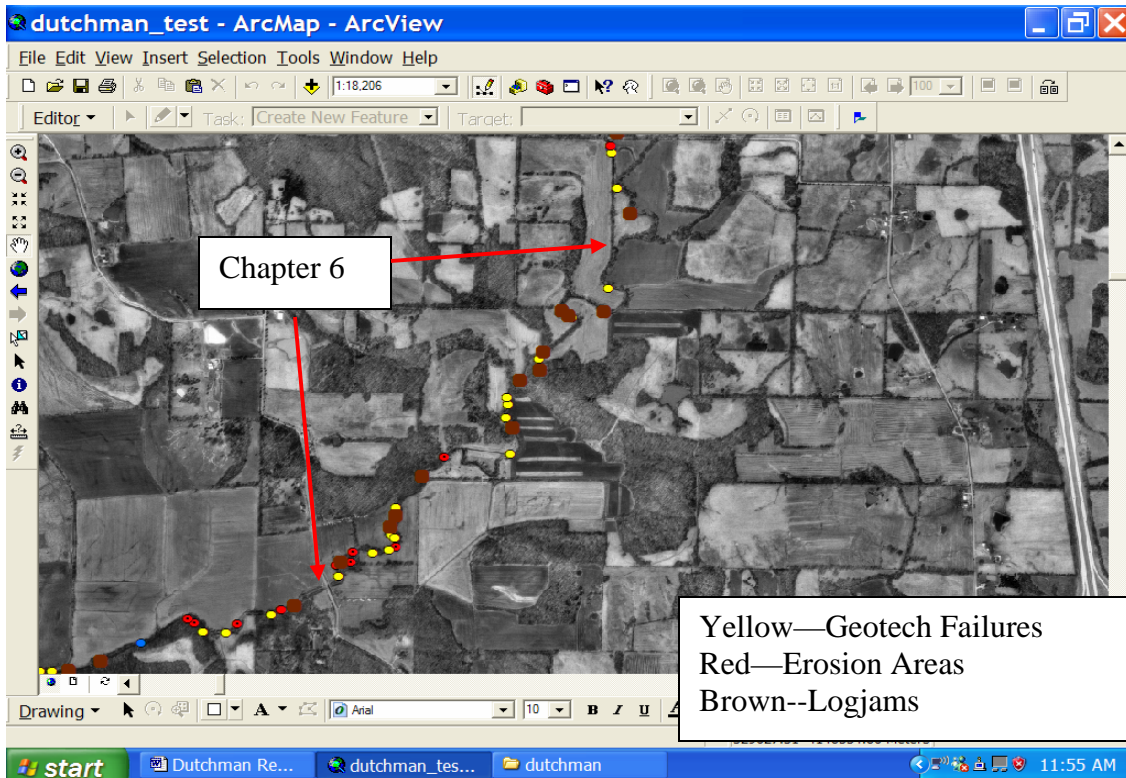
Figure 18 Chapter 6 Dutchman Creek

This chapter is approximately 2.2 miles long with 13 identified geotechnical failures and 5 erosion sites. (Fig. 18) There are no identified grade controls other than two field road crossings, therefore the downcutting from Chapter 5 can and has moved through Chapter 6. In addition, there are some reaches of channel that have been straightened, which are contributing to the downcutting problems.

There is approximately 10 feet of gradient in this reach allowing for approximately 10 grade control structures with 1 foot of net overfall. The stone required for each structure in this reach will be approximately 225 tons for a cost of \$9,000 per structure. The total estimated cost for grade control in Chapter 6 is \$90,000.

The 5 erosion sites needing lateral bank stabilization are at DVD times of 25:52, 26:10, 28:22, 29:36, and 29:55. Stream Barbs are recommended at each site for the same reasons as stated for Chapter 5 and the cost per site will be the same. The estimated cost to install Stream Barbs at 5 sites in Chapter 6 is \$7500 per site or \$37,500 for all 5 sites.

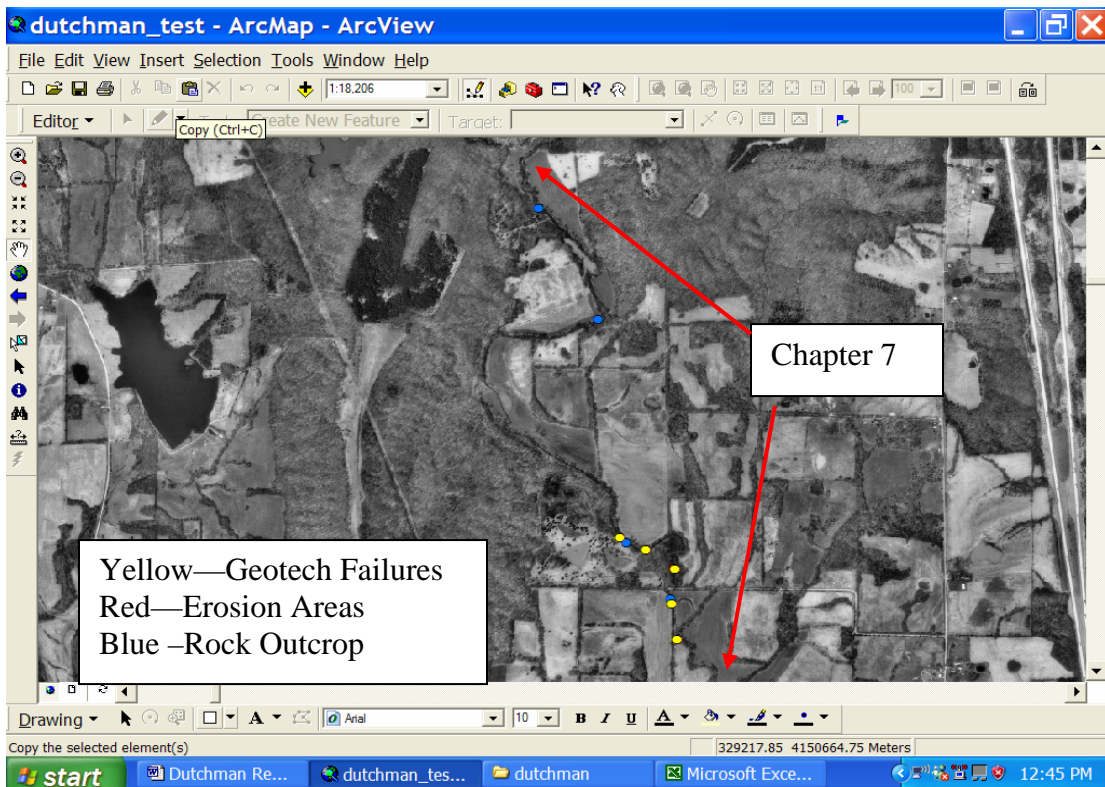
Fig. 19 Chapter 7 Dutchman Creek

This reach begins below Brown Road and extends upstream for approximately 2.2 miles. This reach has only 5 geotechnical failures identified and 2 erosion sites (See Fig. 19).

The recommended treatment for Chapter 7 is to install grade control with 1 foot of net drop allowing for about 10 structures in this reach. As in chapter 6, the cost per structure will be \$9,000 for a total cost of \$90,000.

There are erosion sites at DVD time 30:46, 30:59 and 31:46 that can be treated to prevent lateral migration and also increase aeration. Each site is suitable for approximately 4 Stream Barbs at a cost of \$6,000 per site for a total of \$18,000.

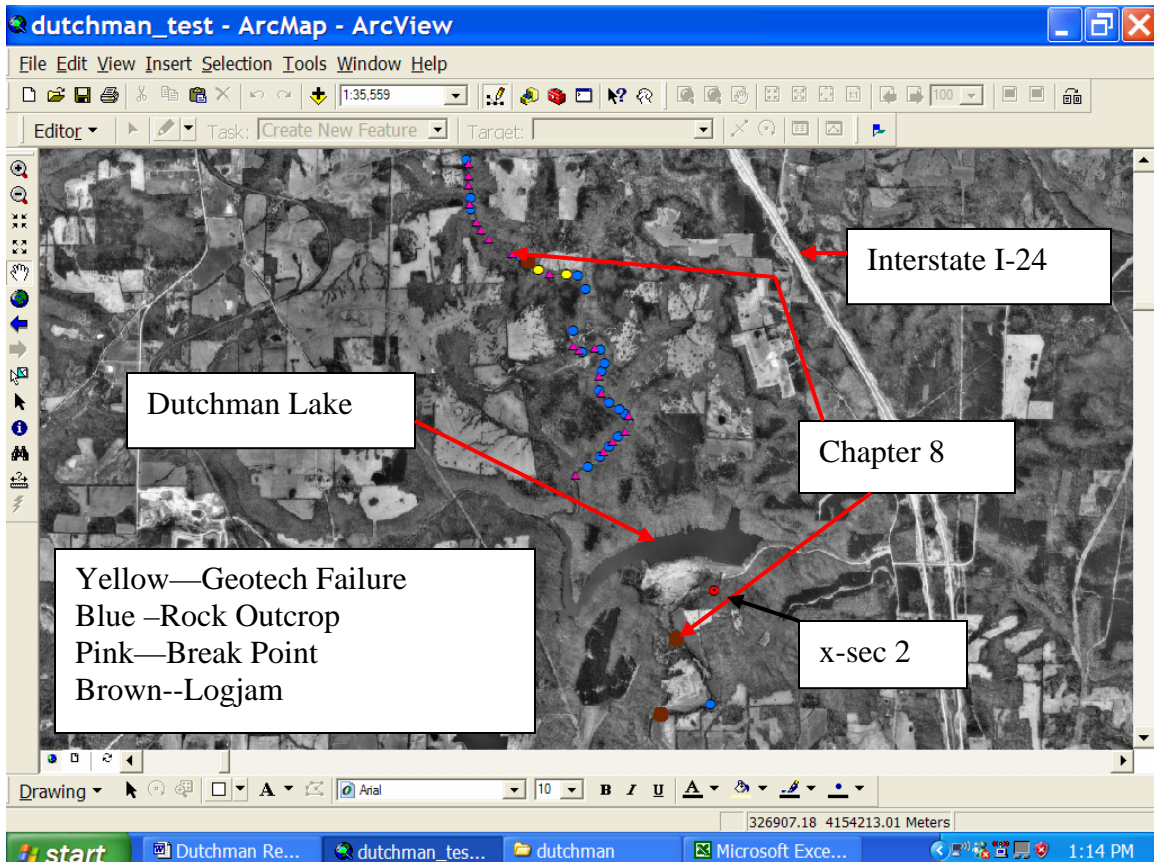
Fig. 20 Chapter 8 Dutchman Creek

Chapter 8 begins below Dutchman Lake and continues upstream past the lake. (Fig. 20) Since there is a significant difference in the channel above the lake, the recommendations for this reach will be divided into two segments.

Below Dutchman Lake: This reach is only 0.6 mile in length and has no identified problem features. Cross section 2 is located in this reach and shows the channel to be severely incised and bank failure can be anticipated. The stability currently present is probably due to the rock outcrops in this reach. The gradient is 4.7 ft./mile and there is only about 3 feet of gradient in this reach, therefore only 2 grade controls can be built. The estimated cost for each structure is \$9,000 each, therefore the total cost is \$18,000 for this reach.

One additional element that may be incorporated is to examine the possibility of adding a boulder field or other energy dissipation device at the outlet end of the principle spillway on Dutchman Lake. The turbulence generated as the overflow operates could do quite a lot of aeration considering the velocity of flow in the spillway pipe. There is no cost estimate for this recommendation as more investigation and consultation with NRCS will be required before any modification to the outlet structure can be recommended.

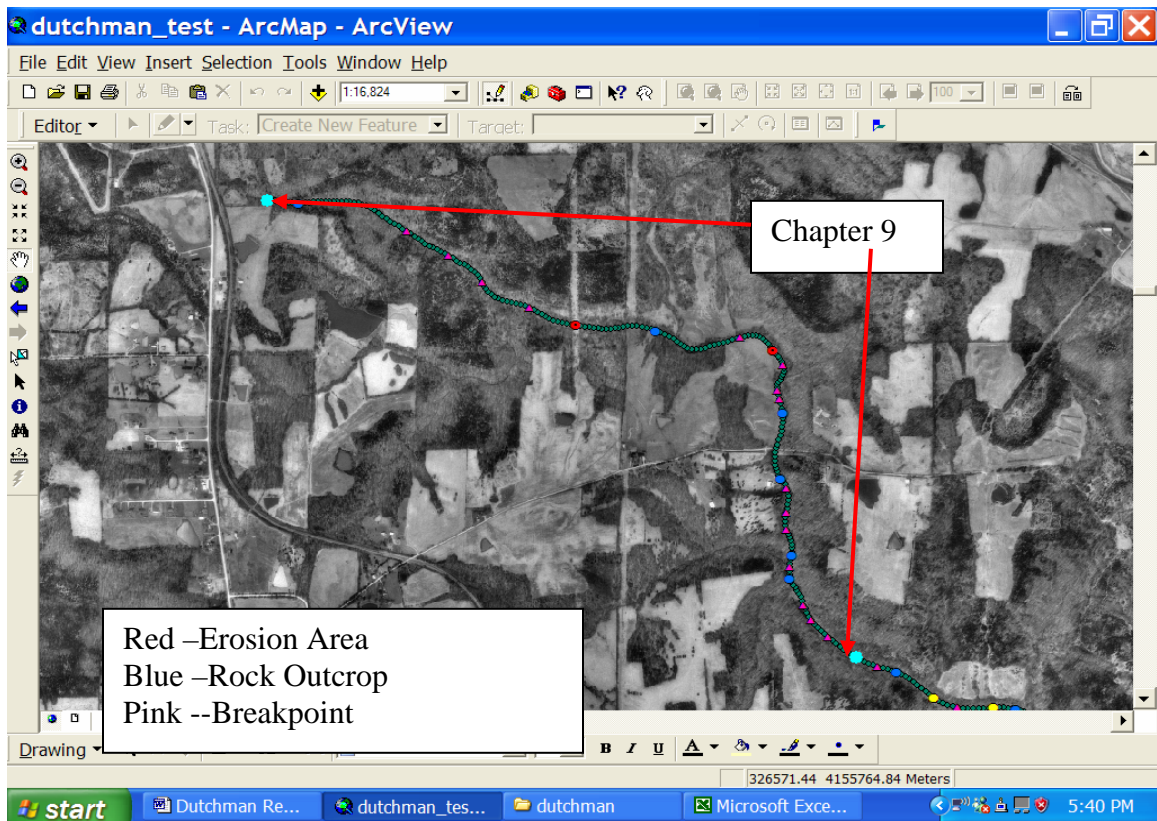
Fig. 21 Chapter 9 Dutchman Creek

This reach of approximately 2.3 miles begins with about 1.3 miles on a 20.6 ft./mile gradient and then increases to approximately 230 ft./mile for the remaining 1.0 mile (Fig. 21). There are 15 breakpoints, 6 rock outcrops and only 2 erosion areas identified in this reach. Similar to Chapter 8 above the lake, there is little need to add instream structures for aeration in this reach.

The two erosion areas are in pastureland at DVD time 42:09 and 42:56 and can be easily treated with Stone Toe Protection. Each is about 200 feet long and can be treated with 0.75 ton/ft. of stone at a cost of approximately \$5,000 each. Therefore, the estimated total cost of treatment for Chapter 9 is \$10,000.
