**AERIAL ASSESSMENT OF THE LITTLE WABASH RIVER
COLES, SHELBY, EFFINGHAM AND CLAY COUNTIES**

June, 2005

Prepared by Wayne Kinney for IL. Dept. of Agriculture

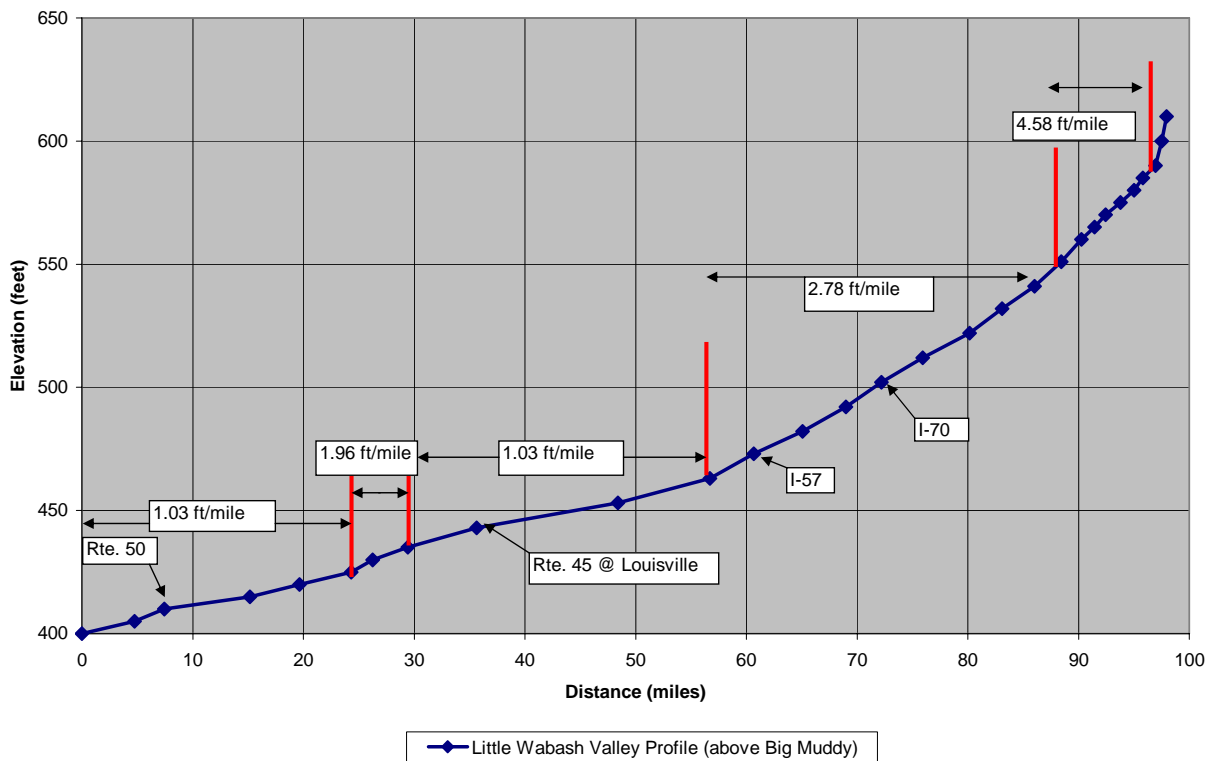
Figure 3. Valley Slope Little Wabash River

The Little Wabash is joined by the Big Muddy Creek at approx. 400 MSL and has a gradient of 1.03 ft/mile for approx. 20 miles. The USGS topographical maps then show an increase in gradient to 1.96 ft/mile for approx. 7 miles before returning to a gradient of 1.03 ft/mile for an additional 30 miles. The increased gradient in this 7 mile reach is disregarded for this study as this reach contains an existing dam on the Little Wabash and a pumping station for the Clay City water supply. Without an accurate channel profile it is assumed that this change in gradient is simply a result of the difference in water surface elevation found above and below the dam. (see Figure 3)

Approximately 57 miles above the Big Muddy Creek confluence and 4 miles below Interstate 57 the gradient increases to an average of 2.78 ft/mile for approx. 32 miles before again increasing to 4.58 ft/mile for 8 miles before reaching Lake Mattoon. There is also a dam on the Little Wabash just below U.S. Rte. 40 that creates a reservoir that the City of Effingham pumps for a portion of its water supply. Curiously there is no change in gradient found on the valley profile created from the USGS topographic maps as there is near the Clay City dam. Further evaluation of the gradient below the Clay City dam may be warranted to determine if there is an actual increase in gradient within this reach.

2. The valley slope changes very near the change in bank failure mode (between chapters 8 and 9 and near x-sec 6) from 1.03 ft/mi. in the lower reaches to 2.78 ft/mi. in the upper reaches. (see Fig. 3)

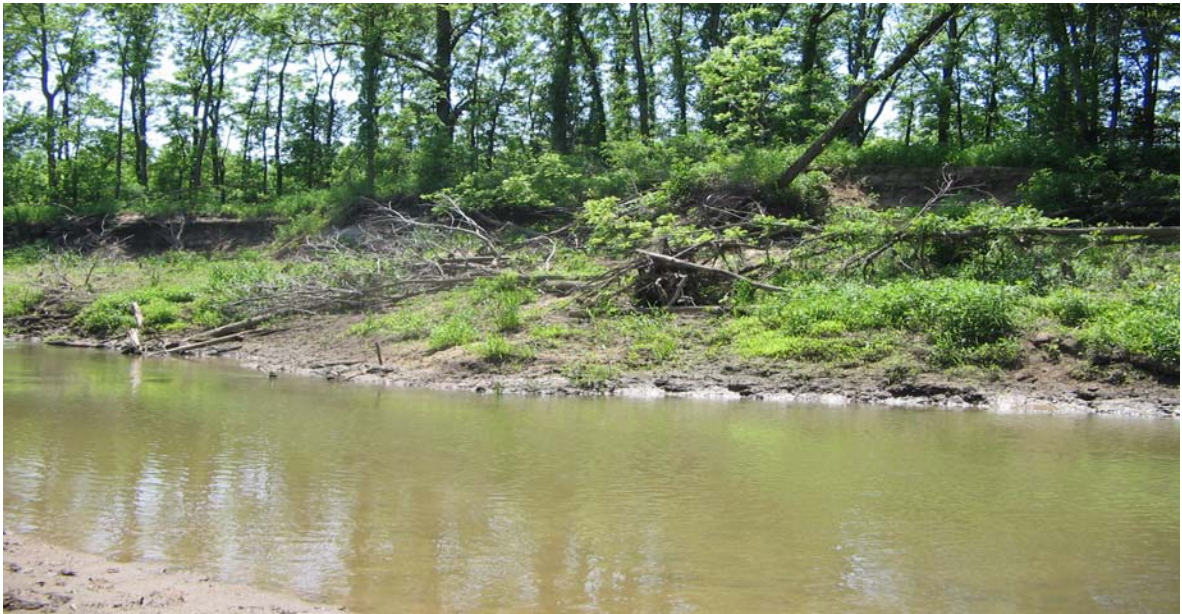
1. Erosion on the middle section of the study area in Chapters 4 thru 9 is classified as primarily “geotechnical failures” caused by soils and geology found in the bank material and stratigraphy. Erosion on the upper and lower portion of the study area however is primarily classified as “bank erosion” caused by channel flows. If the study is divided in three sections, middle, lower and upper reaches with the middle section being chapters 4 thru 9 a very significant change is noted. The lower and upper reaches have “bank erosion” occurring at a ratio of nearly 10 to 1 over geotechnical failures (479 to 50) while the lower reach has geotechnical failures occurring at nearly 15 to 1 over “bank erosion” (536 to 36). (see Fig. 5)

Fig. 4 Geotech Failure near X-sec 6 below Interstate 57.

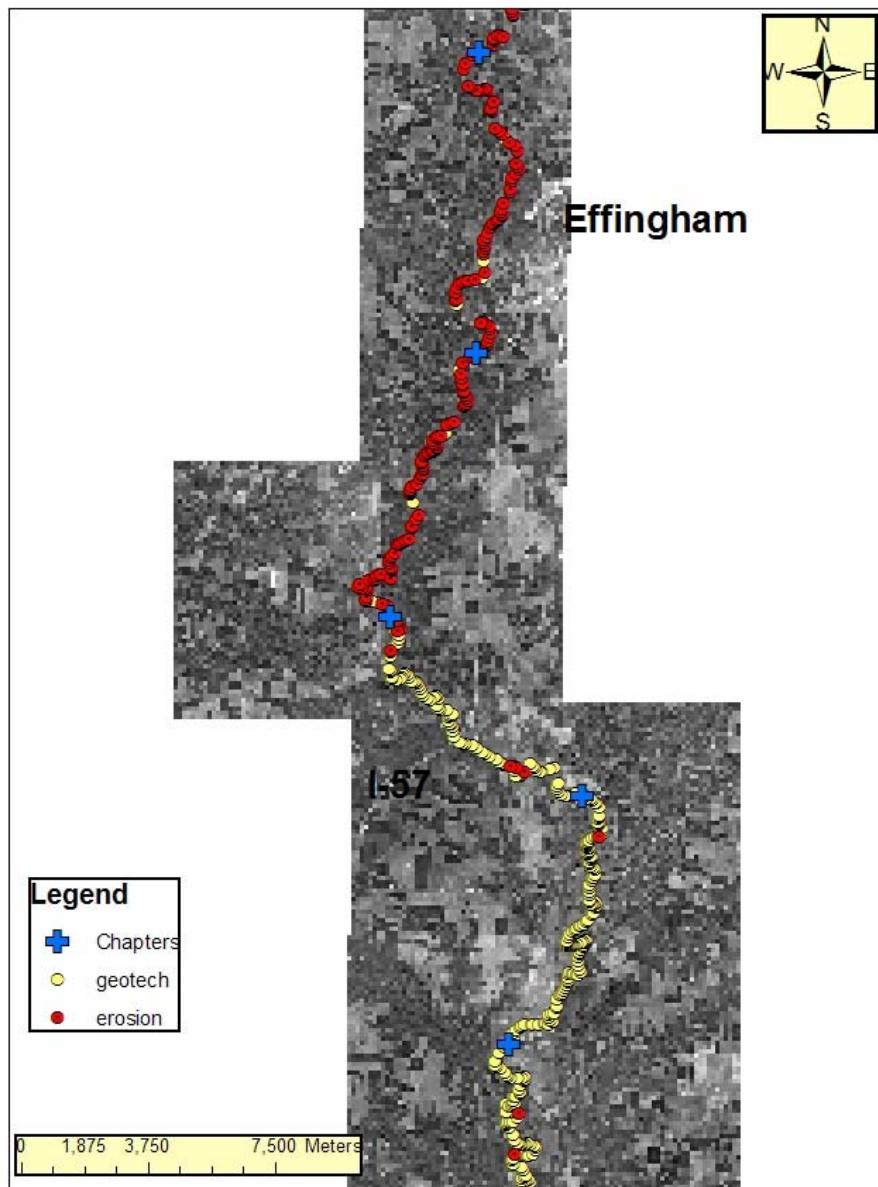
Comparison of Bank Erosion and Geotechnical Failure Locations in Effingham County

Figure 5. Comparison of Bank Failure Mode: Change in mode occurs abruptly just above Interstate 57. Another abrupt change occurs northwest of Clay City between chapters 3 and 4.

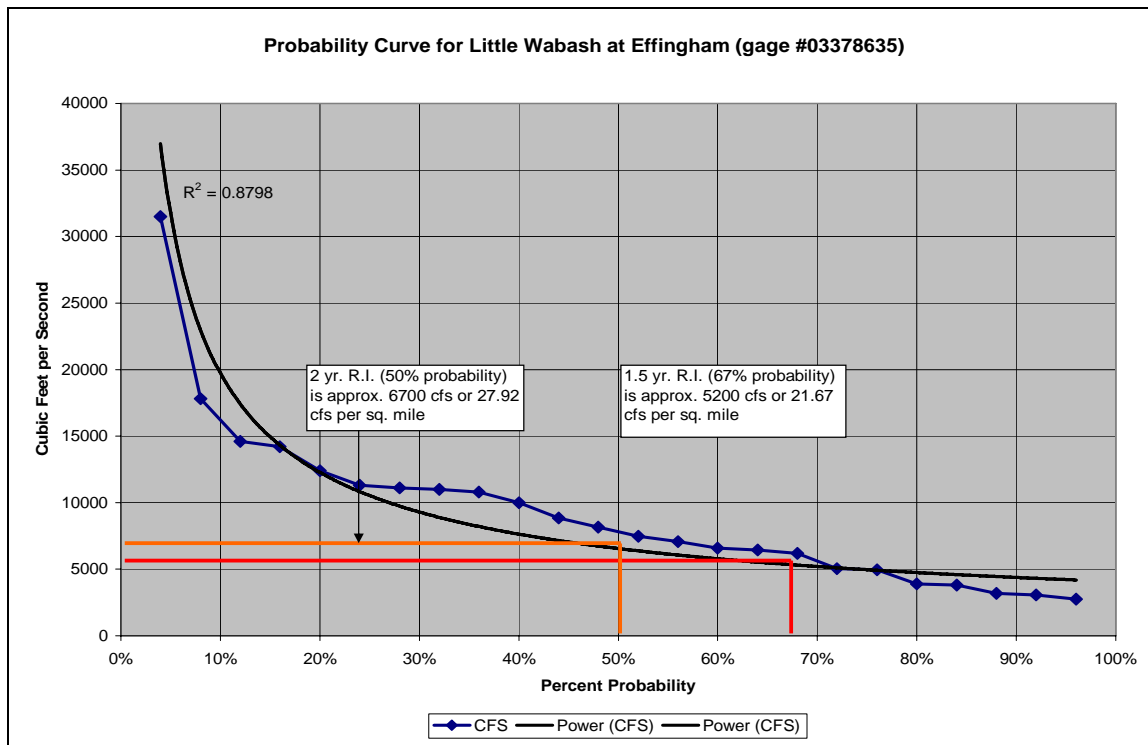
3. Below x-sec 7 the velocity drops from 4.2 ft/sec. to around 2.0 ft/sec.
4. Cross section 1 (chapter 13) carries 55% of predicted Q₂ discharge at top low bank elevation. A Probability Curve plotted for Gage #03378635 (Fig. 11.--1981 to 2004 data) shows the 1.5 yr. return interval storm to be about 78% of the 2 yr. maximum peak discharge. The 55% figure at X-sec 1 then equates to an approx. return interval of less than 1.05 R.I. and by definition makes top bank the “geomorphic bankfull”.

Fig. 11 Probability curve for Maximum Annual Peak Discharge USGS Gage #03378635

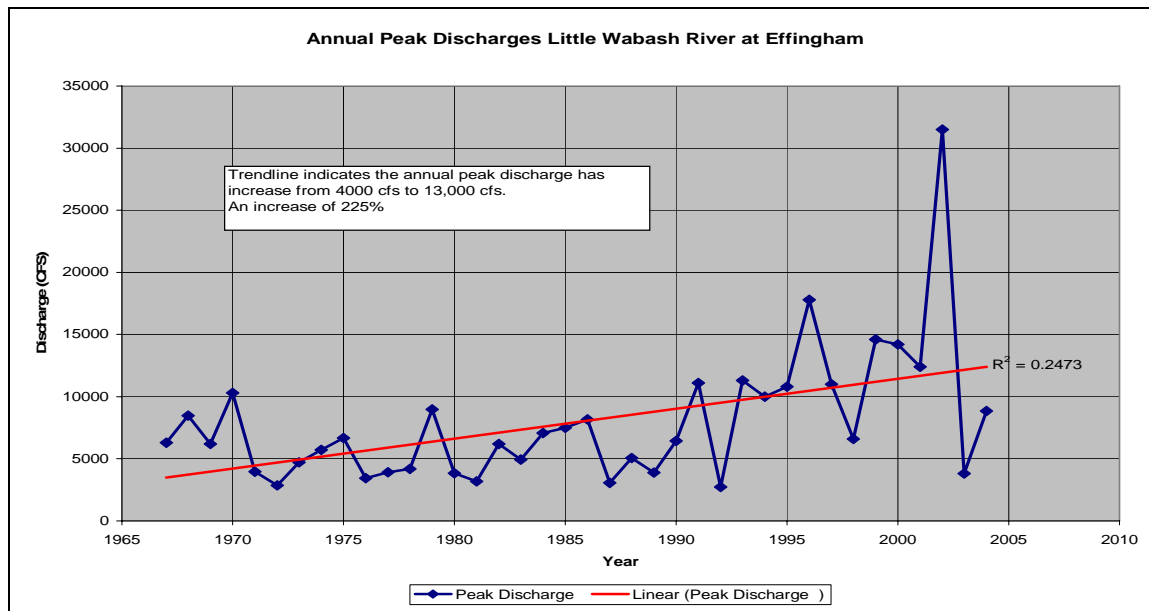
10. A second plot of the Annual Maximum Peak Discharges at both gages indicates an upward trend in peak flows of approx. 225% since records have been collected at Effingham beginning in 1967(Fig. 13). A plot of the Annual maximum Peaks at Clay City indicate an increase of 47% over the same time period (Fig. 14).

Fig. 13 Linear Trendline for Annual Maximum Peak Discharges USGS Gage #03378635 from 1967 thru 2004.

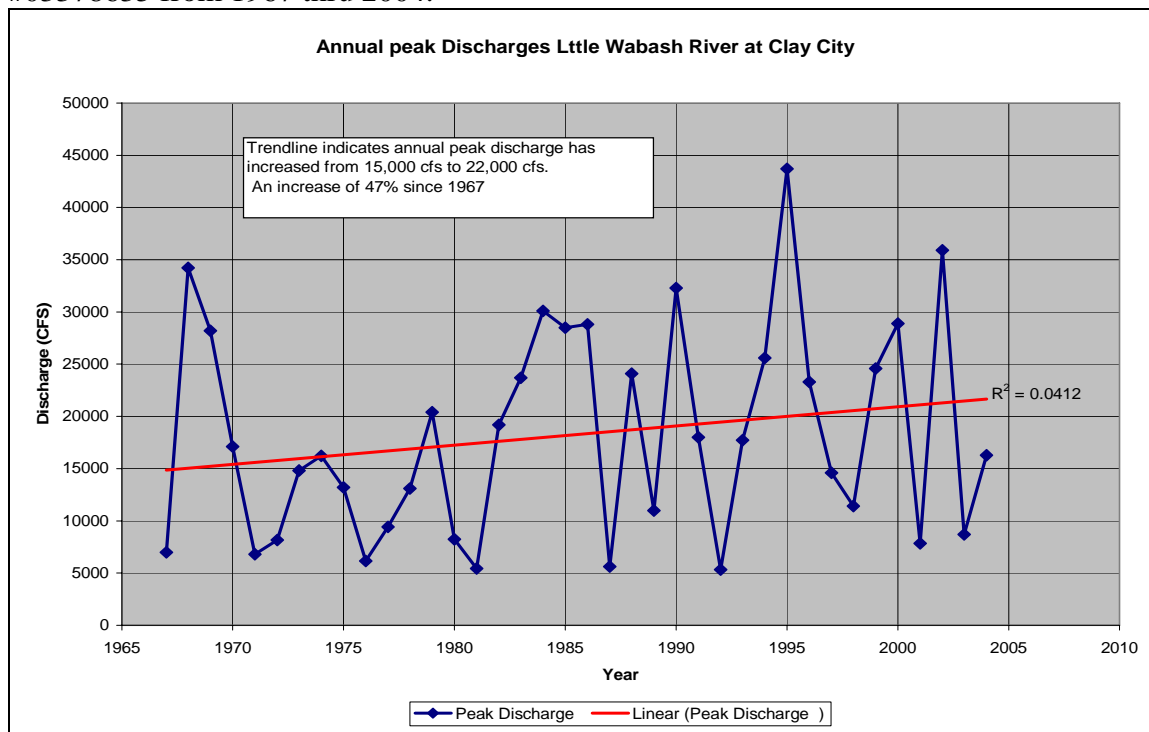
Fig. 14 Linear Trendline for Annual Maximum Peak Discharges for USGS Gage # 03379500 from 1967 thru 2004

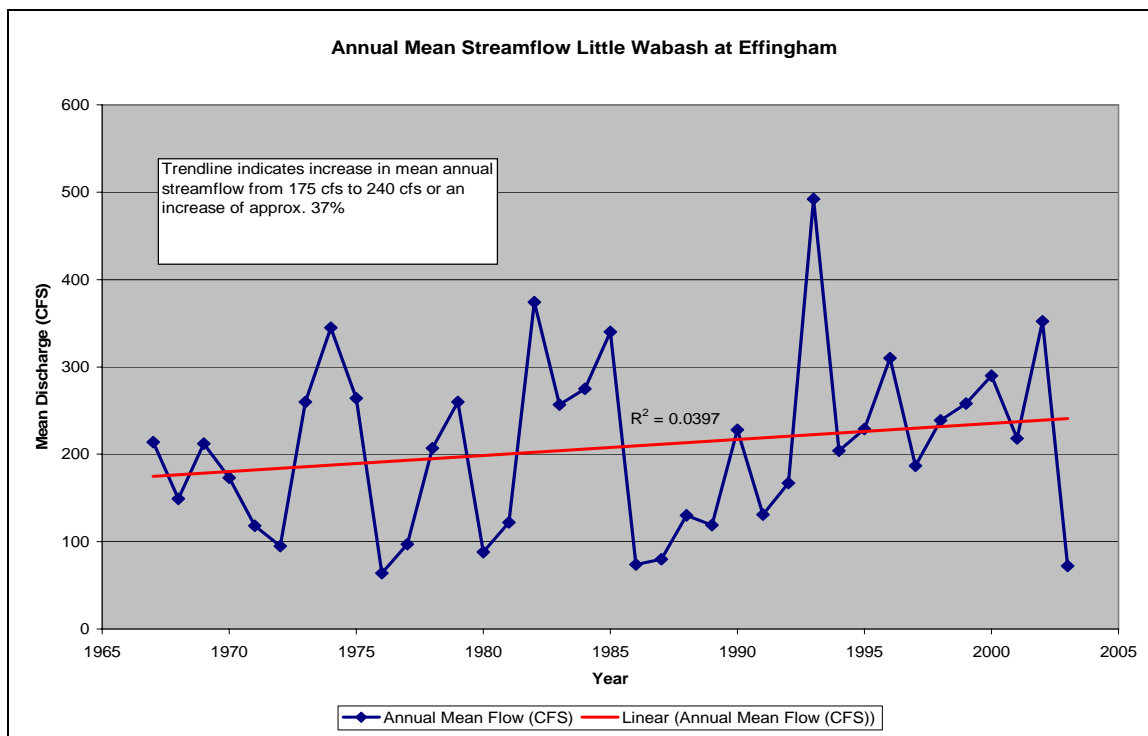
Fig. 15 Linear Trendline for Annual Mean Flow, USGS Gage #03378635 for 1967 thru 2003

11. A third plot of the Annual Mean Streamflow records over the same period at the same gages shows an increase of 37% at Effingham(Fig. 15) and 27% at Clay City(Fig. 16).

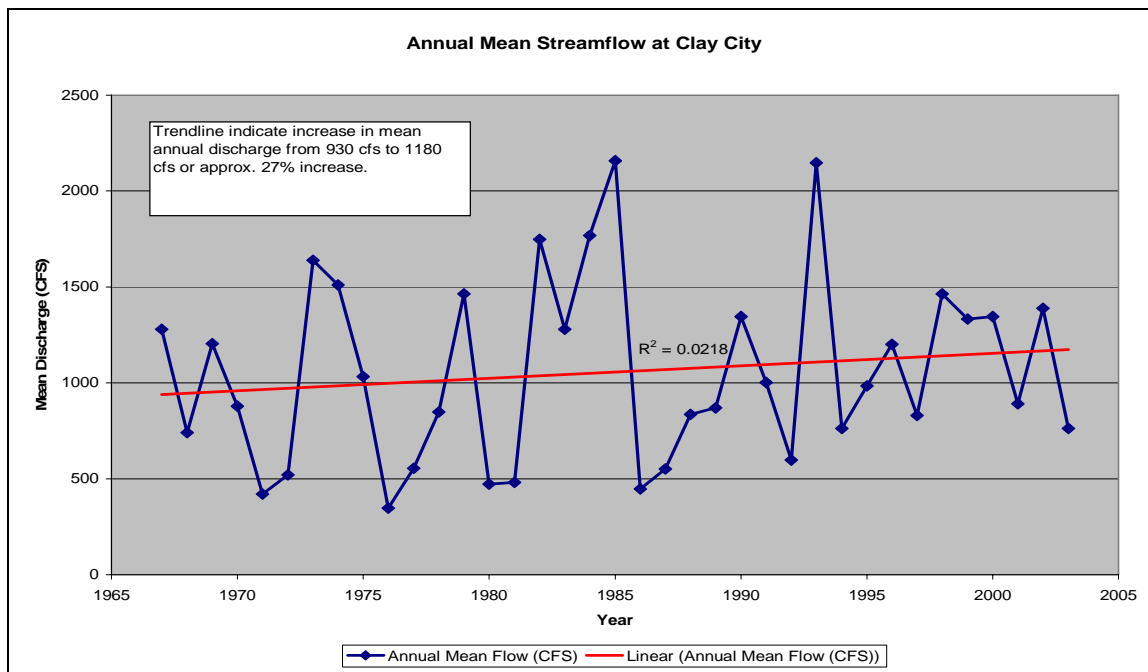
Fig. 16 Linear Trendline for Annual Mean Flow for USGS Gage # 03379500 for 1967 thru 2003.

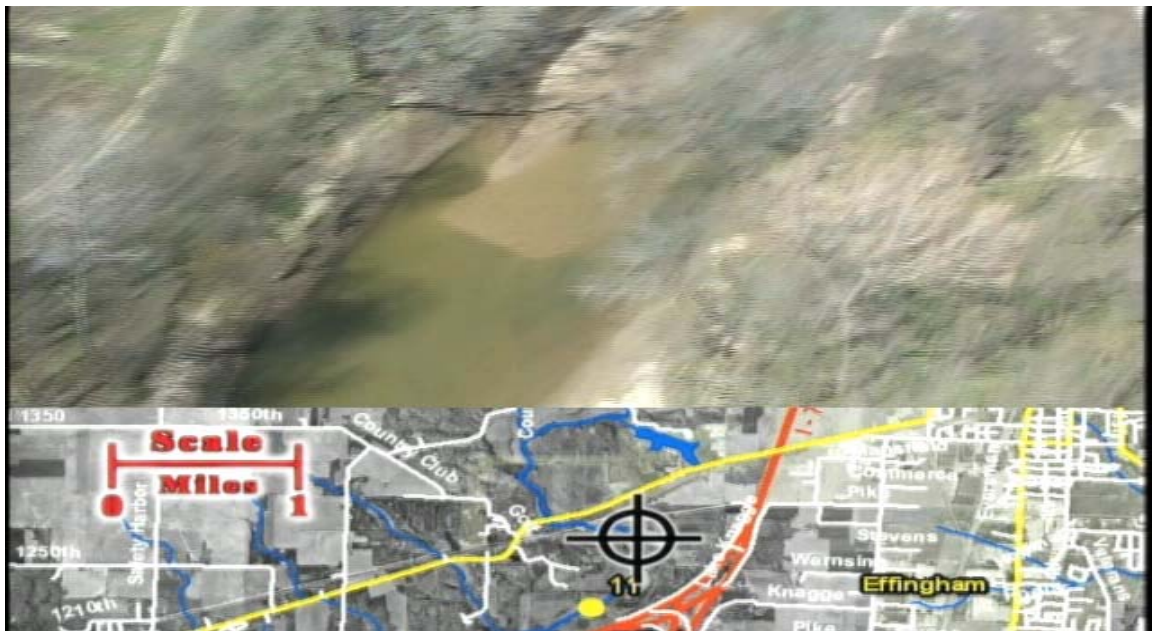
8. Chapters 9 thru 12 show very significant movement of bedload in the form of “sand waves” during low flow. Under high flow events the channel dimension may change significantly depending on the amount of “bedload” that becomes “wash load” (Fig.17).

Fig. 17 Typical “Sand Wave” found in Chapters 9 thru 12

14. The bank failure in the Little Wabash is a **system wide failure** caused by a combination of easily eroded soils and increased discharges. There are no readily available treatment options other than a holistic approach of stream restoration, or the “no action” alternative which will allow the channel evolution process to continue until the channel reaches a new equilibrium under the current and future flow regime. There are reaches that are incised and therefore disconnected to the floodplain (x-sec. 2, 3, 4 and 6) where use of a riffle-pool sequence could be a means to encourage the establishment of a more stable channel.
