**Aerial Assessment Report on Mauvaise Terre River
June 2005
Prepared for IL Dept. of Agriculture by Wayne Kinney**

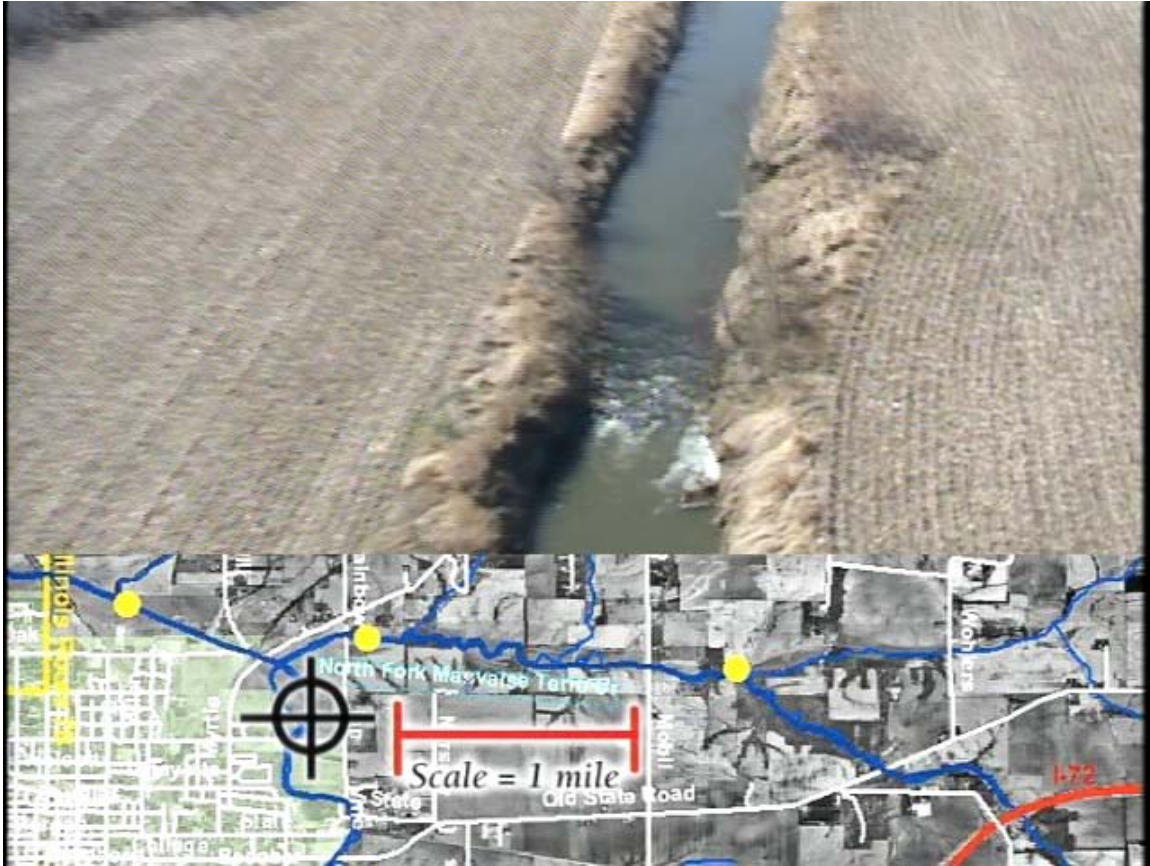
1. The Upper Reach (Chapter 8-10 Disc 2) is approx. 5.3 miles in length with 47 erosion sites identified on the DVD. This reach is experiencing some downcutting and is incised so that Rock Riffle Grade Control structures can be installed to control downcutting, reduce lateral bank erosion and improve DO levels by increasing turbulence. There is at least one reasonable example of a grade control in place in Chapter 8. The design, purpose, or reason for installation is not known, however it is functioning well and appears to have been in place for a number of years.

Fig. 5 Existing Rock Riffle—Mauvaise Terre River

Structures similar to this can be safely placed to a height of 2 to 2.5 ft. above the existing grade according to preliminary calculations. Normal riffle pool sequences will occur at an approximate spacing of 6 bankfull widths, however with such small bedload it appears that bedload can be passed on a much wider spacing. In fact the existing structure in Fig. 5 has maintained a 2.5 foot pool depth as a single structure on this reach.

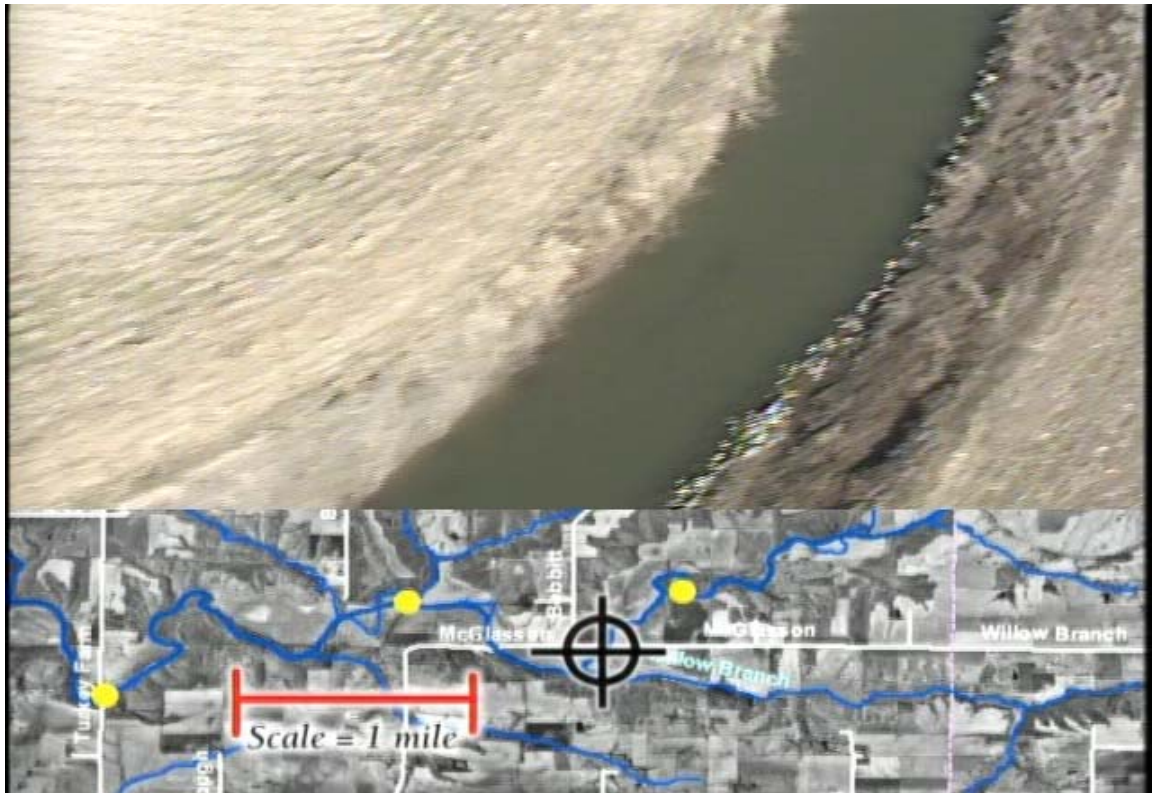
treatment and has been used successfully on Mauvaise Terre River in at least two places recorded on the DVD. Velocity in this reach is consistently 3.0 ft. per sec. or slower. Typical STP installation will be required on an entire meander bend that can be expected to be about 5 times the bankfull width. The following table then will summarize the need for bank stability in these 9 chapters that make up the Middle Reach.

Fig. 6 Stone Toe Protection on Mauvaise Terre River above confluence with Willow Creek.

- The Middle Reach (Chapt. 8 disc 1-Chapt 7 Disc 2) is approx. 16 miles in length with 143 erosion sites identified from the DVD. This reach is a lower gradient with fine bedload and no point bar accumulations. Therefore the treatment recommended for this entire reach is to use a hard toe protection to stabilize the banks and prevent lateral migration. Stone Toe Protection (STP) is the preferred
