DATE: March 4, 2021

FROM: Joseph D. Stitely, P.E., BOW/DWPC/FOS

SUBJECT: Commonfields of Cahokia Water & Sewer District
February 24, 2021 & February 25, 2021 Collection System Inspection

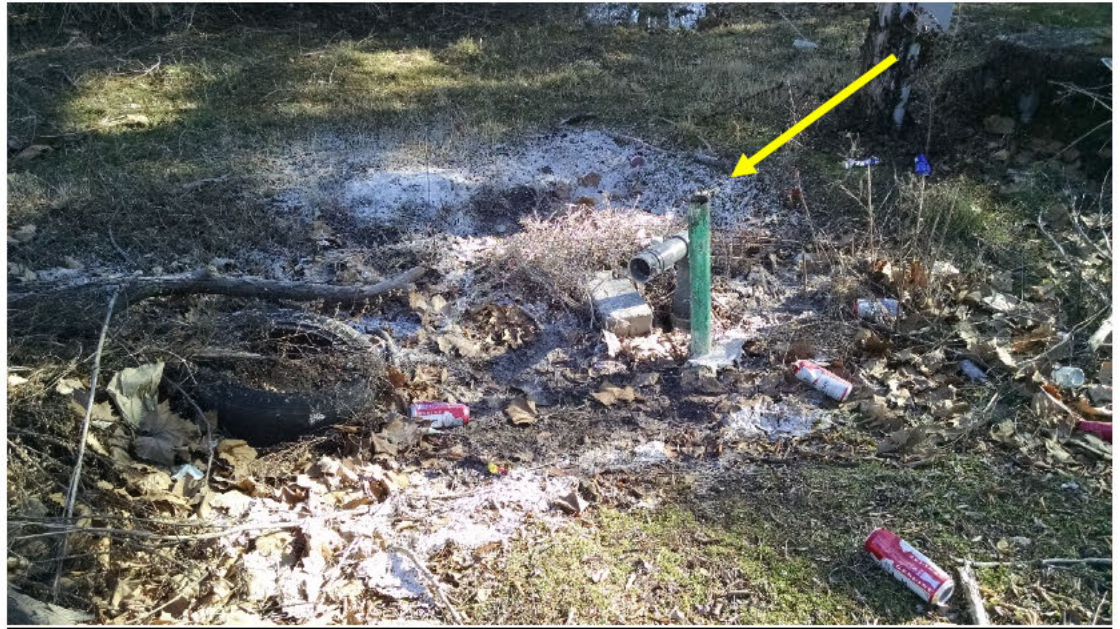
We then drove to the lift station near the intersection of Lauralee and Violet (GPS location: 38°33'26.535" N, 90°07'21.767" W). At the time of the visit, the lift station was not overflowing. We then drove to the Lake Drive Pill Box Lift station (GPS location: 38°35'28.655" N, 90°05'09.140" W). This station has no operational pumps and the control panel has been removed. A PVC "quick connect" coupler has been installed adjacent to the station to periodically pump sewage from the station. A significant amount of sewage debris was observed on the ground surface around the coupler location (see attached

Photo # 001
Date: February 24, 2021
Time: 2:58 p.m.
Taken By: Joe Stitely, BOW
Facility: Commonfields of Cahokia
Location: Lake Drive Pill Box (#21)
Notes: This is a photograph of the quick connect for the Lake Pill Box Lift Station. Both pumps control panel have been removed from the station. A quick connect line has been added to remove sewage from the station. Note the significant sewage debris on the ground surface.

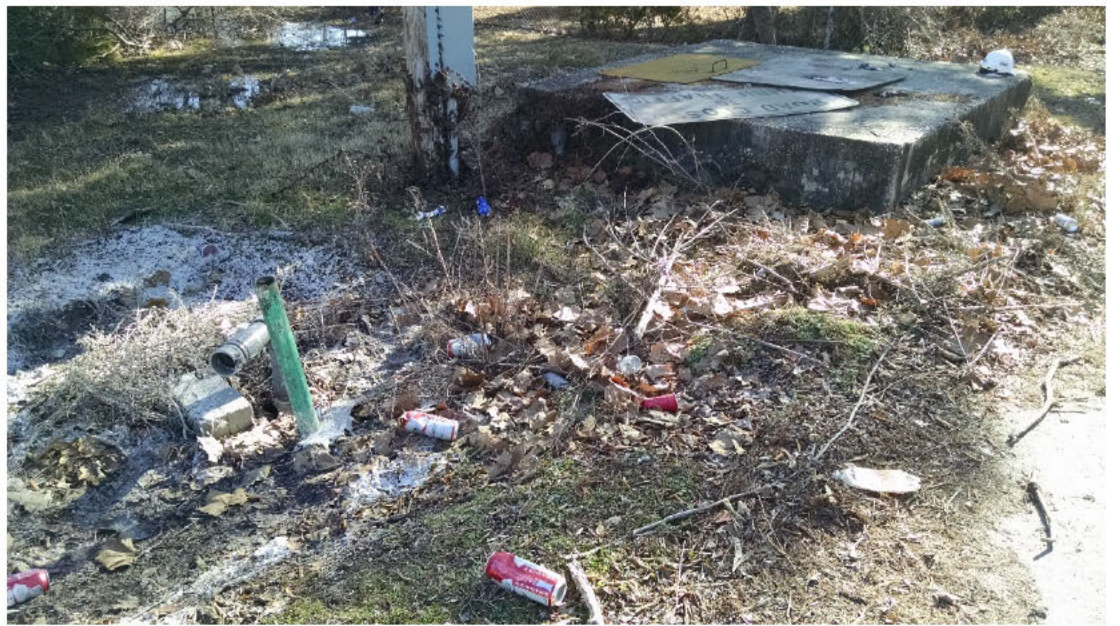
Photo #: 002
Date: February 24, 2021
Time: 2:58 p.m.
Taken By: Joe Stitely, BOW
Facility: Commonfields of Cahokia
Location: Lake Drive Pill Box (#21)
Notes: This is a photograph of the Lake Pill Box Lift Station. Both pumps control panel have been removed from the station. A quick connect line has been added to remove sewage from the station. Again, note the significant sewage debris on the ground surface.

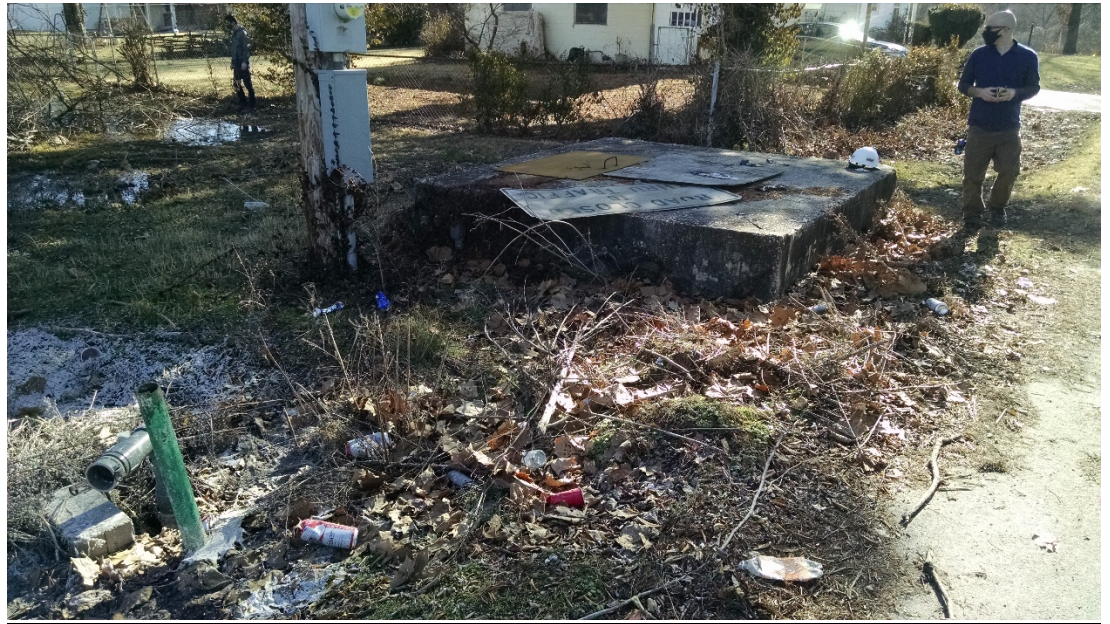
Photo # 003
Date: February 24, 2021
Time: 2:58 p.m.
Taken By: Joe Stitely, BOW
Facility: Commonfields of Cahokia
Location: Lake Drive Pill Box (#21)
Notes: This is another photograph of the quick connect for the Lake Pill Box Lift Station. Both pumps control panel have been removed from the station. A quick connect line has been added to remove sewage from the station. Note the significant sewage debris on the ground surface.

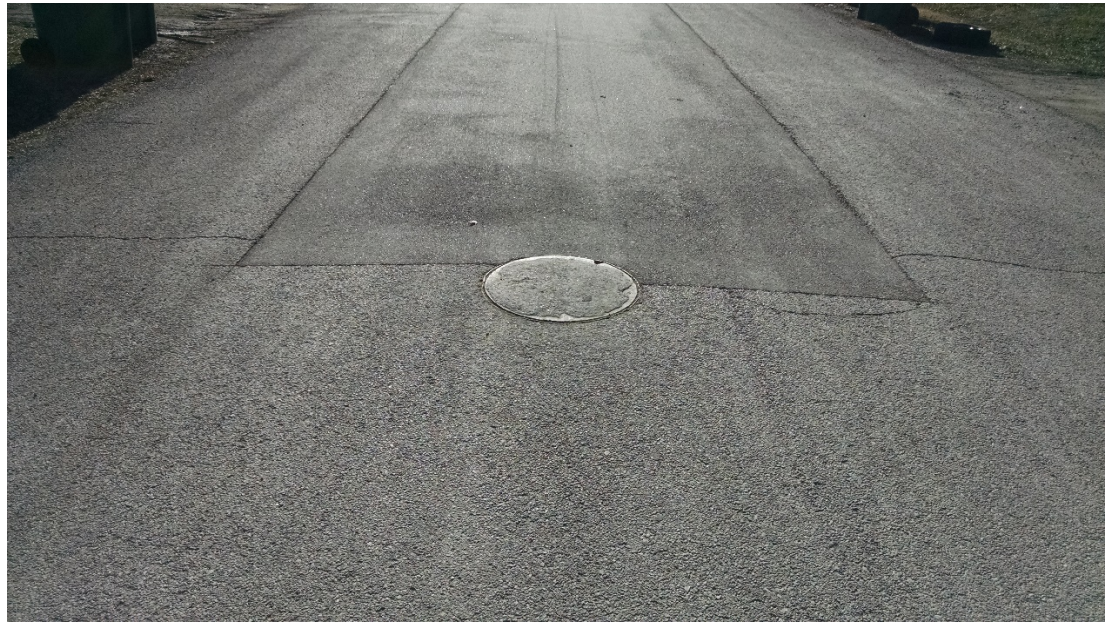
photographs). The closest manhole was observed about 200 feet northeast of the station (see attached photographs). No evidence of any recent overflows was observed around the manhole. We did note what appeared to be a water supply leak in the alley directly southeast of the station. I contacted Gayle Renth, Collinsville DPWS, and made her aware of the water leak and the proximity to the sewage debris.

Photo #: 004
Date: February 24, 2021
Time: 3:04 p.m.
Taken By: Joe Stitely, BOW
Facility: Commonfields of Cahokia
Location: Lake Drive Pill Box (#21).
Notes: This is a photograph of the the closest manhole to the Pill Box Lift Station. The manhole is located another photograph of the lift station located about 200 NE of the Lake Drive Pill Box Station.

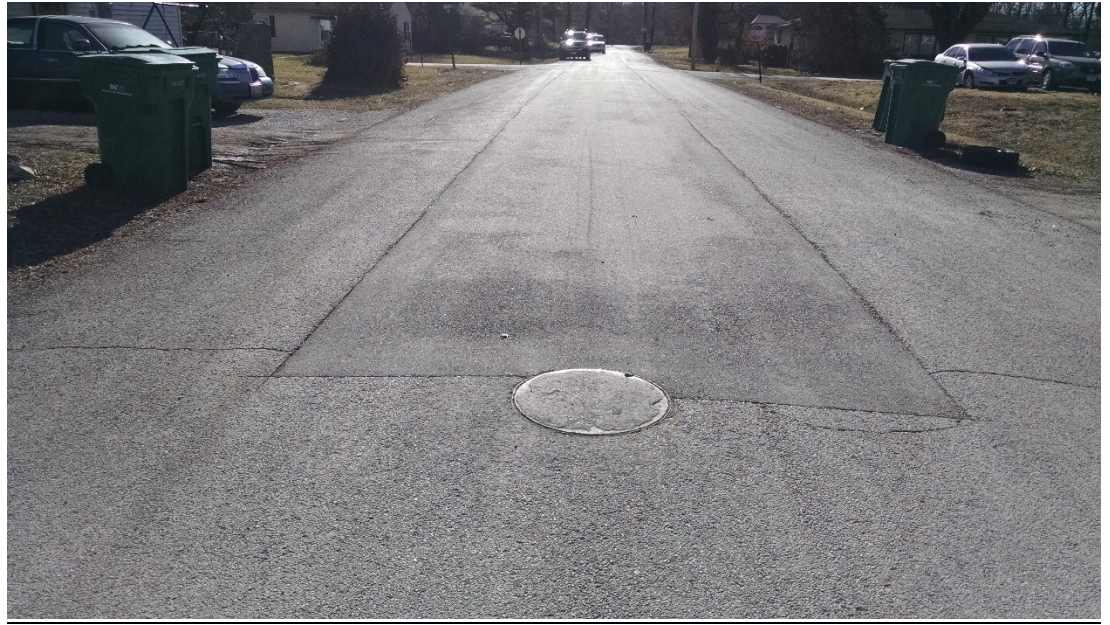
Photo # 005
Date: February 24, 2021
Time: 3:05 p.m.
Taken By: Joe Stitely, BOW
Facility: Commonfields of Cahokia
Location: Lake Drive Pill Box (#21)
Notes: This is another photograph of the closest manhole to the Pill Box Lift Station. The manhole is located another photograph of the lift station located about 200 NE of the Lake Drive Pill Box Station.

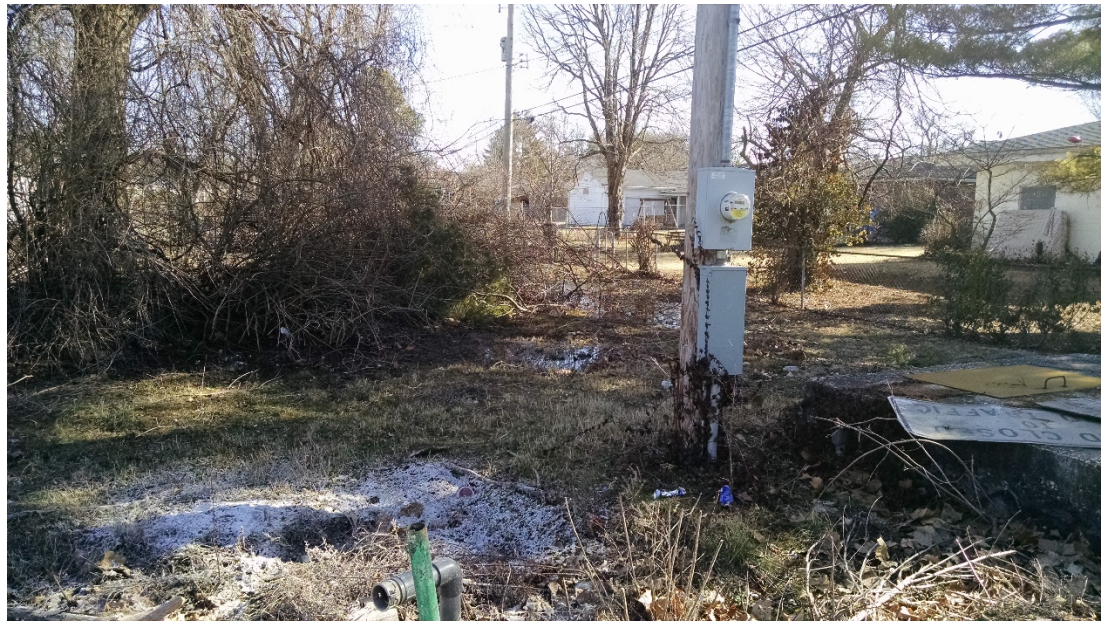
Photo #: 006
Date: February 24, 2021
Time: 3:06 p.m.
Taken By: Joe Stitely, BOW
Facility: Commonfields of Cahokia
Location: Lake Drive Pill Box (#21)
Notes: This is another photograph of the Lake Drive Pill Box Lift Station. Note the pooled water in the background. This freshwater appeared to be from a water line leak.

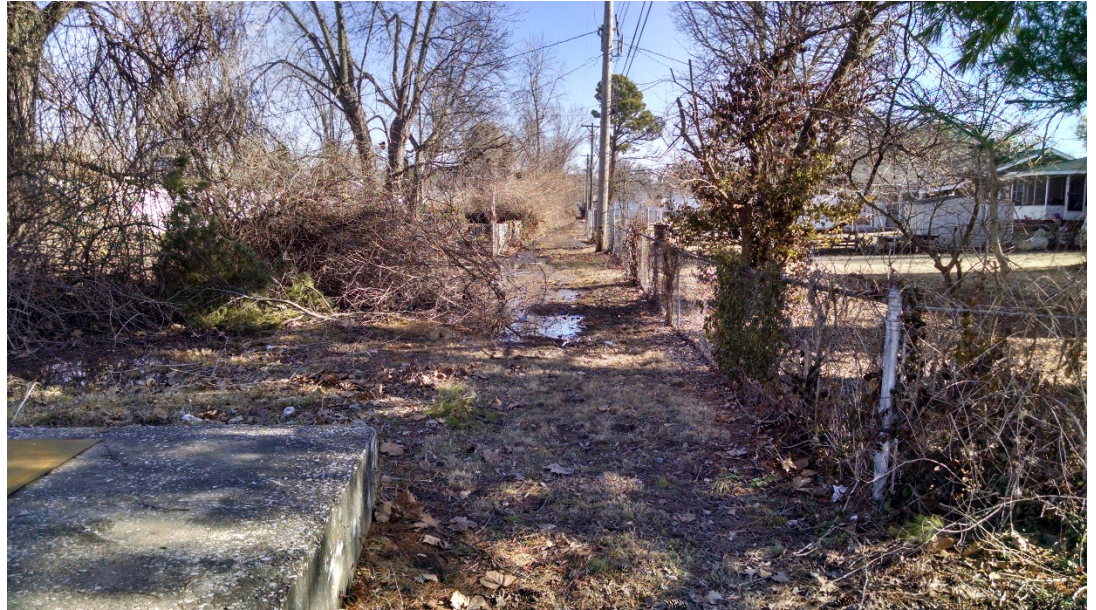
Photo # 007
Date: February 24, 2021
Time: 3:06 p.m.
Taken By: Joe Stitely, BOW
Facility: Commonfields of Cahokia
Location: Lake Drive Pill Box (#21)
Notes: This is another photograph of the Lake Drive Pill Box Lift Station. Note the pooled water in the background. This freshwater appeared to be from a water line leak.

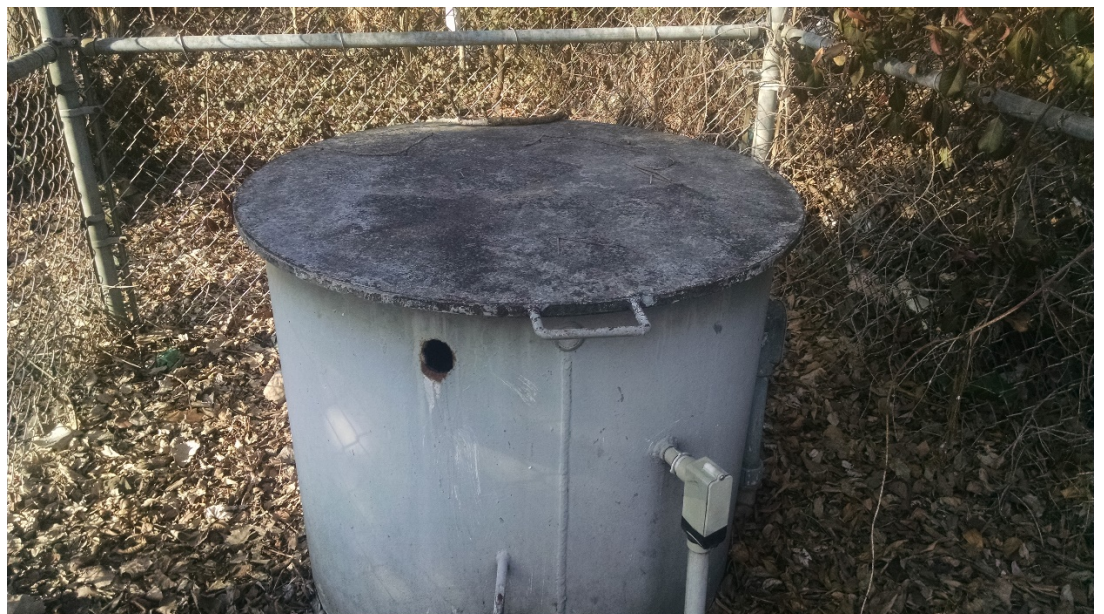
The next morning (February 25, 2021), Dean Maraldo and I observed the 51st & Market Station (GPS Location: 38°34'39.276" N, 90°07'00.000" W). No evidence from a recent overflow was observed. I noted that the chain link fence door for the dry well was unlocked and opened. Also, the access hatch to the dry well was unlocked (see attached photographs). We then drove to a station located near the intersection of 53rd and Market Streets (GPS Location: 38°34'32.643" N, 90°06'52.657" W). The station was a submersible type station with a high-level alarm light. No overflows were occurring at the time of the inspection. However, I noted sewage debris on the ground adjacent to the station from previous overflows (see attached photographs).

Photo #: 008
Date: February 25, 2021
Time: 8:38 a.m.
Taken By: Joe Stitely, BOW
Facility: Commonfields of Cahokia
Location: 51st & Market Station (#2)
Notes: This is a photograph of the lift station located near the intersection of 51st and Market Streets. There was no evidence of a recent overflow at the station. The fence was open and the dry well hatch unlocked.

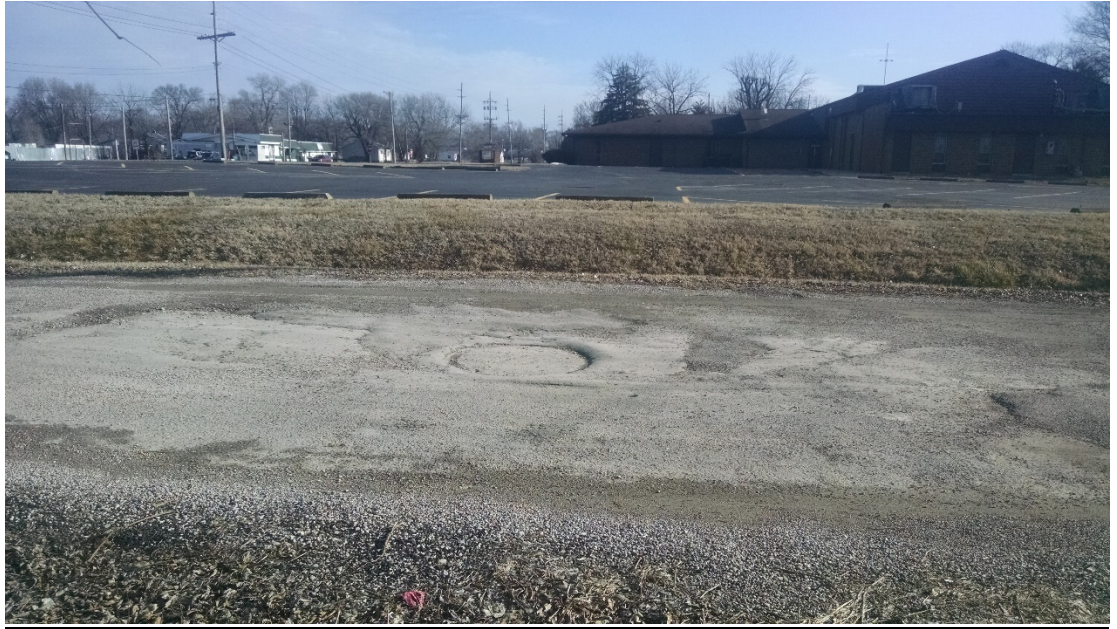
Photo # 009
Date: February 25, 2021
Time: 8:38 a.m.
Taken By: Joe Stitely, BOW
Facility: Commonfields of Cahokia
Location: 51st & Market Station (#2)
Notes: This is a photograph of the station's wet well. No evidence of a recent overflow was observed from the wet well.

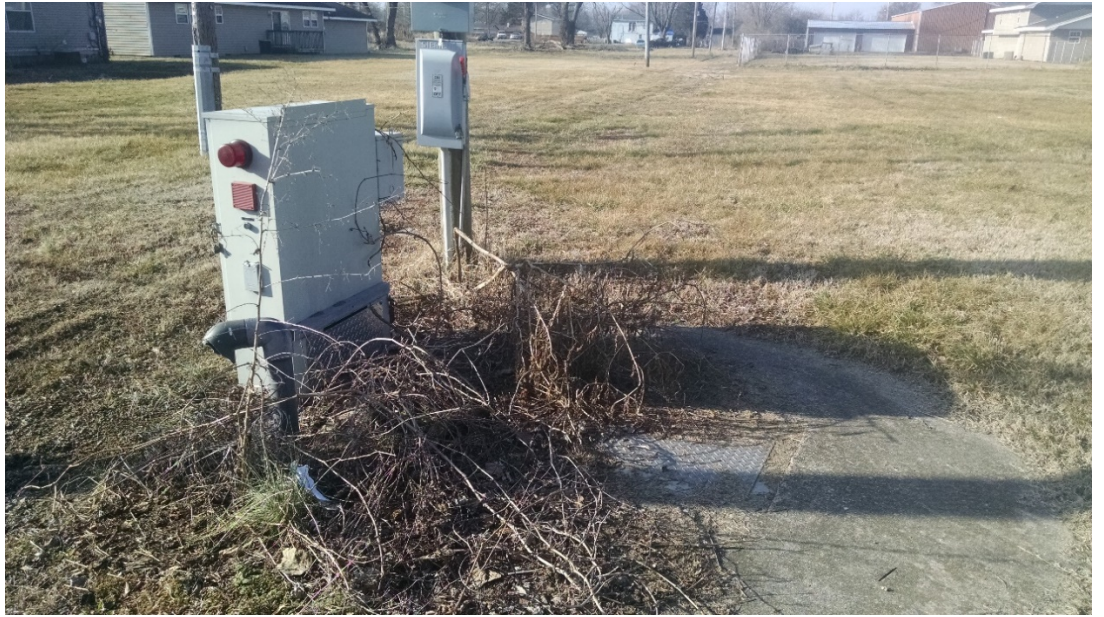
Photo #: 010
Date: February 25, 2021
Time: 8:46 a.m.
Taken By: Joe Stitely, BOW
Facility: Commonfields of Cahokia
Location: 53rd & Market Station (#3)
Notes: This is a photograph of the lift station located near the intersection of 53rd and Market Streets.

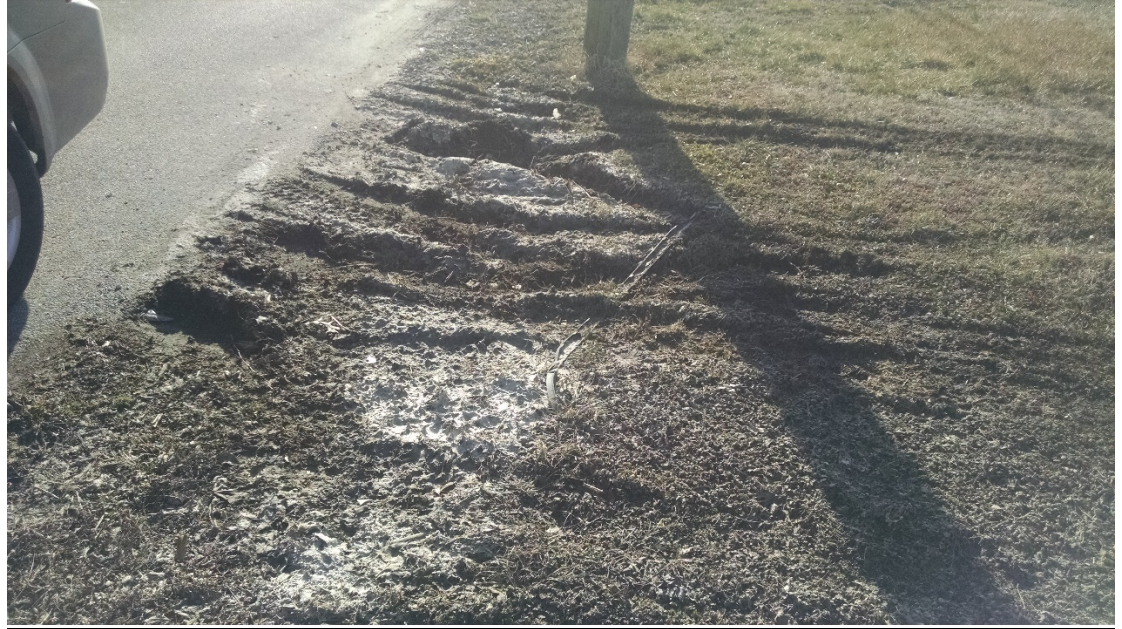
Photo # 011
Date: February 25, 2021
Time: 8:46 a.m.
Taken By: Joe Stitely, BOW
Facility: Commonfields of Cahokia
Location: 53rd & Market Station (#3)
Notes: This is a photograph of the sewage debris on the ground surface adjacent to the lift station.

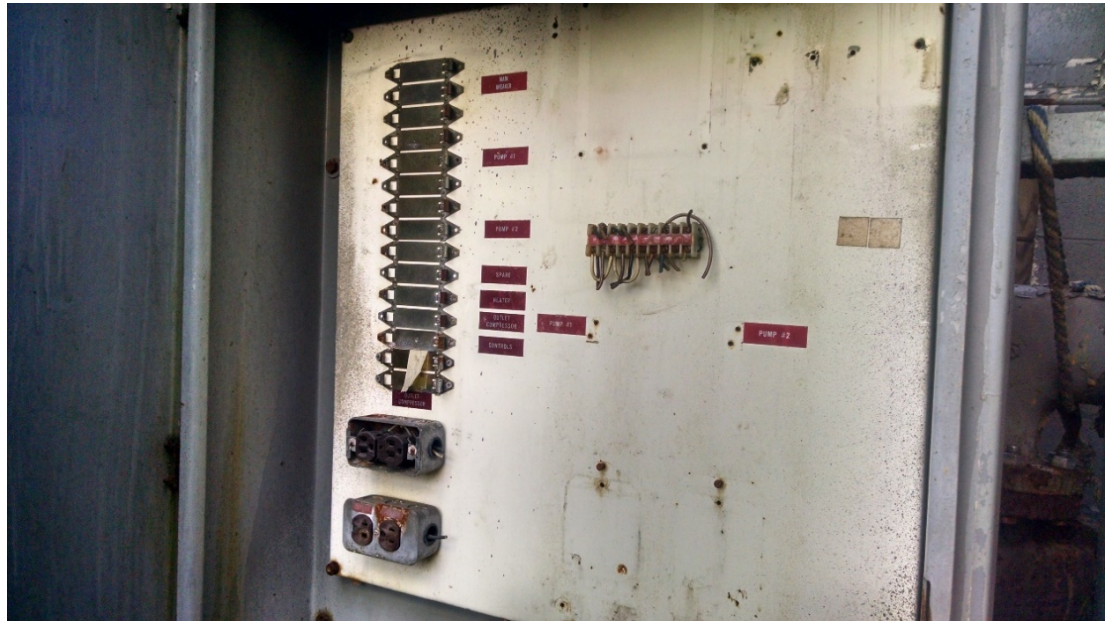
We then drove to the Block House lift station (GPS Location: 38°33'29.705" N, 90°07'25.198" W). The station was in very poor condition and appeared to be abandoned. Walking up to the station, I noted that access door to the station was open (see attached photographs). I also observed that the control panel door was also open (see attached photographs). Looking in the station, I observed that the roof was falling in and the station's wet well had no hatch and was open. This could allow significant precipitation into the wet well. Also, the unsecured station and open wet well posed a significant safety risk. Traiteur later indicated that the station is abandoned.

Photo #: 012
Date: February 25, 2021
Time: 9:06 a.m.
Taken By: Joe Stitely, BOW
Facility: Commonfields of Cahokia
Location: Block House Station (#13)
Notes: This is a photograph of the control panel for the abandoned block house lift station. The door to the station was open and the roof to the station was deteriorated and open to the weather.

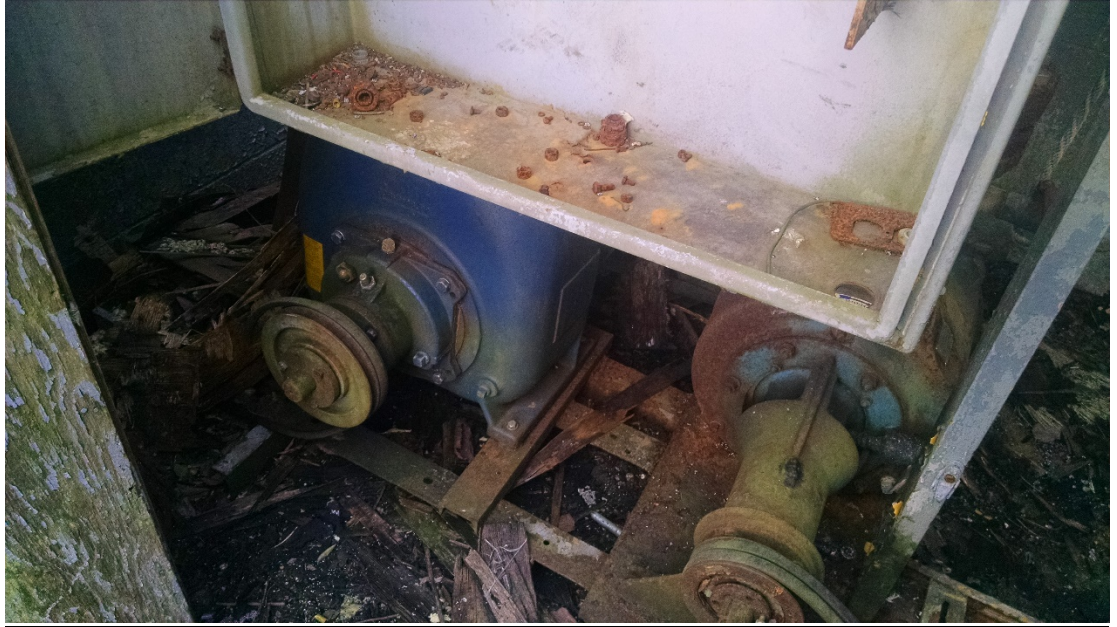
Photo # 013
Date: February 25, 2021
Time: 9:06 a.m.
Taken By: Joe Stitely, BOW
Facility: Commonfields of Cahokia
Location: Block House Station (#13)
Notes: This is a photograph of the abandoned Block House lift station.

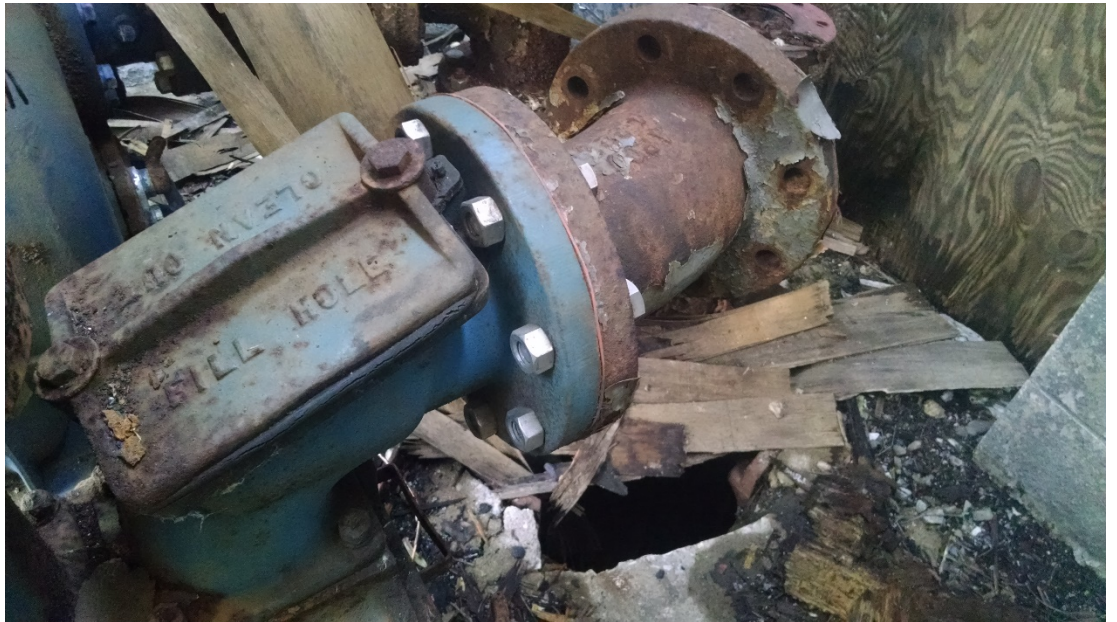
Photo #: 014
Date: February 25, 2021
Time: 9:06 a.m.
Taken By: Joe Stitely, BOW
Facility: Commonfields of Cahokia
Location: Block House Station (#13)
Notes: This is a photograph of the abandoned Block House lift station. Note the open wet well within the station. The open well is a safety issue and a potential I & I route.

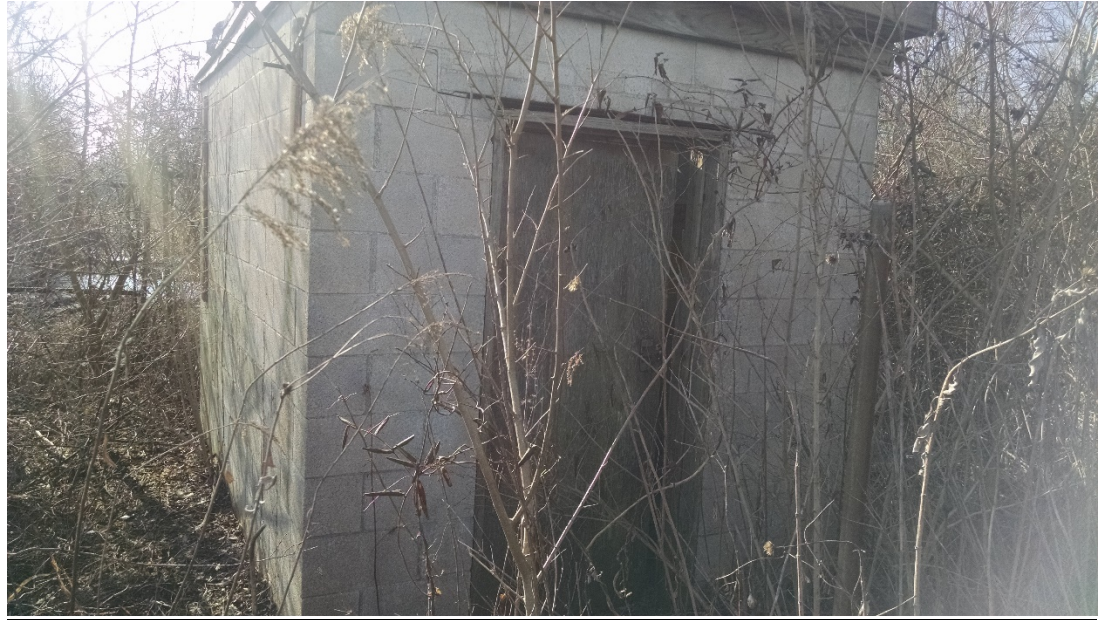
Photo # 015
Date: February 25, 2021
Time: 9:08 a.m.
Taken By: Joe Stitely, BOW
Facility: Commonfields of Cahokia
Location: Block House Station (#13)
Notes: This is a photograph of the outside of the abandoned Block House lift station.

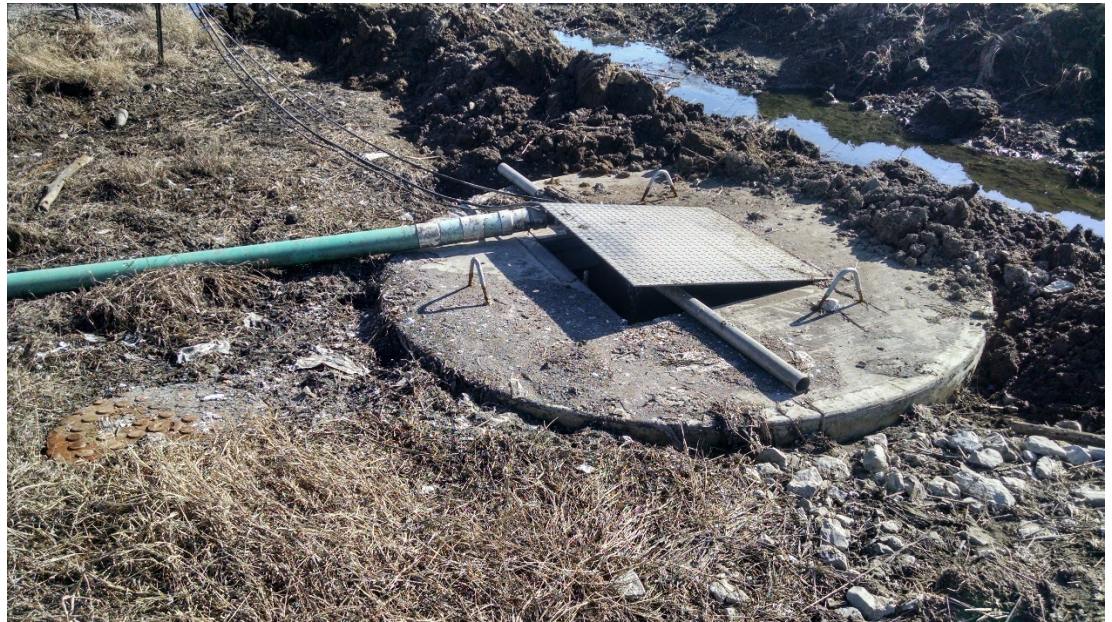
Next, we drove to the Lady of Snows lift station (GPS Location: 38°33'44.717" N, 90°06'11.378" W). The concrete cap had recently been replaced (see attached photographs). The station had a temporary submersible pump installed in the station that was pumping above ground via 4-inch PVC pipe to a downstream manhole (see attached photographs). I also saw sewage debris on the ground surface from previous overflows immediately adjacent to the replaced concrete lid (see attached photographs). I also noted

Photo #: 016
Date: February 25, 2021
Time: 9:48 a.m.
Taken By: Joe Stitely, BOW
Facility: Commonfields of Cahokia
Location: Lady of Snows (#20)
Notes: This is a photograph of the Lady of Snows lift station. The concrete cap had recently been replaced. The station had a temporary submersible pump installed that was pumping above ground to downstream manhole.

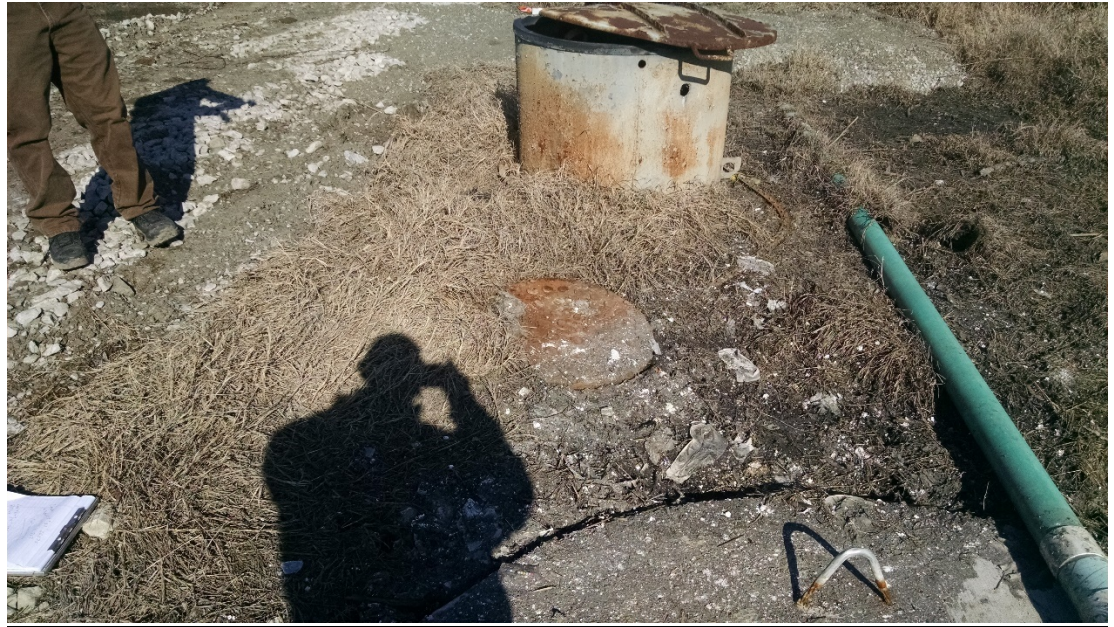
Photo # 017
Date: February 25, 2021
Time: 9:49 a.m.
Taken By: Joe Stitely, BOW
Facility: Commonfields of Cahokia
Location: Lady of Snows (#20)
Notes: This is a photograph of the Lady of Snows lift station. Note the sewage debris on the ground surface from previous overflows.

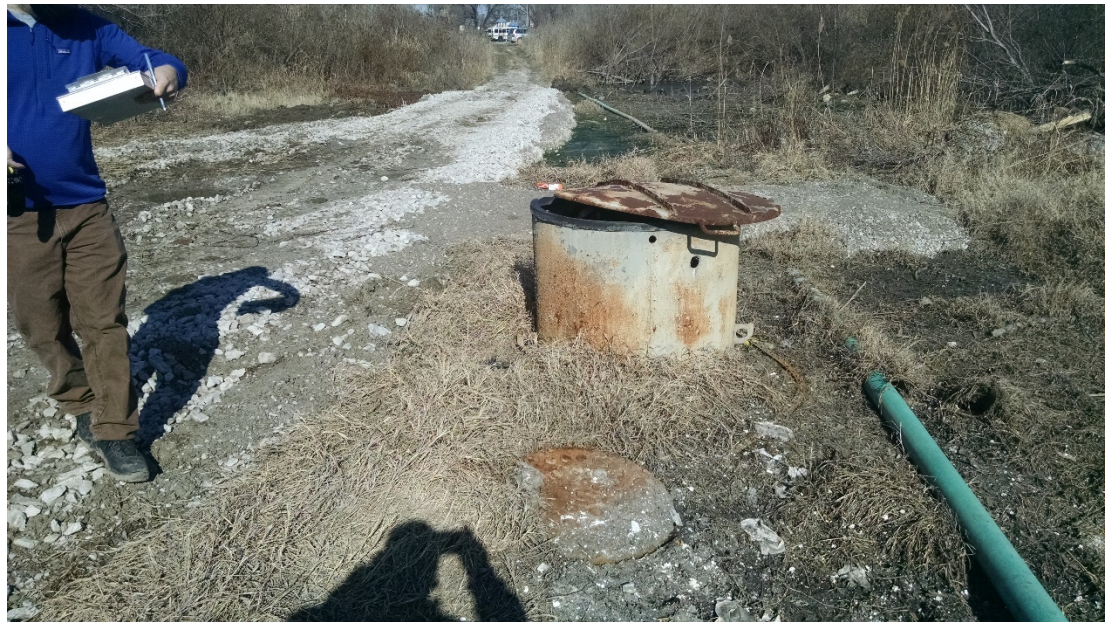
that the station's dry well lid was partially open and unlocked (see attached photographs). Near the downstream manhole, we noted some discarded broken PVC pipe. It appeared to be from previous breaks in the above ground line to the manhole. Traiteur later confirmed that the line has had breaks in the past.

Photo #: 018
Date: February 25, 2021
Time: 9:49 a.m.
Taken By: Joe Stitely, BOW
Facility: Commonfields of Cahokia
Location: Lady of Snows (#20)
Notes: This is a photograph of the Lady of Snows lift station. This a photograph of the abandoned dry well for the station. The well was not properly locked or secured. Again., note the sewage debris on the ground surface from previous overflows.

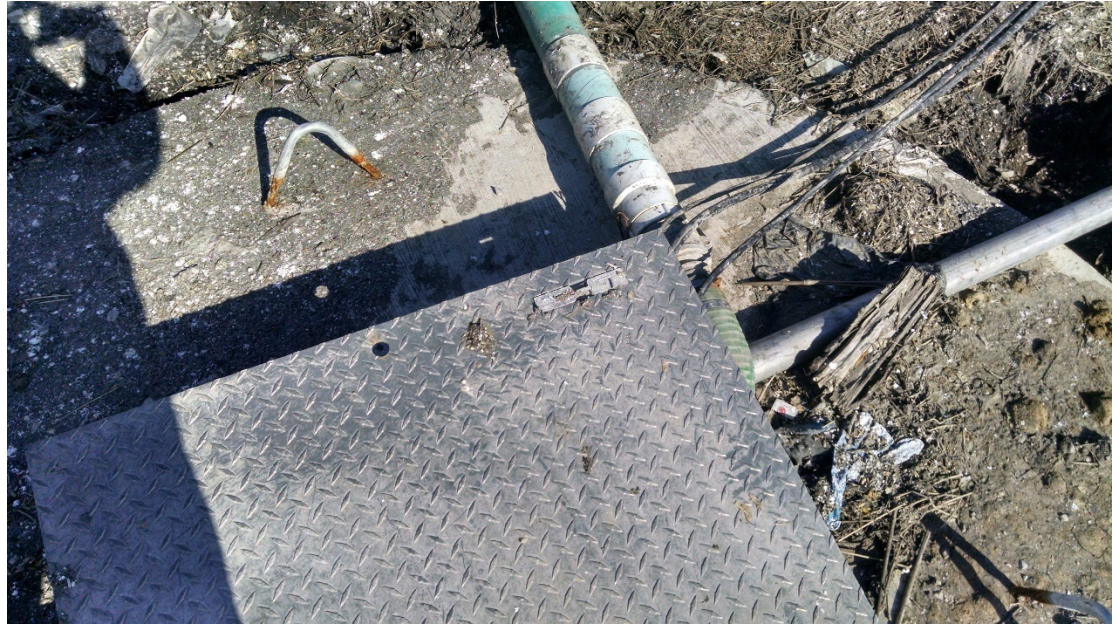
Photo # 019
Date: February 25, 2021
Time: 9:49 a.m.
Taken By: Joe Stitely, BOW
Facility: Commonfields of Cahokia
Location: Lady of Snows (#20)
Notes: This is a photograph of the Lady of Snows lift station. This a closeup photo of the wet well lid. Note that the lid is not properly secured due to the PVC exiting through the top of the wet well. Also note the wiring entering through the wet well lid.

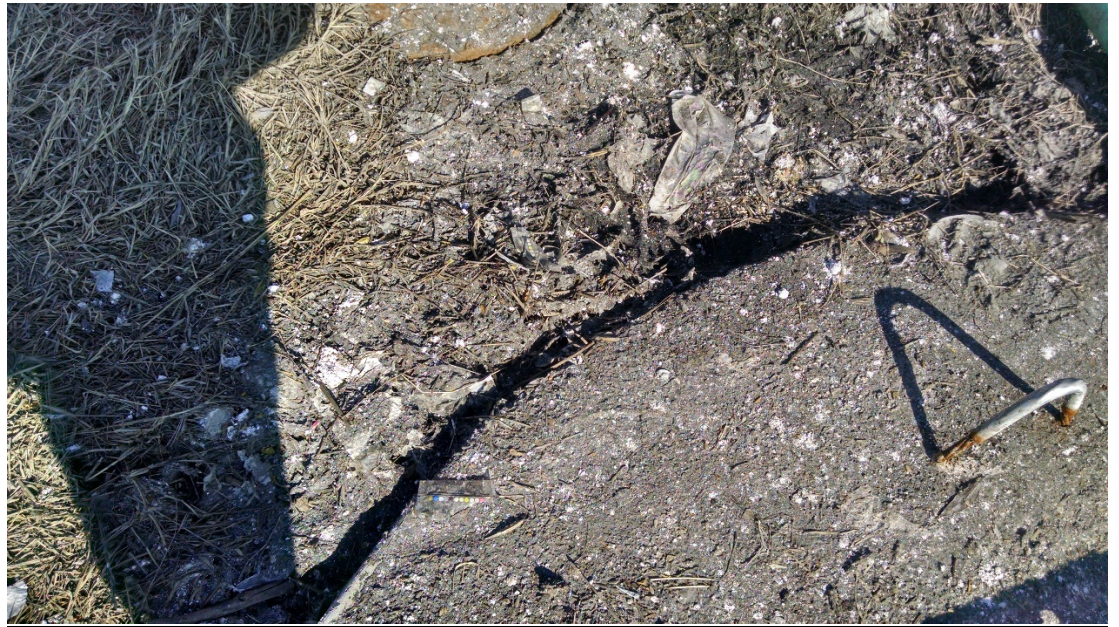
Photo #: 020
Date: February 25, 2021
Time: 9:50 a.m.
Taken By: Joe Stitely, BOW
Facility: Commonfields of Cahokia
Location: Lady of Snows (#20)
Notes: This is a closeup photograph of the sewage debris on the ground surface next to the wet well lid.

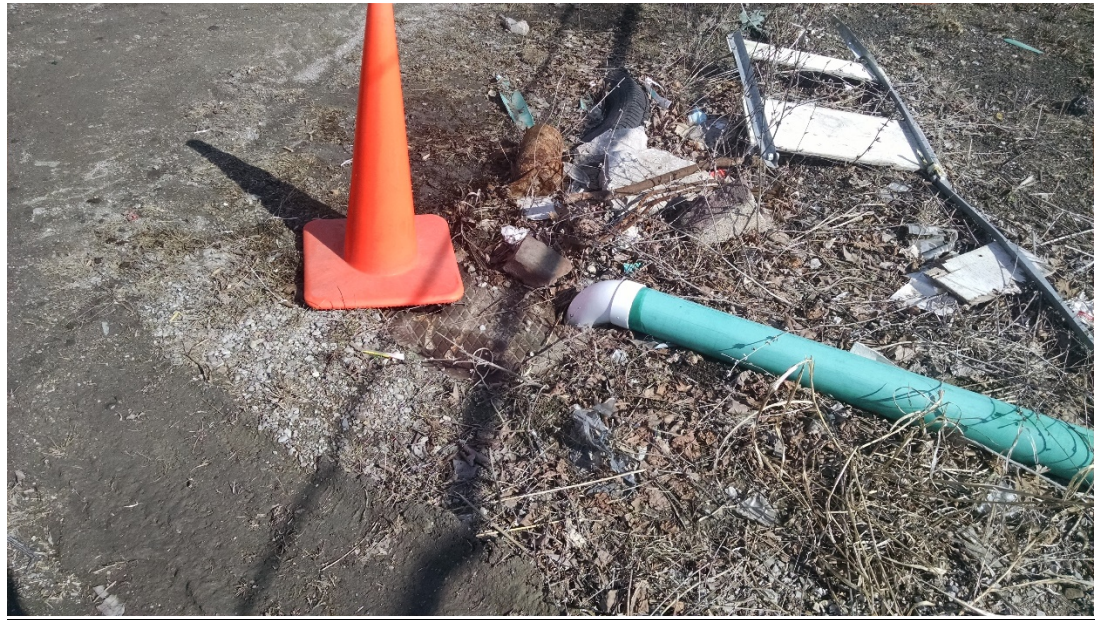
Photo # 021
Date: 10:19 a.m.
Time: Joe Stitely, BOW
Taken By: Commonfields of Cahokia
Facility: Lady of Snows (#20)
Location: This is a photograph of the
Notes: downstream manhole that
the temporary submersible
was discharging. The
manhole is located about
350 feet east of the station.

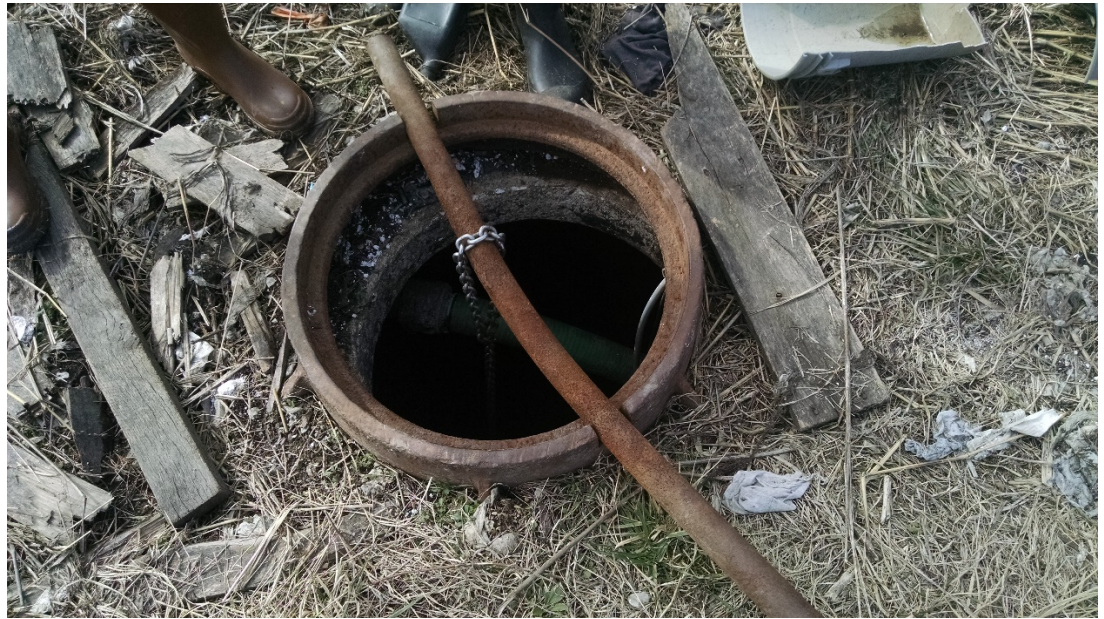
We then returned to the Block House station with the other US EPA representatives. At the Block House Station, we noted that there was a power pole about 300 feet northwest of the station. At the power pole, there was an unnamed lift station (GPS Location: 38°33'31.830" N, 90°07'27.750" W). The manhole lid was removed, and a metal pipe was across the manhole opening. The pipe was holding up a temporary submersible pump via a chain (see attached photographs). I noted a child's shoe adjacent to the open manhole lid. Later, I explained to Traiteur that the open manhole lid is a safety risk and it must be covered.

Photo #: 022
Date: February 25, 2021
Time: 10:39 a.m.
Taken By: Joe Stitely, BOW
Facility: Commonfields of Cahokia
Location: NW of Block House
Notes: This is a photograph of an
unnamed station located
about 300 feet NW of the
Block House lift Station.
The lid was removed, and
a pipe is holding up a
temporary submersible
pump via a chain. This
station is a safety risk.

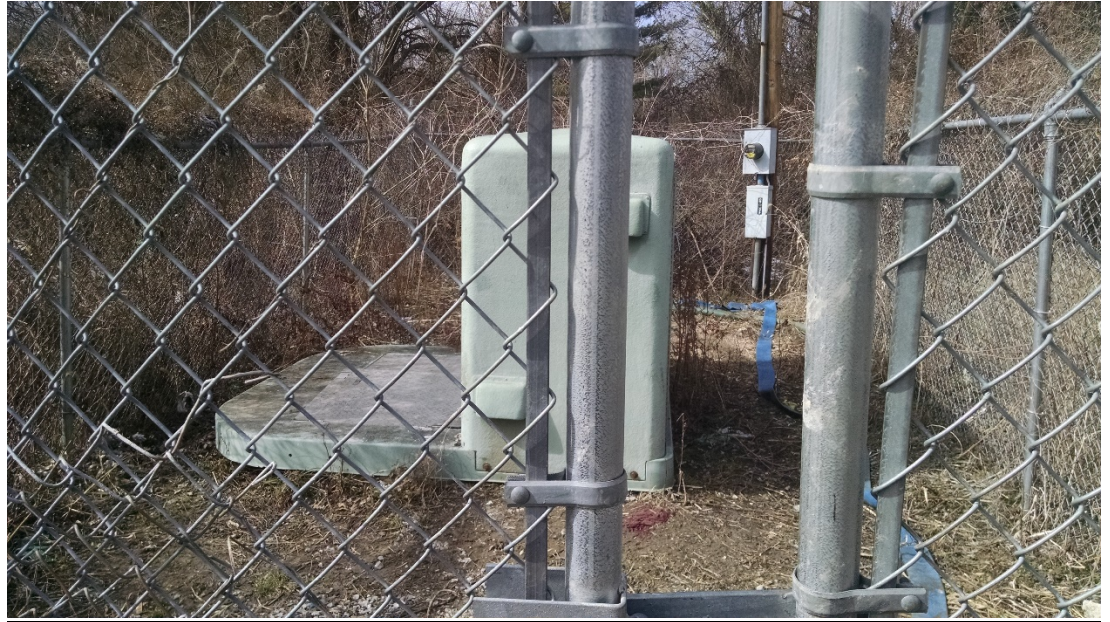
We then stopped at the 9 Violet lift station (GPS Location: 38°33'23.532" N, 90°07'23.930" W). The station is a Smith and Loveless type station (see attached photographs). No overflows were occurring from the station at the time of the visit. However, I did note that there was sewage debris on the ground surface adjacent to the station from previous overflows.

Photo # 023
Date: February 25, 2021
Time: 10:58 a.m.
Taken By: Joe Stitely, BOW
Facility: Commonfields of Cahokia
Location: █ Violet Station (#1)
Notes: This is a photograph of the lift station located near the Violet Drive. There was sewage debris on the ground surface next to the station due to previous overflows.

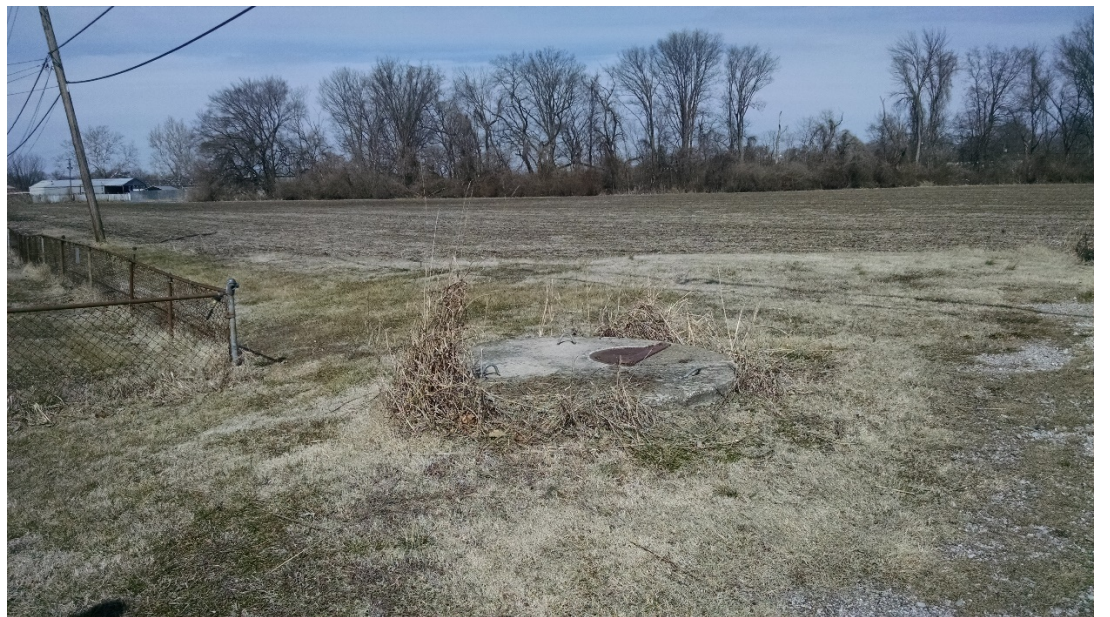
Photo #: 024
Date: February 25, 2021
Time: 12:09 p.m.
Taken By: Joe Stitely, BOW
Facility: Commonfields of Cahokia
Location: Bridgedale Station (#14)
Notes: This is a photograph of the Bridgedale lift station. The station was utilizing a temporary submersible pump.

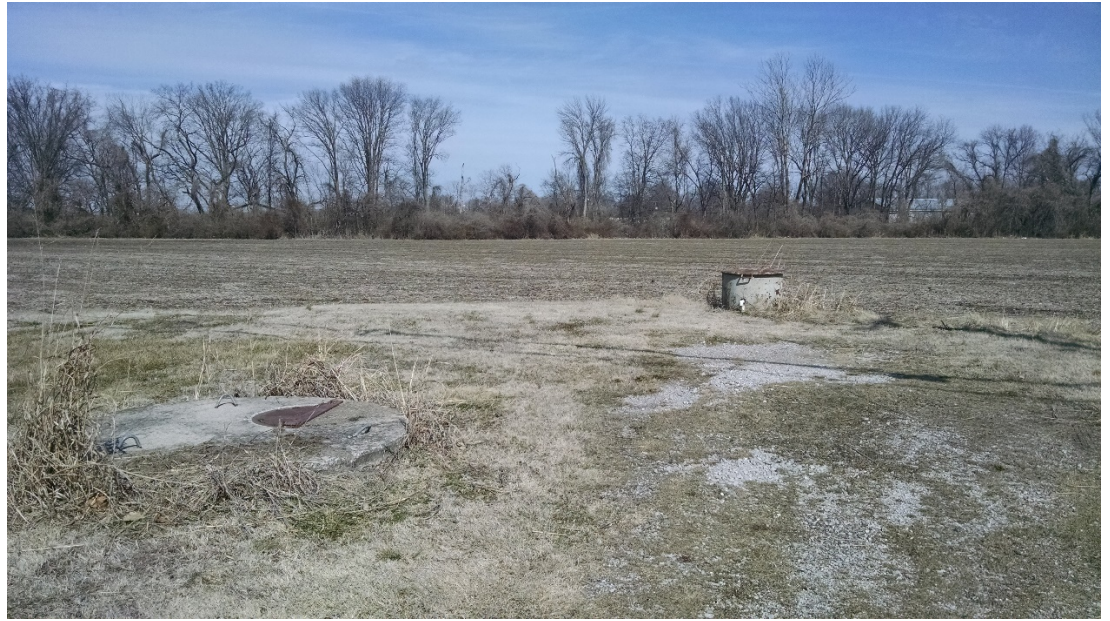
Next, Joan Rogers, US EPA, and I observed the Bridgedale lift station (GPS Location: 38°32'55.102" N, 90°08'30.456" W). No overflows were observed during the inspection of the lift station. The station is operating by a temporary submersible pump. The dry well hatch was not properly locked. Opening the hatch to the station's dry well, I observed that the dry well was full of water. We then observed the Greystone Apartment complex lift station (GPS Location: 38°34'41.492" N, 90°06'32.392" W). The station appeared to be in good working order. No evidence of any recent overflows was observed at the station. The station is equipped with a high-level alarm. It should be noted that if an overflow were to occur from the lift station, it would discharge onto the apartment complex's playground area. We then drove to the Creston Drive lift station (GPS Location: 38°34'27.780" N, 90°03'42.123" W). The station appeared to be in good working order. No evidence of any recent overflows was observed. The control panel was surrounded by a screened chain link fence. The fence gate was locked at the time of the inspection. Finally, we stopped at the Superior lift station (GPS Location: 38°34'22.035" N, 90°03'32.728" W). No evidence of any recent overflows was observed. The station appeared to be operating satisfactorily. The station's wet well was secured with a chain and padlock (see attached photographs). However, it did not appear that the station's high-level alarm light for the station was operational.

Photo # 025
Date: February 25, 2021
Time: 12:09 p.m.
Taken By: Joe Stitely, BOW
Facility: Commonfields of Cahokia
Location: Bridgedale Station (#14)
Notes: This is another photograph of the Bridgedale lift station. The station's dry well was full of water and not locked to prevent access.

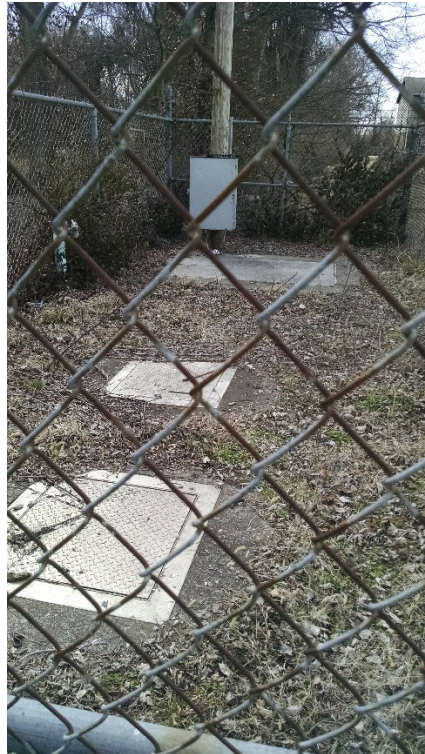
Photo #: 026
Date: February 25, 2021
Time: 1:11 p.m.
Taken By: Joe Stitely, BOW
Facility: Commonfields of Cahokia
Location: Greystone Apts. (#18)
Notes: This is a photograph of the lift station located in the Greystone Apartment complex. No evidence of any recent overflows. It should be noted that if an overflow were to occur, it would discharge onto a playground area.

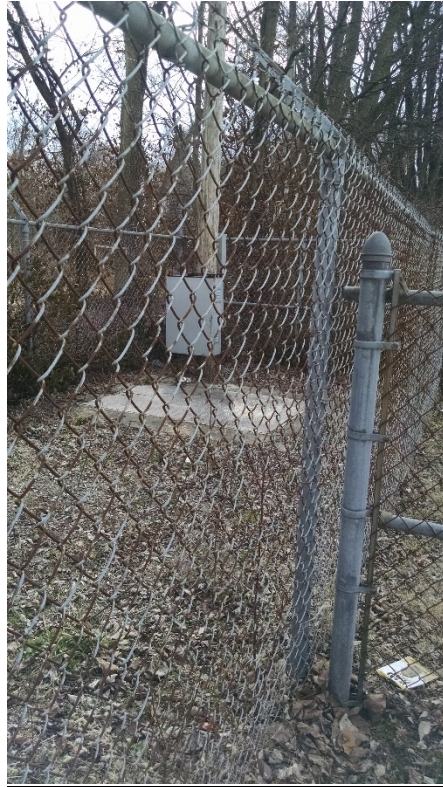
Photo # 027
Date: February 9, 2021
Time: 1:11 p.m.
Taken By: Joe Stitely, BOW
Facility: Commonfields of Cahokia
Location: Greystone Apts (#18)
Notes: This is another photograph of the lift station located in the Greystone Apartment complex.

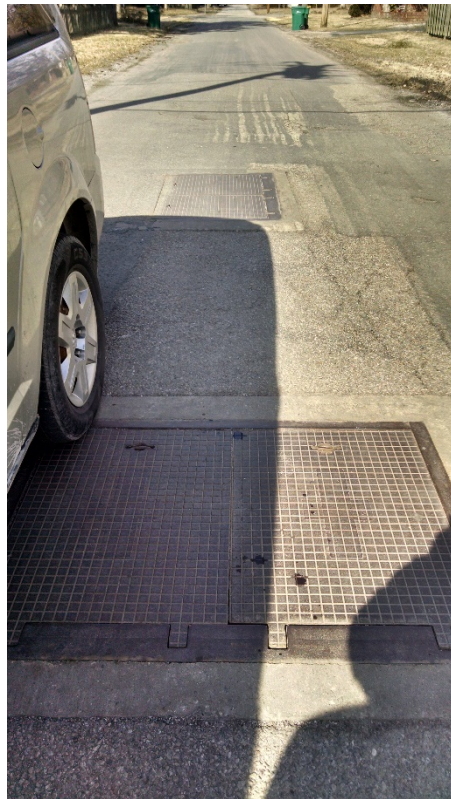
Photo #: 028
Date: February 25, 2021
Time: 1:40 p.m.
Taken By: Joe Stitely, BOW
Facility: Commonfields of Cahokia
Location: Creston Drive (#17)
Notes: This is a photograph of the wet well and dry well for the Creston Street lift station.

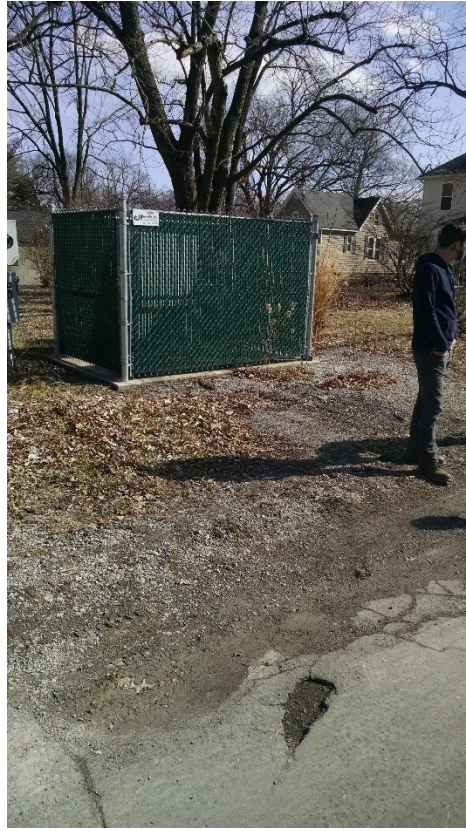
Photo # 029
Date: February 25, 2021
Time: 1:40 p.m.
Taken By: Joe Stitely, BOW
Facility: Commonfields of Cahokia
Location: Creston Drive (#17)
Notes: This is a fenced area surrounding the control panel for the Creston Street lift station.
