DATE: March 4, 2021

FROM: Joseph D. Stitely, P.E., BOW/DWPC/FOS

SUBJECT: Commonfields of Cahokia Water & Sewer District
February 24, 2021 & February 25, 2021 Collection System Inspection

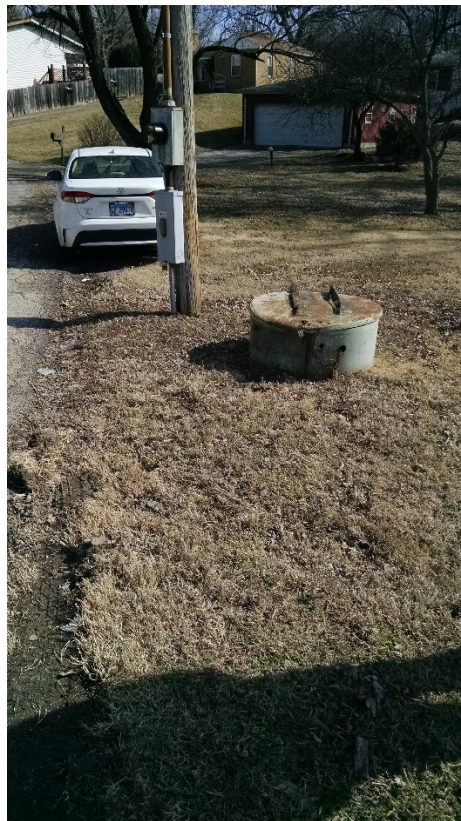
Photo #: 030
Date: February 25, 2021
Time: 1:46 p.m.
Taken By: Joe Stitely, BOW
Facility: Commonfields of Cahokia
Location: Superior Station (#26)
Notes: This is a photograph of the Superior lift station. The access hatch to the dry well was properly locked and secured.

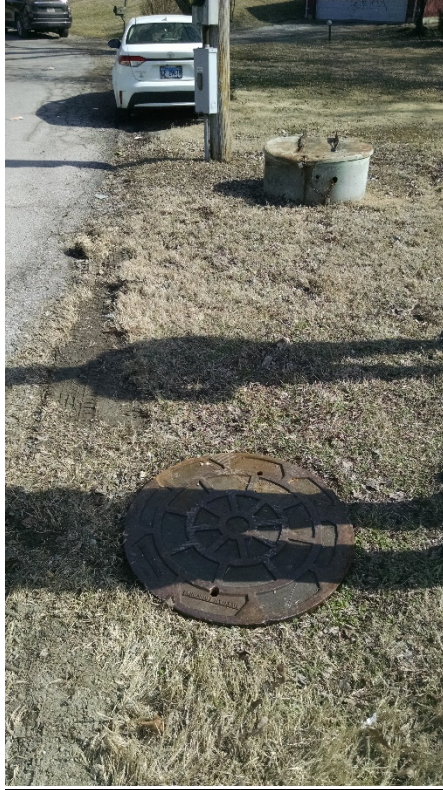
Photo # 031
Date: February 25, 2021
Time: 1:46 p.m.
Taken By: Joe Stitely, BOW
Facility: Commonfields of Cahokia
Location: Superior Station (#26)
Notes: This is a photograph of the wet well and dry well for the Superior lift station.
