# ILLINOIS ENVIRONMENTAL PROTECTION AGENCY

DATE: June 30, 2022  
TO: Todd Bennett, Manager BOW/DWPC/FOS  
FROM: Gregg Sanders, BOW/DWPC/FOS - Collinsville  
SUBJECT: Cahokia Heights  
Collection System Inspection

St. Clair County/ Cahokia Heights  
Temporary Bypasses & SSOs  
FOS File

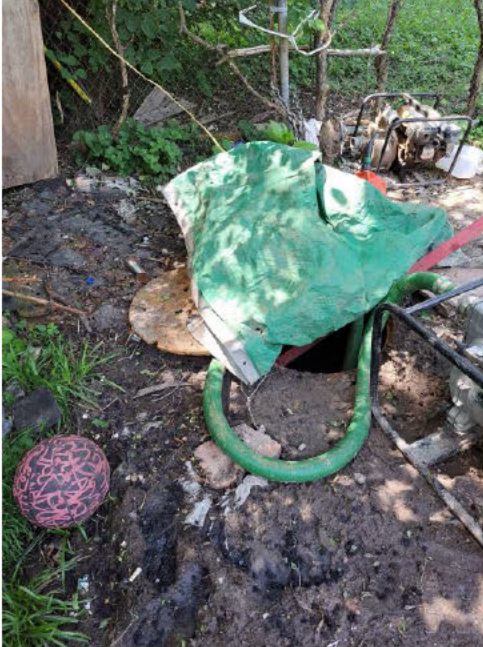
[REDACTED]  
On the way to [REDACTED], the following circumstances were observed near the road at [REDACTED]: a debris pile, temporary fencing, and an open hole in the ground. Upon further inspection it was determined: (1) a collapsed sewer was present; (2) an above ground bypass pipe dumps into an adjacent downstream manhole; and (3) the receiving manhole drains underground to another nearby manhole under Lazarcheff Drive. The bypass pipe was traced upstream to the corner backyard; where it was connected to the effluent side of a gasoline powered portable pump. The contents on the ground and adjacent to the pump were indicative

of recent wet and dry sewage and other sewage debris, but no active SSO was occurring at the time. Significant sewer odor was present. While there, the resident complained of unbearable sewer odor that routinely makes its way into the house from outdoors. The resident communicated the following additional concerns related to the sewer and bypassing: (1) she has a young child whom could potentially come in contact with the sewage; (2) sewage has overflowed into the backyard in the past; (3) she was stressed regarding the intensity of the outdoor odors entering the house and whether the sewer would be repaired; (4) the fencing surrounding the sewer collapse is insecure allowing easy public access; (5) there is a pile of debris located next to the collapsed sewer; and (6) solids are collected along the concrete gutter in front of the house. At the time of the inspection, the upstream manhole was not surcharged. Both the resident and the city reported that the city runs the pump daily.

Date: 6/9/2022  
Photo by: Gregg Sanders  
Bypass Manhole, Pump & Solids on  
Ground at [REDACTED].

In a follow-up discussion with the City, the City agreed to: (1) put up a more secure fence surrounding the collapsed sewer; (2) remove sewage solids from the ground and mix powdered chlorine into the remaining soil; (3) remove the debris located between the collapse and the road; (4) remove the solids from the concrete street gutter in front of the house; and (5) reconfigure and seal the upstream and downstream manholes as necessary to reduce sewer odors surrounding the house. The resident was made aware of these agreements and encouraged to develop an odor log having dates and times to: track odors; rate the odors; and note any activities the odors prevent the residence from performing. The resident was informed that the city commented that they had this section of sewer on a list for permanent repairs; as part of using a future grant source.

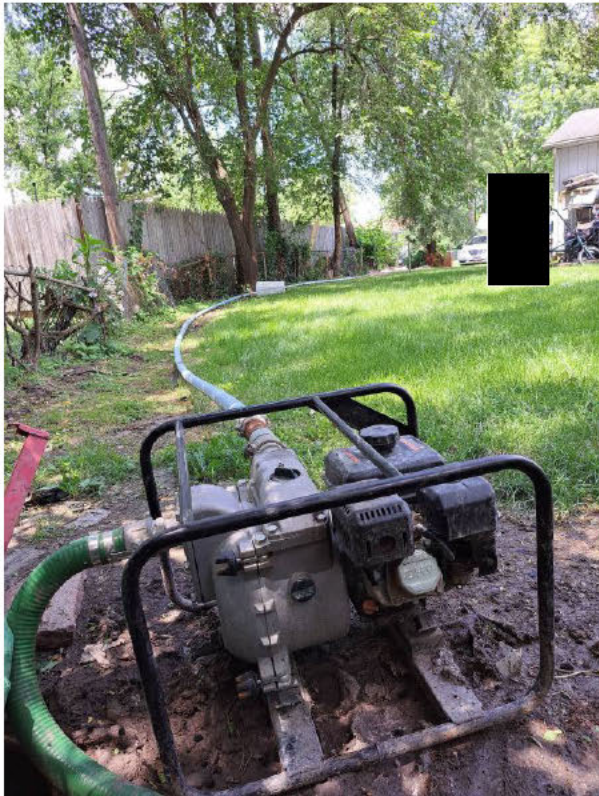
Date: 6/9/2022  
Photo by: Gregg Sanders  
Bypass Line at [REDACTED].

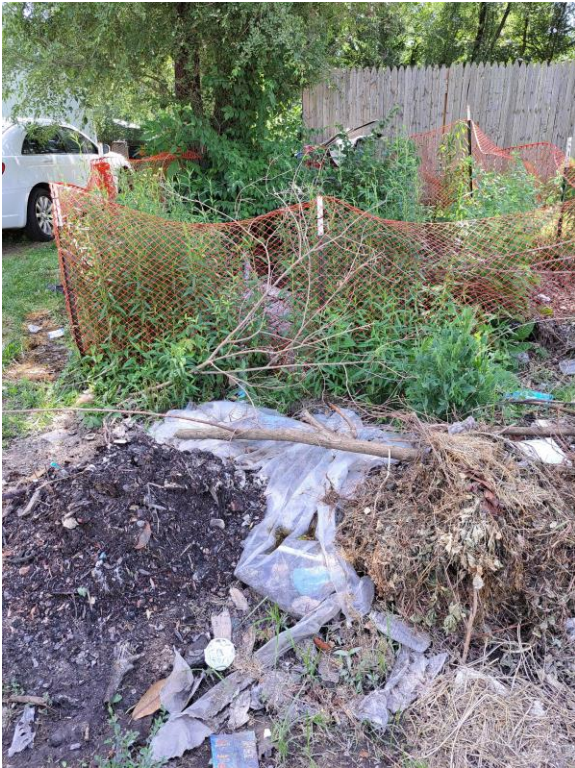
**Sewer Collapse, Receiving Manhole,  
Debris, Vegetation, Temporary Fencing  
At [REDACTED].**

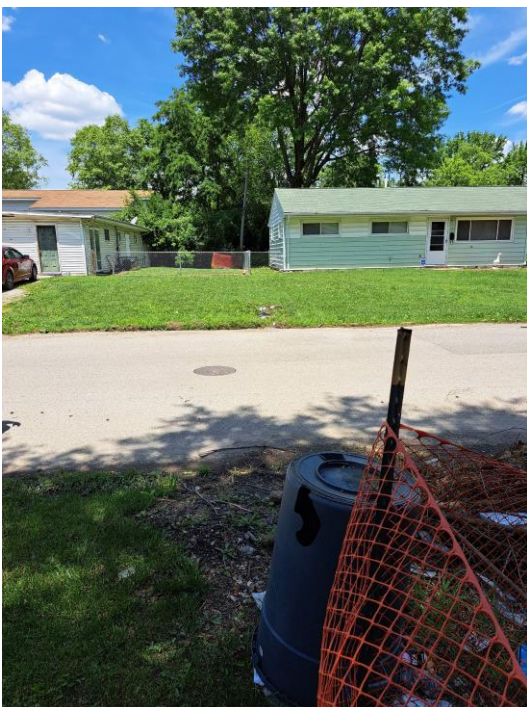
**Manhole in Road Receives Temporary  
Bypass Discharges from: (1) Parklane  
Drive Collapse & Lazarcheff Connected  
Network and (2) the [REDACTED]  
[REDACTED] Collapse Network.**

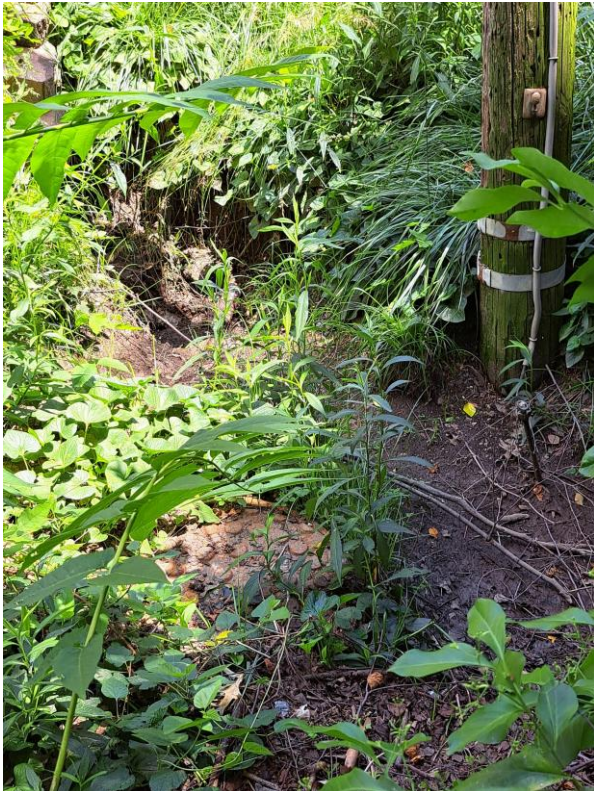
■■■■■■■■■■, ■■■■■■■■■■, and ■■■■■■■■■■  
Inspection of the backyard of ■■■■■■■■■■ revealed a collapsed sewer/manhole on the opposite side of the resident's chain link fence and adjacent to where four adjacent back properties meet. Bypass piping runs downstream through the homeowner's backyard and dumps at a sewer manhole in the backyard of a neighbor; located at ■■■■■■■■■■. The downstream manhole at the ■■■■■■■■■■ address is very close to both houses, and a strong odor was present there at the time of the inspection. The rest of the bypass piping behind ■■■■■■■■■■ runs: upstream; northeasterly; and behind the homes leading to the backyard of ■■■■■■■■■■, where a submersible pump in a manhole exists. The pump pulls sewer from the southwesterly underground sewer, due to the collapse, and then returns it back southwesterly by above ground bypass line to the aforementioned manhole at the ■■■■■■■■■■ residence. Although this network runs behind homes on the other side of the road from ■■■■■■■■■■, these are separate bypass networks. However, both networks do end up emptying into the same manhole in the middle of the road near ■■■■■■■■■■, which flows by gravity to the Blue Water Lift Station. There is also a white PVC pipe present in the same area as the collapse behind ■■■■■■■■■■, extending from the neighbor's backyard off of Kenneth Street. The city agreed to determine what this pipe is connected to; there was no active flow from it at the time of the inspection. The resident at ■■■■■■■■■■ communicated that the outdoor odors that come into the house are unbearable. The ■■■■■■■■■■ resident was informed that the city commented that this section of the sewer was on their list of

Date: 6/9/2022  
Photo by: Gregg Sanders  
**Sewer/Manhole Collapse Behind**

██████████.

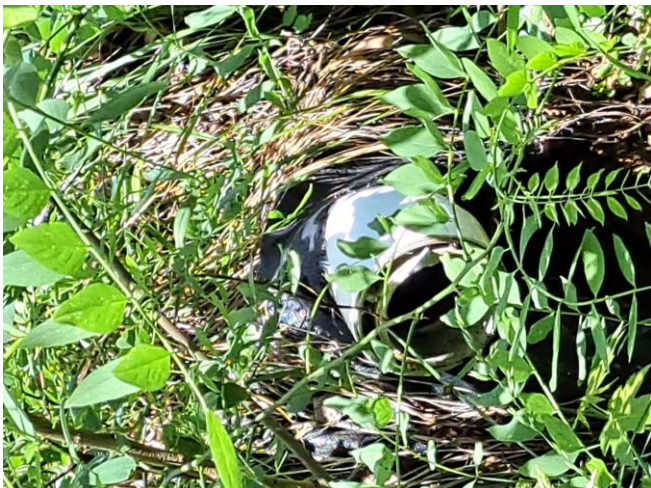
6/9/2022  
Photo by: Gregg Sanders  
**Pipe of Unknown Use Behind**  
██████████ **Near the**  
**Sewer Collapse/Manhole. The**  
**Pipe Extends from Neighbor's**  
**Yard on** ██████████.

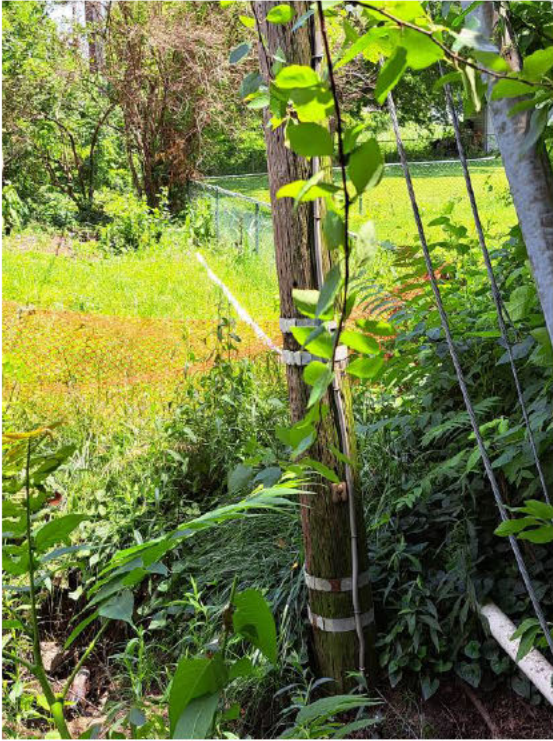
Bypass Behind and Runs Toward [REDACTED]  
[REDACTED]. The Bypass Pump  
Connection is Behind [REDACTED],  
Which is Further in the Background and  
Not in the Picture.

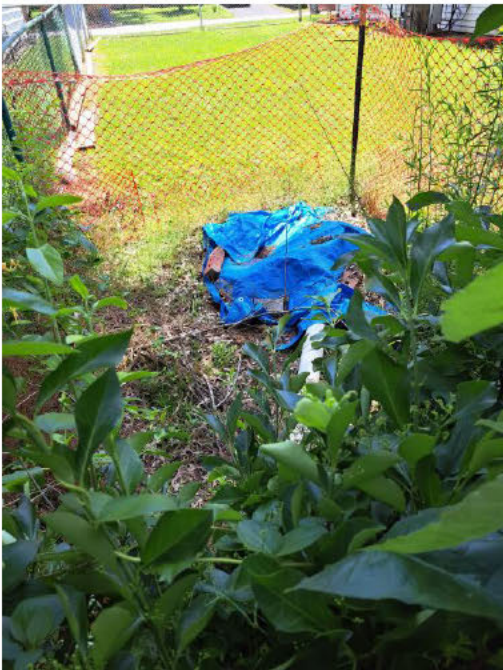
Bypass Receiving Manhole Location at  
[REDACTED] Backyard. Picture  
Taken from [REDACTED] Backyard.

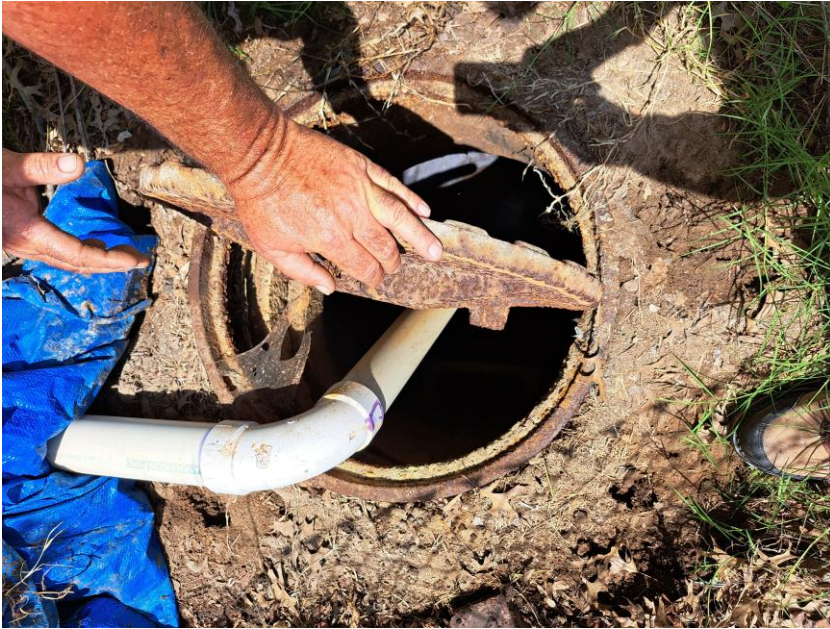
Mr. Culpepper lifted manhole covers at: the [REDACTED] residence; the [REDACTED] backyard location; and near Bluewater Lane behind the neighboring resident to the [REDACTED] resident. None of the manholes were surcharged, but all lids were laying on top of the bypass lines running down into the center of the manholes. This leaves relatively large, unsealed, open-atmosphere gaps that release sewer odors. The use of tarps to cover some of the manholes may not have had the desired outcomes that the city initially intended.

Date: 6/9/2022  
Photo by: Gregg Sanders  
**Bypass Receiving**  
**Manhole at** [REDACTED]  
[REDACTED] **Backyard – Tarp Removed.**

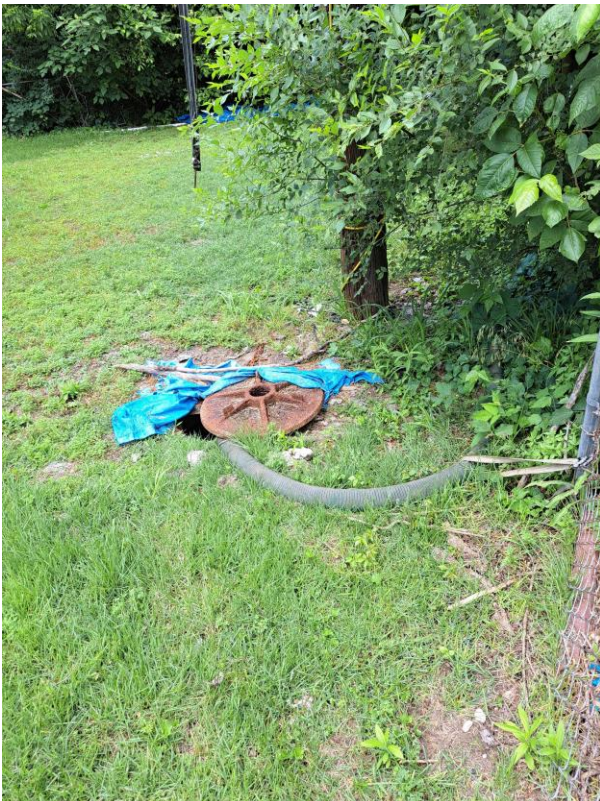
Date: 6/9/2022  
Photo by: Gregg Sanders  
**Bypass Pumping Manhole at** [REDACTED]  
[REDACTED] **for Residences on**  
**Parklane Drive &** [REDACTED]  
[REDACTED].

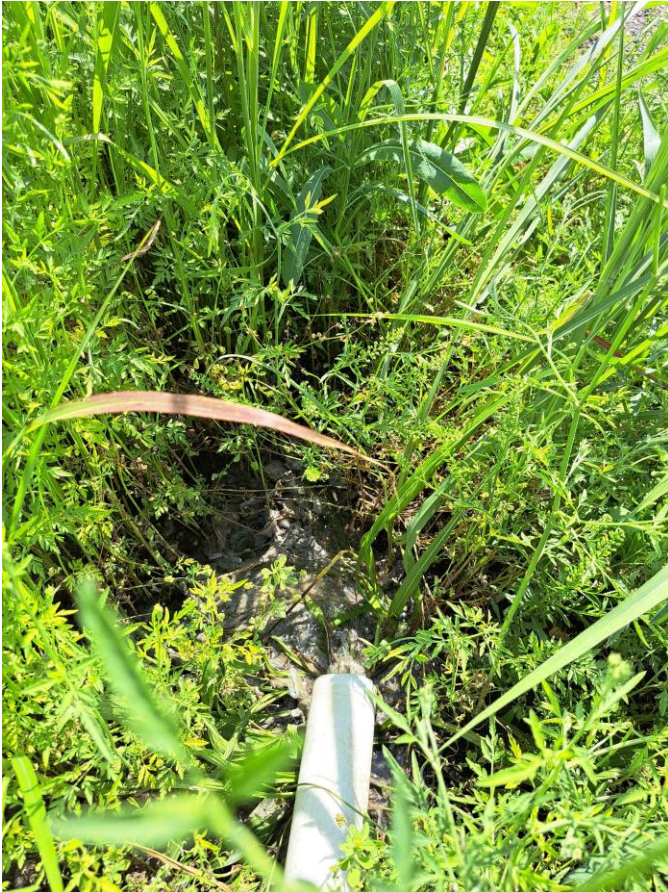
[REDACTED]  
While in the area, a resident located at [REDACTED] commented that the city had ran a sewer line in the back of the yard; along Blue Water Lane. Upon inspection, an active SSO was accumulating in the ditch of the backyard; a break in a bypass line had occurred. A photo of the ponding SSO is attached. The separation of the bypass line was observed to occur, within high weeds, and sewer made its way through the weeds to a low open area of the ditch. The pumping manhole was found behind the neighbor's backyard fence. The electric pump was powered through an electrical outlet in the garage at [REDACTED]. The bypass line was followed to the end of Blue Water Lane to where it dumps into another manhole, which is downstream of another observed collapsed sewer. This downstream manhole also takes flows from nearby Andrew Street and gravity feeds the Blue Water Sewer Lift Station. The resident at [REDACTED] reported that strong odor had entered her house routinely in the past.

**Bypass Line Break Behind**

**██████████ & Along Blue Water Lane – Accumulated in Ditch Behind**

**██████████.**

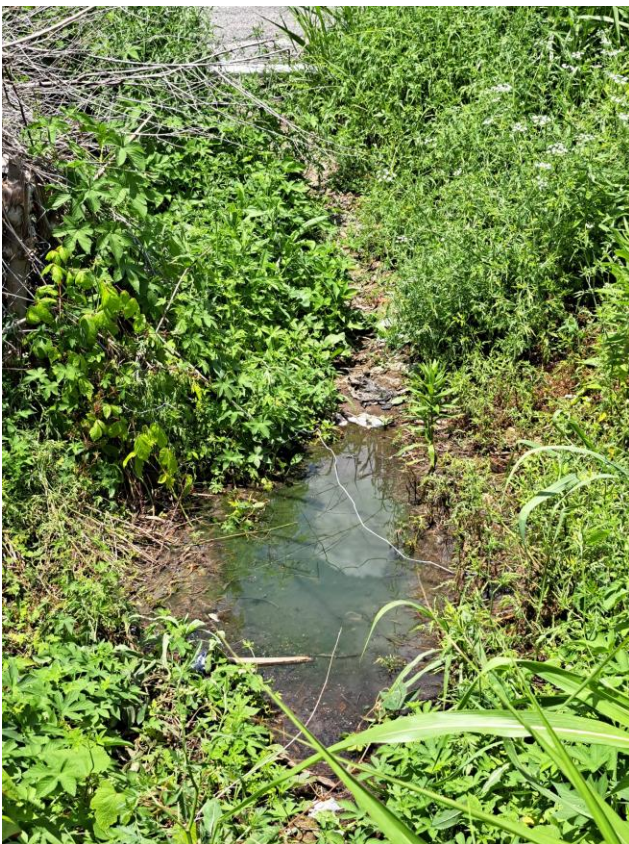
**Accumulated SSO from Line Break.**

**SSO Traveled Through Heavy Vegetation to This Ponding Point.**

**Intact portion of Bypass Line is in the Background.**

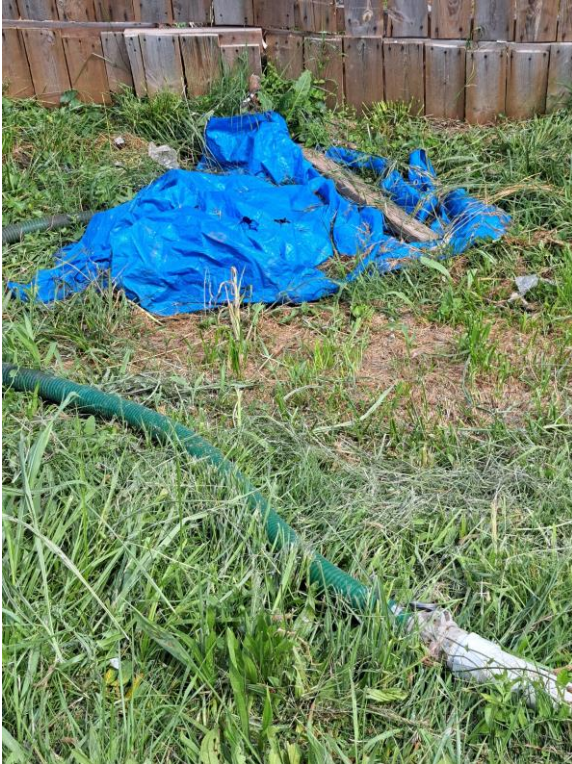
**Bypass Pump Location Behind and Next To [REDACTED] & Along Blue Water Lane.**

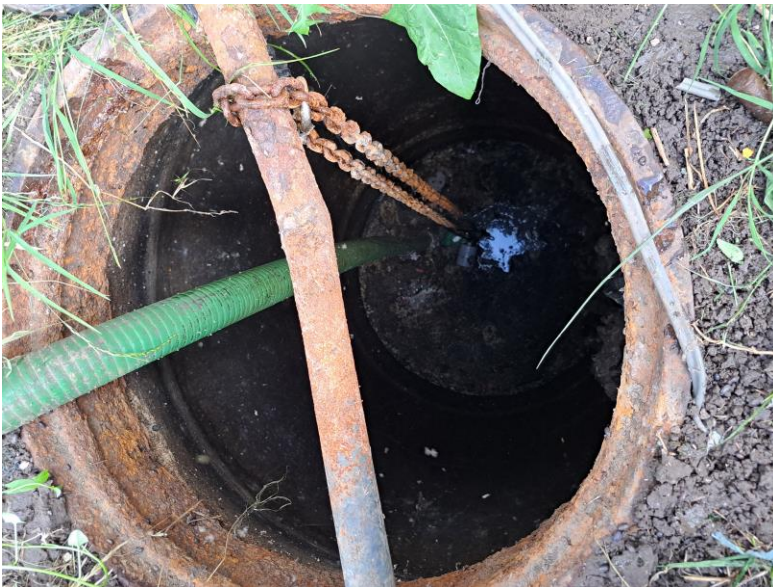
**Bypass Pump Opened Manhole Behind and Next to [REDACTED] & Along Blue Water Lane.**

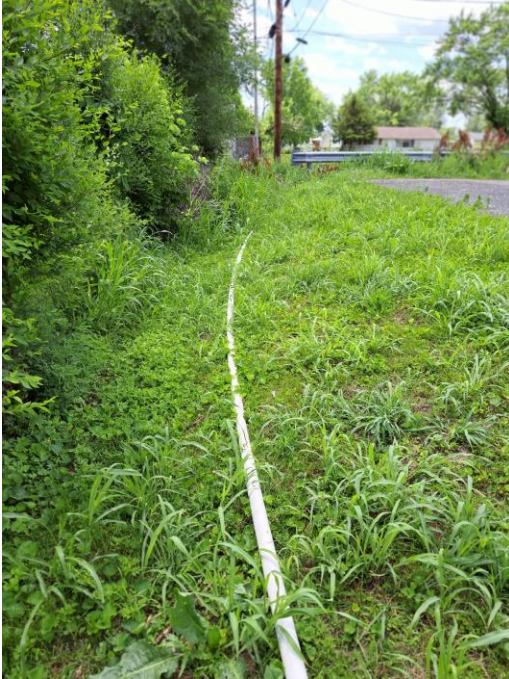
**Bypass Line Towards Sewer Collapse  
& Receiving Manhole Along Blue Water  
Lane.**

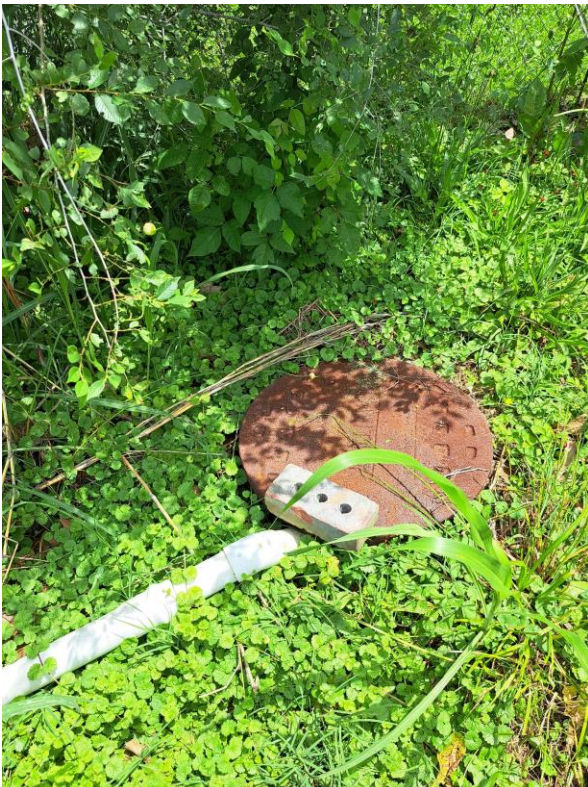
**Receiving Bypass Manhole Along  
Blue Water Lane.**

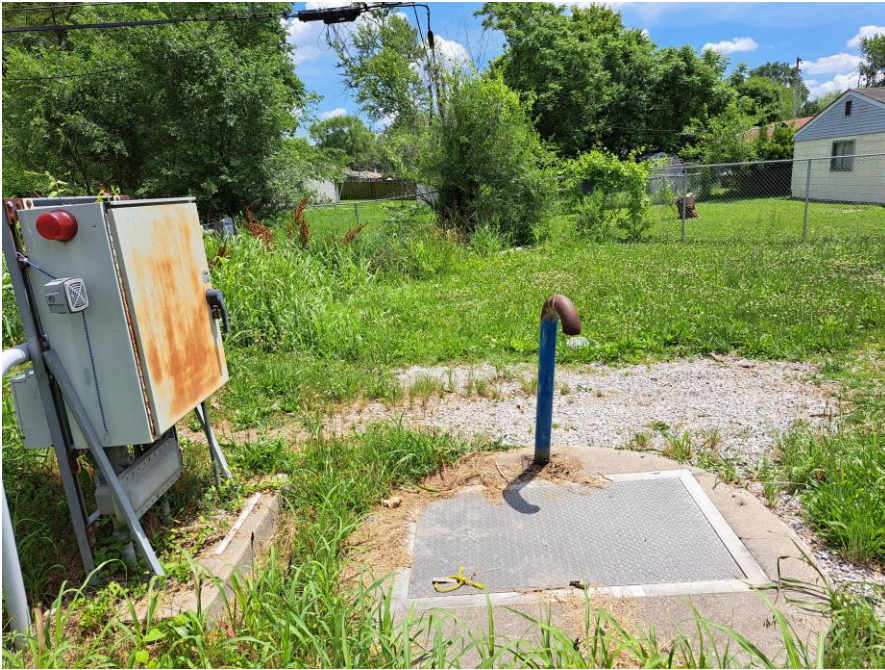
Date: 6/9/2022  
Photo by: Gregg Sanders  
**Blue Water Lift Station Receives  
Flows from All 3 Bypass Networks.**

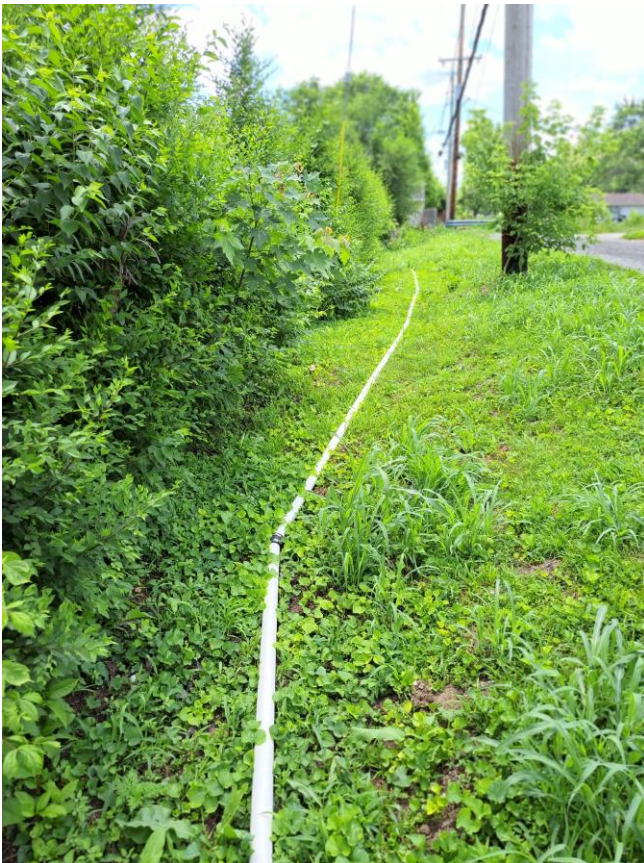
Date: 6/9/2022  
Photo by: Gregg Sanders  
**More Bypass Pipe Along Blue Water  
Lane.**
