ASBESTOS SURVEY REPORT

Fox Shores Apartments
430 N River Street
Aurora, Illinois 60506

August 18, 2017
Partner Project Number: 17-191725.1

Subject: Asbestos Survey Report
430 N River Street
Aurora, Illinois 60506
Partner Project No. 17-191725.1

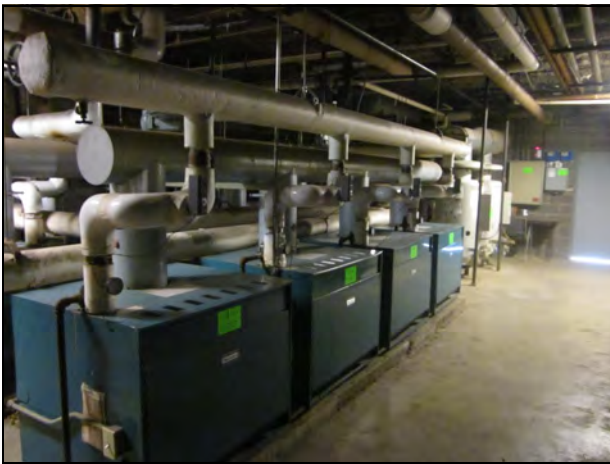
3. View of the boiler room. The TSI all appears to be fiberglass and in good condition.

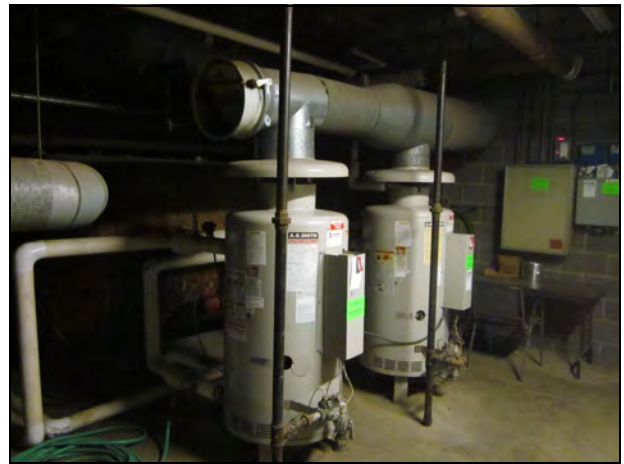
4. View of boiler room equipment. The TSI all appears to be fiberglass and in good condition.

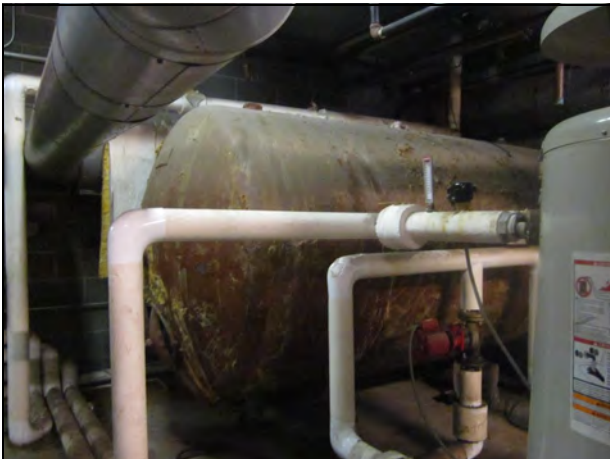
5. View of the hot water holding tank. Bits of fiberglass insulation are stuck to the tank.

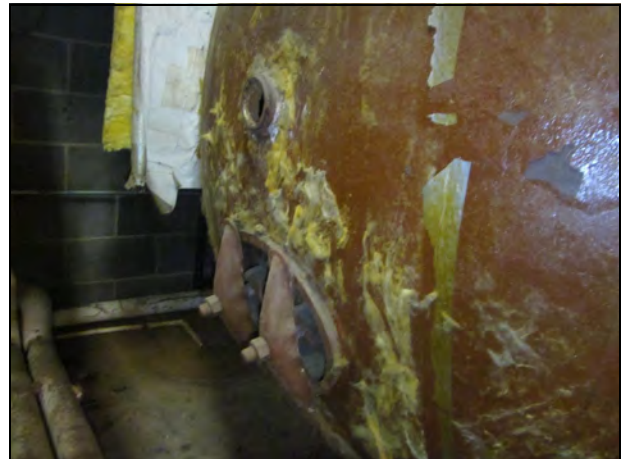
6. Close-up of the previous photo.

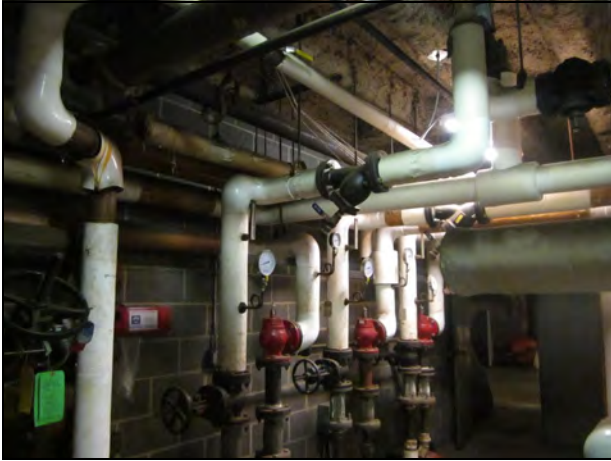
7. View of the piping in the boiler room. All of the TSI appears to be fiberglass and in good condition.

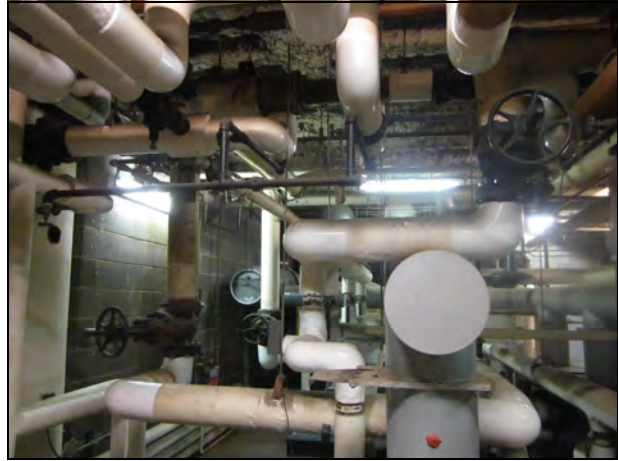
8. View of the piping in the boiler room. All of the TSI appears to be fiberglass and in good condition.

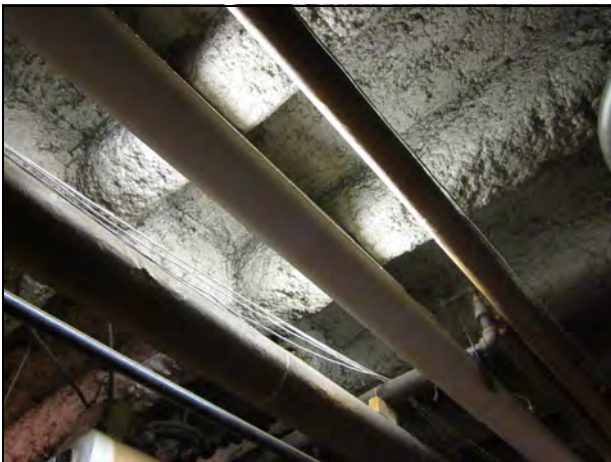
9. View of the spray-on fireproofing on the concrete ceiling of the boiler room.

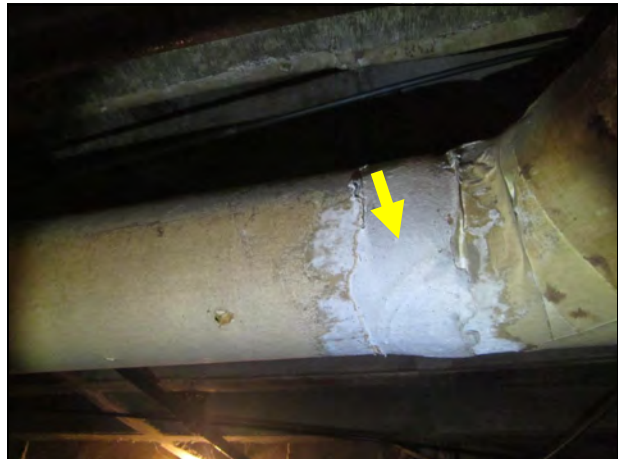
Thermal System Insulation (TSI) Joints, located in the garage - approximately 100 joints/fittings on pipes

While several joints were negative, extensive additional testing would be required to further delineate pipes with ACM joints and those without it, which was beyond the scope of this assessment.

12. View of the TSI joint: Sample #4, near parking spot #34. The TSI on the pipe run is fiberglass.

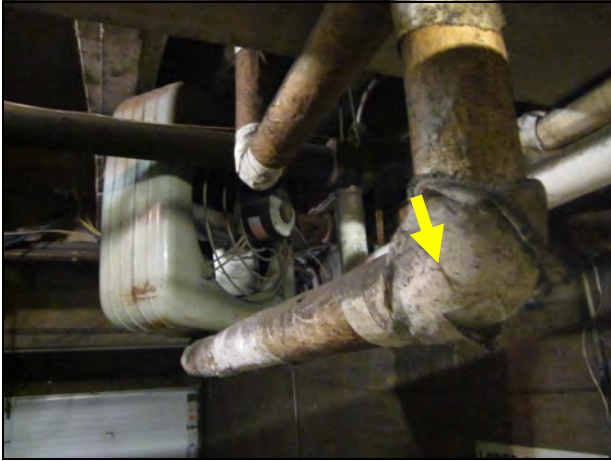
13. View of TSI joint sample #5, near the roll-up garage door. The pipe run TSI is fiberglass.

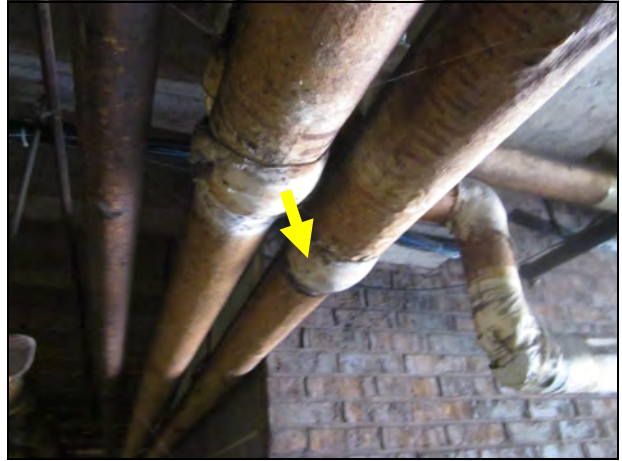
14. View of TSI joint Sample #6, near the elevator equipment room. The pipe run TSI is fiberglass.

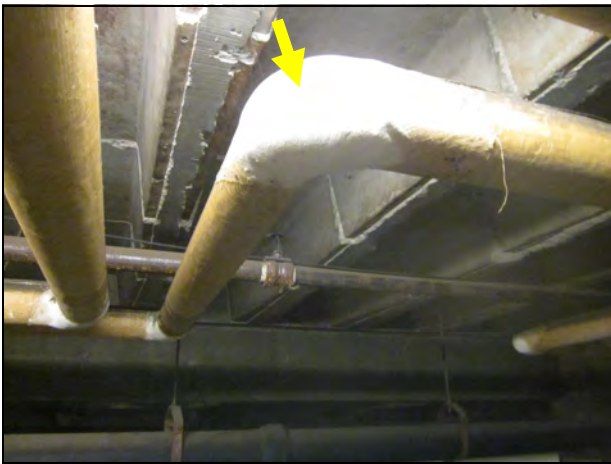
15. View of TSI joint Sample #7, near parking spot #10. The pipe run TSI is fiberglass.

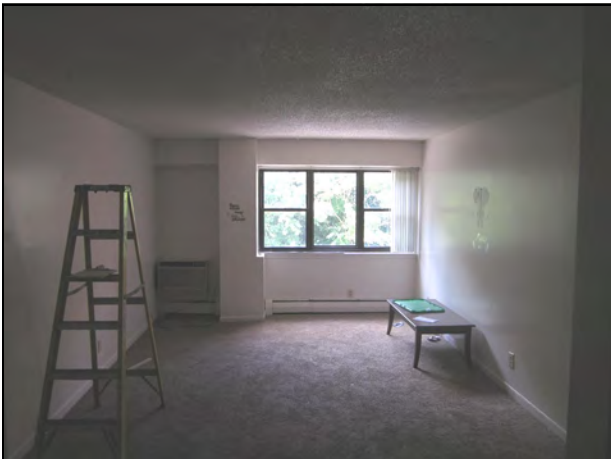
Joint Compound and Gypsum Board, located on all walls and ceilings - approximately 200,000 SF

The gypsum board did not test positive for asbestos, however because it is not practically separable from the joint compound, both materials are considered ACM.

17. View of a typical Living Room; note the textured ceiling, and gypsum board (drywall) throughout.

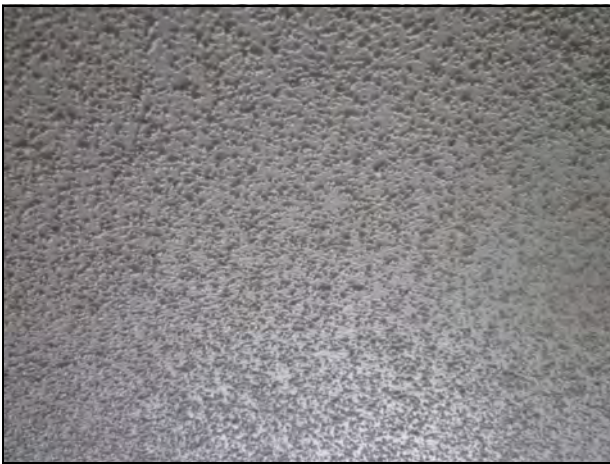
Textured Surfacing Material, located on all ceilings - approximately 100,000 square feet (SF)

Generally in good condition, though sporadic damage observed throughout, particularly at closet doors which rubbed off whole sections of the textured material within the door radius.

21. Close-up of the texture surfacing material present on the ceilings. The material is applied to gypsum board.

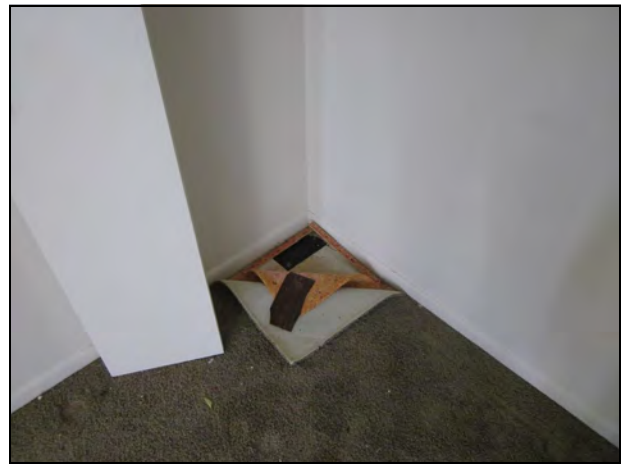
Floor tile, red, 9"x9", and Black Mastic, located on all floors in the facility (units and common halls) except for unit kitchens and bathrooms - approximately 100,000 SF

22. View of a bedroom closet; the pulled back carpet reveals floor tile and black mastic.

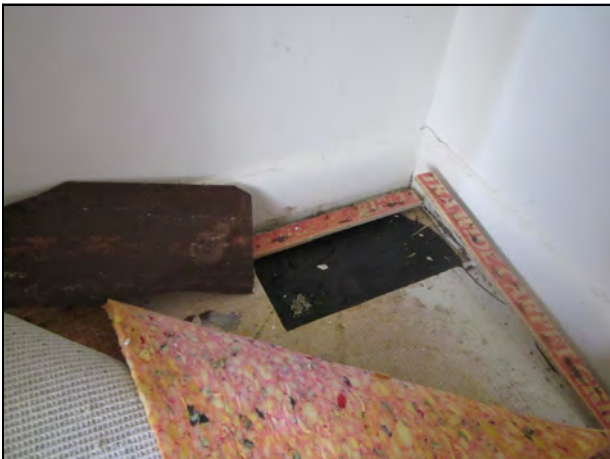
23. Close-up of the previous photo. The red tile is on the left, the black mastic is on the right. The white is either paint or leveling compound.

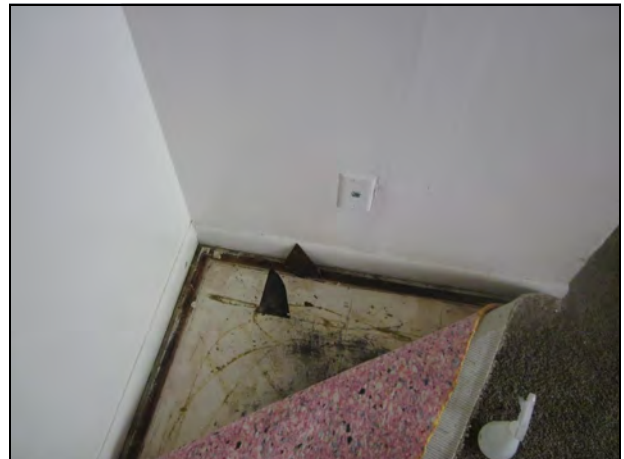
24. Another view of the same flooring system present in another unit.

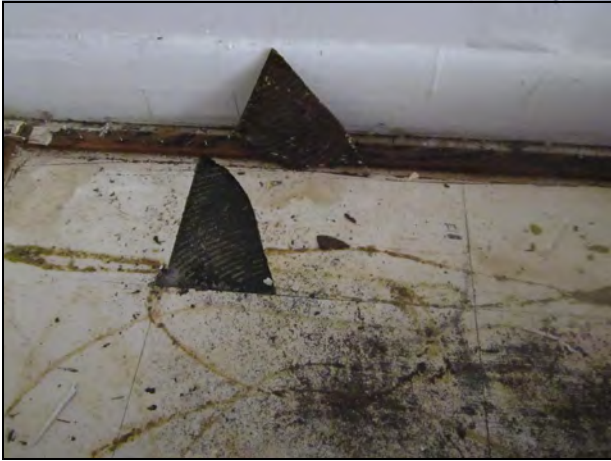
25. Close-up of the previous photo.

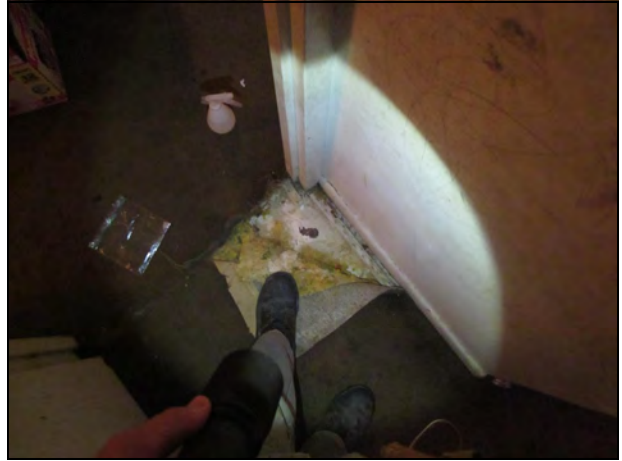
26. Another view of the same flooring system.

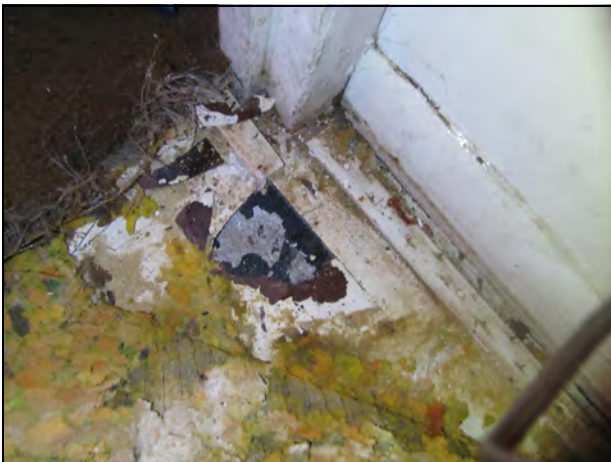
27. Close-up of the previous photo.

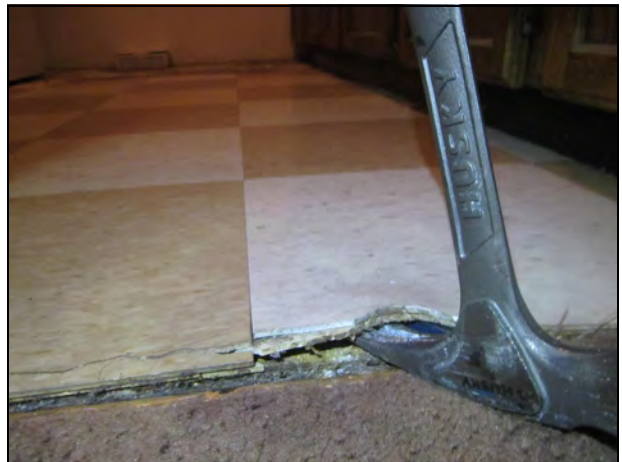
Kitchen **floor tile mastic**, located in kitchens and presumably bathrooms – approximately 10,000 SF

28. View of a typical kitchen floor system. Two layers of tile over plywood, on top of concrete.

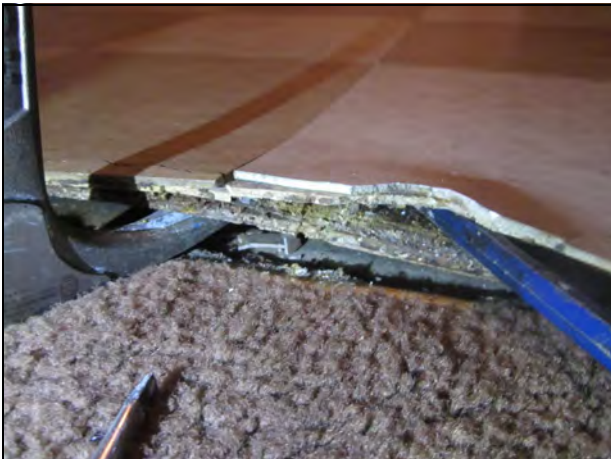
29. Close-up of the previous photo.

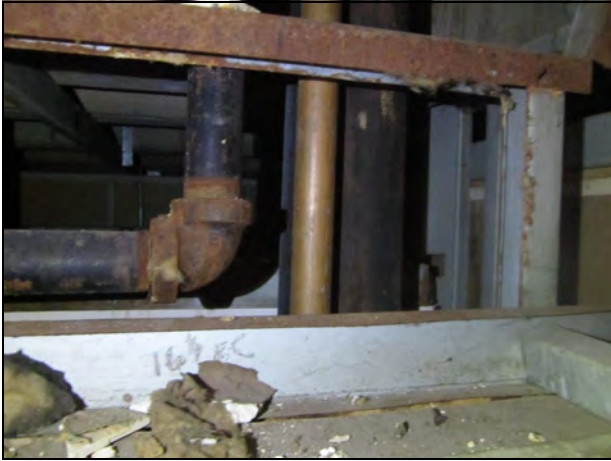
31. View inside the hatch revealing non-insulated pipes.

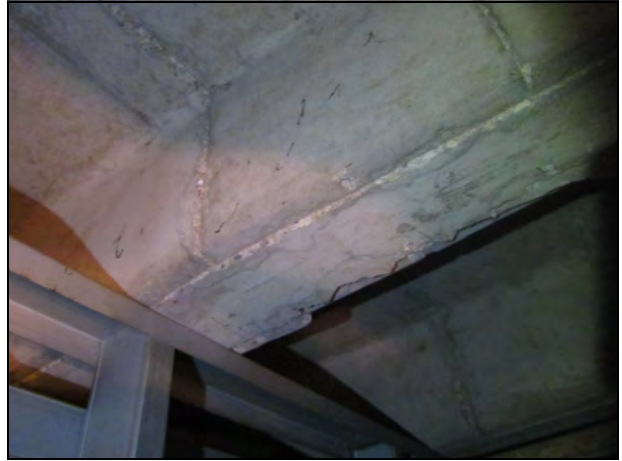
32. View inside the hatch showing concrete without spray-on fireproofing.

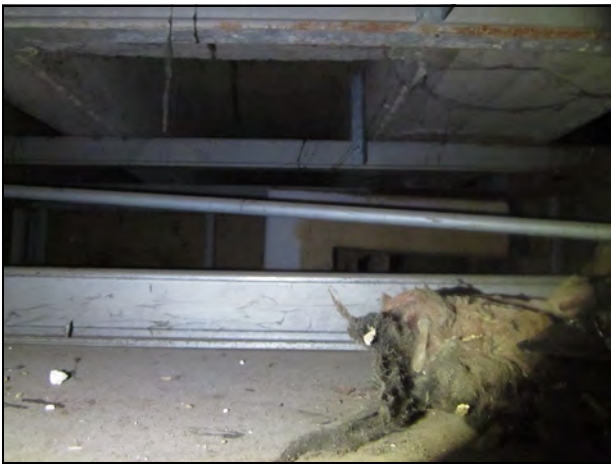
Duct insulation, kitchen/bathroom exhaust ducts – approximately 1-2 per unit, leading to roof vents

They ducts were not sampled and are presumed to contain asbestos. The ducts were observed above ceilings but not accessible without causing significant damage.

33. View inside the hatch of an insulated duct (could not be sampled) probably for bathroom/kitchen exhaust.

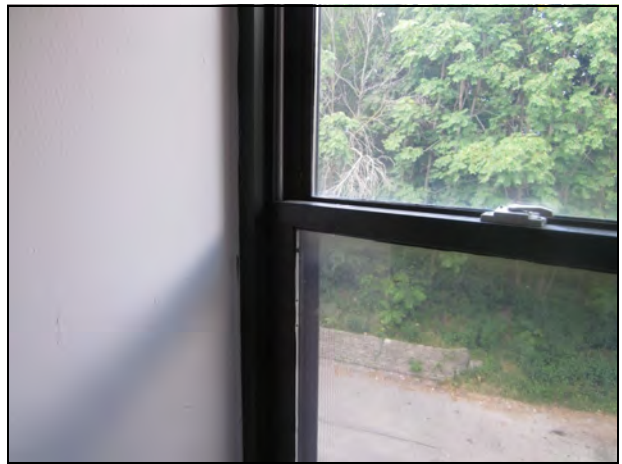
34. View of a typical window with caulk.

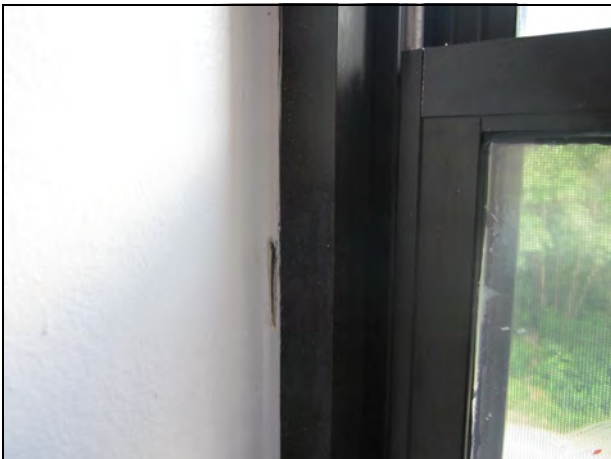
35. Close-up of a typical window caulk sample location.

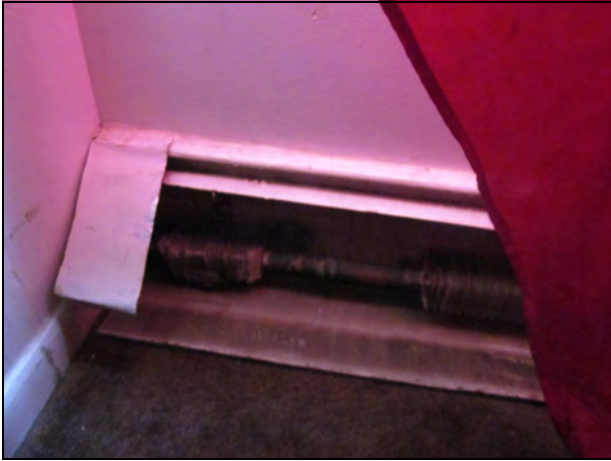
37. View of a typical unit baseboard heater. No insulation was observed.
