# LIMITED HAZARDOUS MATERIALS SURVEY REPORT

## **Fox Shore Apartments**

430 N River Road Aurora, IL 60506

Report Date: February 24, 2026

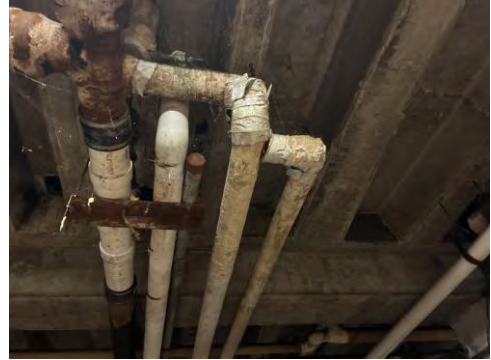
**Condition:** Significantly Damaged

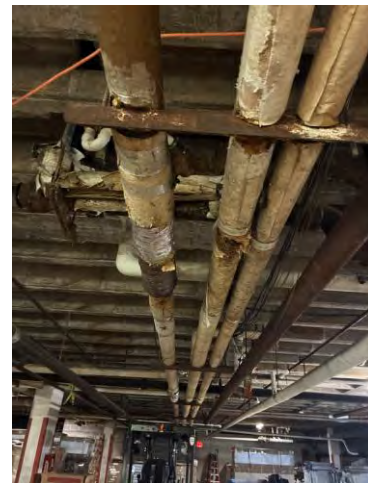
**Sample Numbers:** FSA-021726-3A, FSA-021726-3B, FSA-021726-3C

**Material Description:** Insulation Pipe

**Condition:** Significantly Damaged

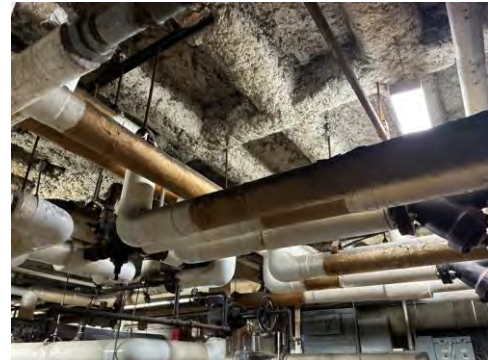
**Sample Numbers:** FSA-021726-5A, FSA-021726-5B, FSA-021726-5C

**Material Description:** Fireproofing

**Condition:** Good

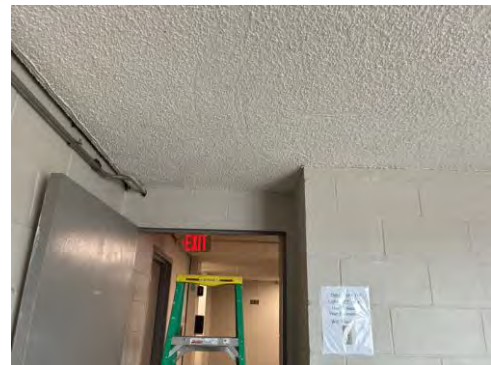
**Sample Numbers:** FSA-021726-7A, FSA-021726-7B, FSA-021726-7C

Asbestos Positive Materials Fox Shore Apartments					
Samples	Material	Location	Percentage/ Type	Approx. Quantity	Condition / Material Type / NESHAP Category
FSA-021726-7A FSA-021726-7B FSA-021726-7C	White Acoustic Ceiling Finish	Fourth Floor Laundry	3% Chrysotile	100 SF	Good Surfacing RACM
FSA-021726-13A FSA-021726-13B FSA-021726-13C	White Acoustic Ceiling Finish	Apartment Unit 401	5.25% Chrysotile	400 SF	Damaged Surfacing RACM

**Material Description:** Acoustic Ceiling Finish

**Condition:** Good

Results of laboratory analysis confirmed asbestos was identified within some of the bulk samples collected. The asbestos-containing materials were found to be in good condition at the time of the inspection. Removal of asbestos-containing materials should be performed by an IDPH licensed asbestos abatement contractor, and should be handled, stored, and disposed of according to all local, state, and federal regulations.

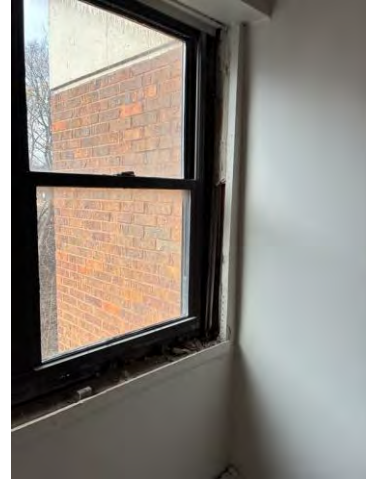
**Sample Numbers:** FSA-021726-12A, FSA-021726-12B, FSA-021726-12C  
**Material Description:** Caulking  
**Material Color:** White  
**Accessible Material:** Accessible  
**Reason Inaccessible:** N/A  
**Asbestos Detected:** Negative  
**Asbestos Type:** No Asbestos Detected  
**Homogeneous Area:** Unit 401 Living Room Area  
**Total Approximate Quantity:** 20 LF  
**Condition:** Good  
**Material Type:** Misc.  
**NESHAP Category:** N/A  
**Notes:** Not Applicable

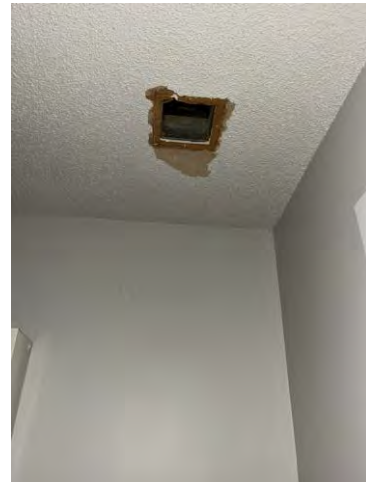
**Sample Numbers:** FSA-021726-13A, FSA-021726-13B, FSA-021726-13C  
**Material Description:** Acoustic Ceiling Finish  
**Material Color:** White  
**Accessible Material:** Accessible  
**Reason Inaccessible:** N/A  
**Asbestos Detected:** Positive  
**Asbestos Type:** Chrysotile  
**Homogeneous Area:** Apartment Unit 401  
**Total Approximate Quantity:** 400 SF  
**Condition:** Damaged  
**Material Type:** Surfacing  
**NESHAP Category:** RACM  
**Notes:** Not Applicable

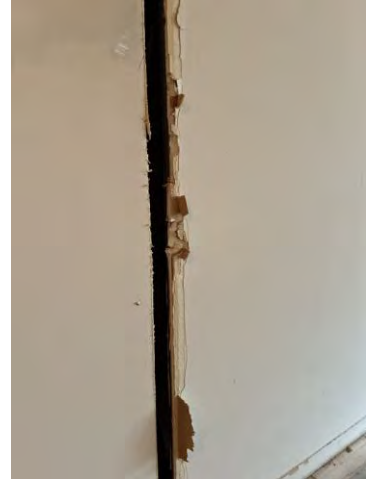
**Sample Numbers:** FSA-021726-16A  
**Material Description:** Wallboard Gypsum With Joint Compound  
**Material Color:** Tan White  
**Accessible Material:** Accessible  
**Reason Inaccessible:** N/A  
**Asbestos Detected:** Trace  
**Asbestos Type:** Chrysotile  
**Homogeneous Area:** Unit 410 Between Kitchen And Living Room  
**Total Approximate Quantity:** 100 SF  
**Condition:** Damaged  
**Material Type:** Misc.  
**NESHAP Category:** N/A  
**Notes:** Not Applicable

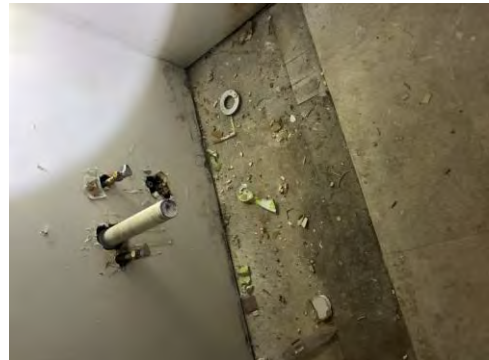
**Sample Numbers:** FSA-021826-17A, FSA-021826-17B, FSA-021826-17C  
**Material Description:** Wallboard Gypsum With Joint Compound  
**Material Color:** Tan White  
**Accessible Material:** Accessible  
**Reason Inaccessible:** N/A  
**Asbestos Detected:** Trace  
**Asbestos Type:** Chrysotile  
**Homogeneous Area:** Apartment 303 Kitchen  
**Total Approximate Quantity:** 100 SF  
**Condition:** Damaged  
**Material Type:** Misc.  
**NESHAP Category:** N/A  
**Notes:** Not Applicable

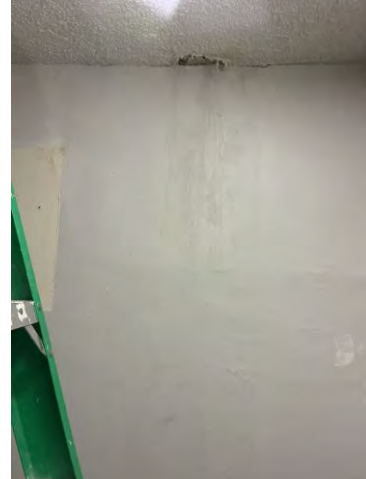
**Sample Numbers:** FSA-021826-18A, FSA-021826-18B, FSA-021826-18C  
**Material Description:** Acoustic Ceiling Finish  
**Material Color:** White  
**Accessible Material:** Accessible  
**Reason Inaccessible:** N/A  
**Asbestos Detected:** Negative  
**Asbestos Type:** No Asbestos Detected  
**Homogeneous Area:** Apartment 303 Bathroom  
**Total Approximate Quantity:** 400 SF  
**Condition:** Damaged  
**Material Type:** Surfacing  
**NESHAP Category:** N/A  
**Notes:** Not Applicable

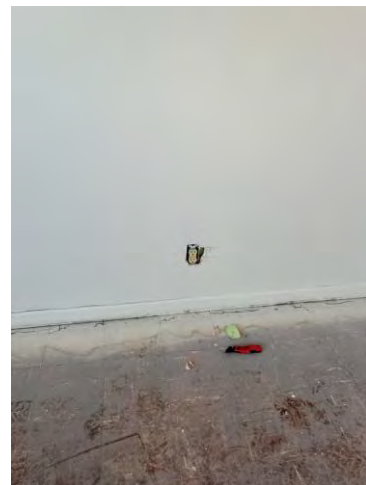
**Sample Numbers:** FSA-021826-19A, FSA-021826-19B, FSA-021826-19C  
**Material Description:** Wallboard Gypsum With Joint Compound  
**Material Color:** White  
**Accessible Material:** Accessible  
**Reason Inaccessible:** N/A  
**Asbestos Detected:** Negative  
**Asbestos Type:** No Asbestos Detected  
**Homogeneous Area:** Apartment 304 Living Room Area  
**Total Approximate Quantity:** 400 SF  
**Condition:** Good  
**Material Type:** Misc.  
**NESHAP Category:** N/A  
**Notes:** Not Applicable

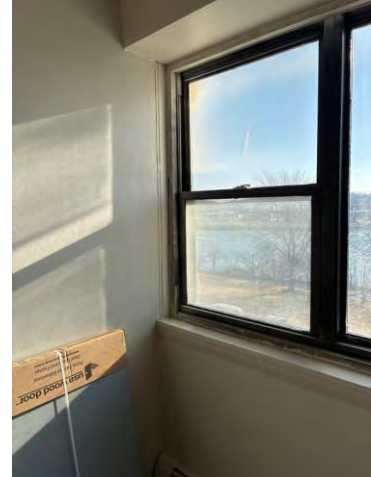
**Sample Numbers:** FSA-021826-20A, FSA-021826-20B, FSA-021826-20C  
**Material Description:** Caulking  
**Material Color:** White  
**Accessible Material:** Accessible  
**Reason Inaccessible:** N/A  
**Asbestos Detected:** Negative  
**Asbestos Type:** No Asbestos Detected  
**Homogeneous Area:** Apartment 304 Living Room Window  
**Total Approximate Quantity:** 20 LF  
**Condition:** Good  
**Material Type:** Misc.  
**NESHAP Category:** N/A  
**Notes:** Not Applicable

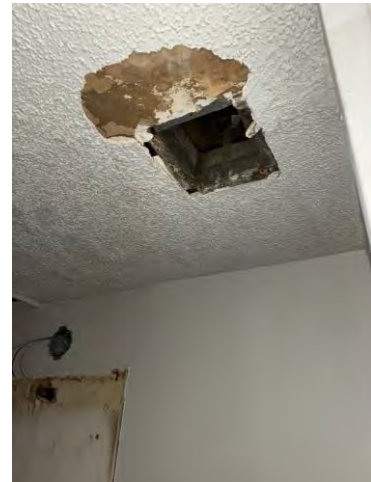
**Sample Numbers:** FSA-021826-21A, FSA-021826-21B, FSA-021826-21C  
**Material Description:** Acoustic Ceiling Finish  
**Material Color:** White  
**Accessible Material:** Accessible  
**Reason Inaccessible:** N/A  
**Asbestos Detected:** Positive  
**Asbestos Type:** Chrysotile  
**Homogeneous Area:** Apartment 304 Bathroom  
**Total Approximate Quantity:** 400 SF  
**Condition:** Damaged  
**Material Type:** Surfacing  
**NESHAP Category:** RACM  
**Notes:** Not Applicable

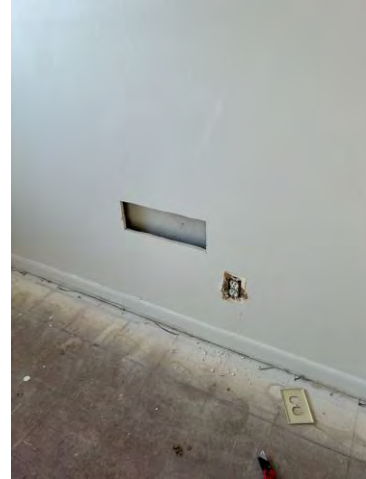
**Sample Numbers:** FSA-021826-22A, FSA-021826-22B, FSA-021826-22C  
**Material Description:** Wallboard Gypsum With Joint Compound  
**Material Color:** Tan White  
**Accessible Material:** Accessible  
**Reason Inaccessible:** N/A  
**Asbestos Detected:** Negative  
**Asbestos Type:** No Asbestos Detected  
**Homogeneous Area:** Apartment 312 Living Room Area  
**Total Approximate Quantity:** TBD  
**Condition:** Good  
**Material Type:** Misc.  
**NESHAP Category:** N/A  
**Notes:** Not Applicable

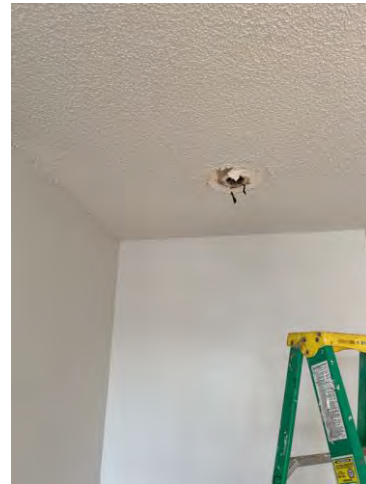
**Sample Numbers:** FSA-021826-23A, FSA-021826-23B, FSA-021826-23C  
**Material Description:** Acoustic Ceiling Finish  
**Material Color:** White  
**Accessible Material:** Accessible  
**Reason Inaccessible:** N/A  
**Asbestos Detected:** Positive  
**Asbestos Type:** Chrysotile  
**Homogeneous Area:** Apartment Unit 312  
**Total Approximate Quantity:** 400 SF  
**Condition:** Damaged  
**Material Type:** Surfacing  
**NESHAP Category:** RACM  
**Notes:** Not Applicable

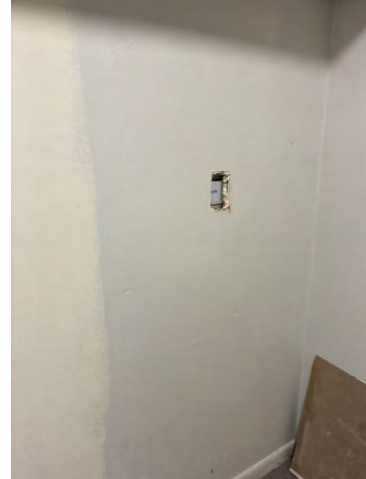
**Sample Numbers:** FSA-021826-24A, FSA-021826-24B, FSA-021826-24C  
**Material Description:** Wallboard Gypsum With Joint Compound  
**Material Color:** White  
**Accessible Material:** Accessible  
**Reason Inaccessible:** N/A  
**Asbestos Detected:** Trace  
**Asbestos Type:** Chrysotile  
**Homogeneous Area:** Apartment 210 Kitchen Area  
**Total Approximate Quantity:** 200 SF  
**Condition:** Good  
**Material Type:** Misc.  
**NESHAP Category:** N/A  
**Notes:** Not Applicable

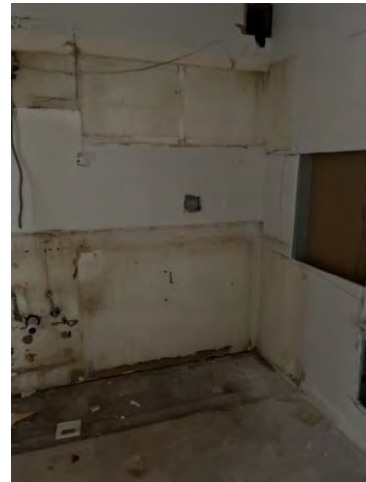
<b>Asbestos Trace Materials Fox Shore Apartments</b>					
<b>Samples</b>	<b>Material</b>	<b>Location</b>	<b>Percentage/ Type</b>	<b>Approx. Quantity</b>	<b>Condition</b>
FSA-021826-25A	White, Tan Wallboard Gypsum With Joint Compound	Apartment Unit 407 Kitchen	<1% Chrysotile (Joint Compound)	400 SF	Damaged
FSA-021826-30A	White, Tan Wallboard Gypsum With Joint Compound	Second Floor Hallway	<1% Chrysotile (Joint Compound)	1000 SF	Good
FSA-021826-33A	White, Tan Wallboard Gypsum With Joint Compound	Apartment 205 Kitchen	<1% Chrysotile (Joint Compound)	400 SF	Damaged
FSA-021826-35A	White, Tan Wallboard Gypsum With Joint Compound	Apartment Unit 208 Bathroom	<1% Chrysotile (Joint Compound)	400 SF	Damaged

**Sample Numbers:** FSA-021826-25A  
**Material Description:** Wallboard Gypsum With Joint Compound  
**Material Color:** Tan White  
**Accessible Material:** Accessible  
**Reason Inaccessible:** N/A  
**Asbestos Detected:** Trace  
**Asbestos Type:** Chrysotile  
**Homogeneous Area:** Apartment Unit 407 Kitchen  
**Total Approximate Quantity:** 400 SF  
**Condition:** Damaged  
**Material Type:** Misc.  
**NESHAP Category:** N/A  
**Notes:** Not Applicable

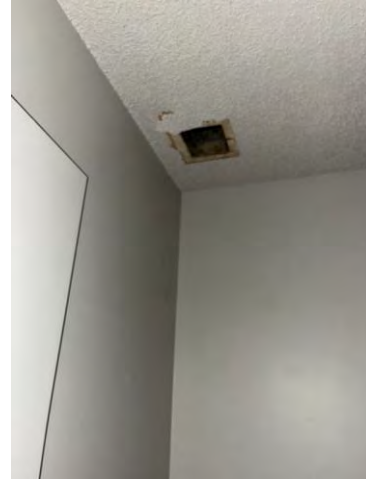
**Sample Numbers:** FSA-021826-26A  
**Material Description:** Acoustic Ceiling Finish  
**Material Color:** White  
**Accessible Material:** Accessible  
**Reason Inaccessible:** N/A  
**Asbestos Detected:** Positive  
**Asbestos Type:** Chrysotile  
**Homogeneous Area:** Apartment Unit 407 Bathroom  
**Total Approximate Quantity:** 400 SF  
**Condition:** Significantly Damaged  
**Material Type:** Misc.  
**NESHAP Category:** RACM  
**Notes:** Not Applicable

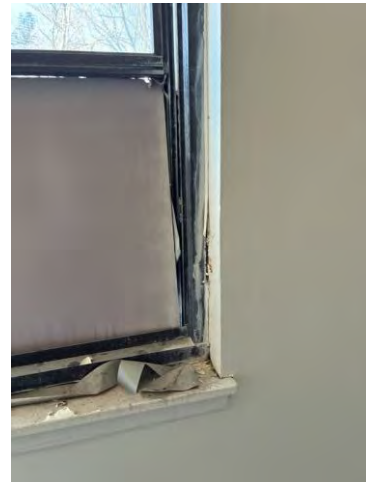
**Sample Numbers:** FSA-021826-27A  
**Material Description:** Caulking  
**Material Color:** White  
**Accessible Material:** Accessible  
**Reason Inaccessible:** N/A  
**Asbestos Detected:** Negative  
**Asbestos Type:** No Asbestos Detected  
**Homogeneous Area:** Apartment Unit 407 Bedroom  
**Total Approximate Quantity:** 24 LF  
**Condition:** Good  
**Material Type:** Misc.  
**NESHAP Category:** N/A  
**Notes:** Not Applicable

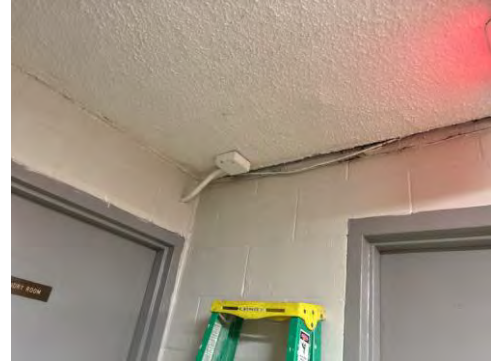
**Sample Numbers:** FSA-021826-28A  
**Material Description:** Acoustic Ceiling Finish  
**Material Color:** White  
**Accessible Material:** Accessible  
**Reason Inaccessible:** N/A  
**Asbestos Detected:** Positive  
**Asbestos Type:** Chrysotile  
**Homogeneous Area:**  
 Third Floor Hallway  
**Total Approximate Quantity:** 1000 SF  
**Condition:** Good  
**Material Type:** Surfacing  
**NESHAP Category:** RACM  
**Notes:** Not Applicable

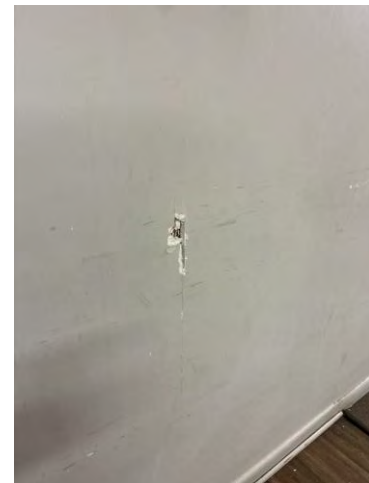
**Sample Numbers:** FSA-021826-29A  
**Material Description:** Wallboard Gypsum With Joint Compound  
**Material Color:** White  
**Accessible Material:** Accessible  
**Reason Inaccessible:** N/A  
**Asbestos Detected:** Negative  
**Asbestos Type:** No Asbestos Detected  
**Homogeneous Area:** Third Floor Hallway  
**Total Approximate Quantity:** 1000 SF  
**Condition:** Significantly Damaged  
**Material Type:** Misc.  
**NESHAP Category:** N/A  
**Notes:** Not Applicable

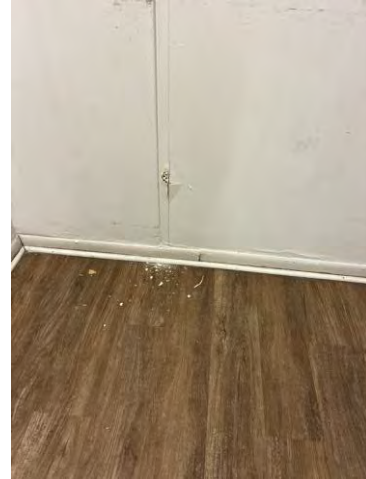
**Sample Numbers:** FSA-021826-30A  
**Material Description:** Wallboard Gypsum With Joint Compound  
**Material Color:** Tan White  
**Accessible Material:** Accessible  
**Reason Inaccessible:** N/A  
**Asbestos Detected:** Trace  
**Asbestos Type:** Chrysotile  
**Homogeneous Area:** Second Floor Hallway  
**Total Approximate Quantity:** 1000 SF  
**Condition:** Good  
**Material Type:** Misc.  
**NESHAP Category:** N/A  
**Notes:** Not Applicable

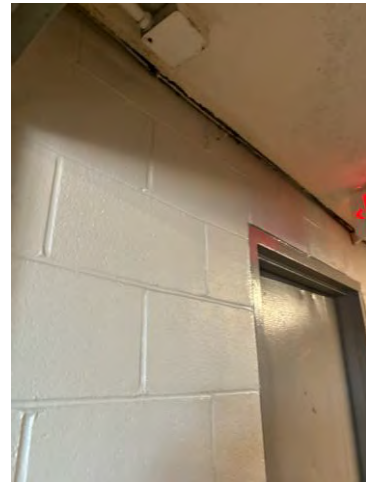
**Sample Numbers:** FSA-021826-31A  
**Material Description:** Acoustic Ceiling Finish  
**Material Color:** White  
**Accessible Material:** Accessible  
**Reason Inaccessible:** N/A  
**Asbestos Detected:** Positive  
**Asbestos Type:** Chrysotile  
**Homogeneous Area:** Second Floor Hallway  
**Total Approximate Quantity:** 1000 SF  
**Condition:** Good  
**Material Type:** Surfacing  
**NESHAP Category:** RACM  
**Notes:** Not Applicable

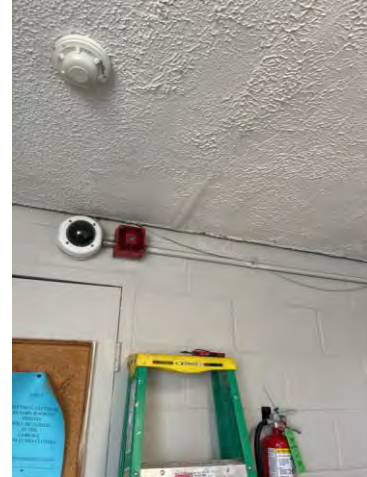
FSA-021826-32A	White Acoustic Ceiling Finish	2nd Floor Hallway	3% Chrysotile	100 SF	Good Surfacing RACM
FSA-021826-34A	White, Tan Acoustic Ceiling Finish	Apartment Unit 205	3% Chrysotile	400 SF	Damaged Surfacing RACM

**Sample Numbers:** FSA-021826-32A  
**Material Description:** Acoustic Ceiling Finish  
**Material Color:** White  
**Accessible Material:** Accessible  
**Reason Inaccessible:** N/A  
**Asbestos Detected:** Positive  
**Asbestos Type:** Chrysotile  
**Homogeneous Area:** 2nd Floor Hallway  
**Total Approximate Quantity:** 100 SF  
**Condition:** Good  
**Material Type:** Surfacing  
**NESHAP Category:** RACM  
**Notes:** Not Applicable

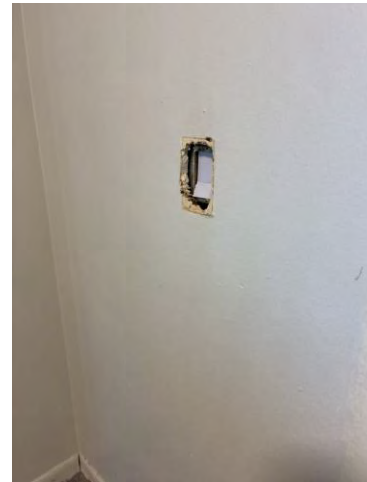
**Sample Numbers:** FSA-021826-33A  
**Material Description:** Wallboard Gypsum With Joint Compound  
**Material Color:** Tan White  
**Accessible Material:** Accessible  
**Reason Inaccessible:** N/A  
**Asbestos Detected:** Trace  
**Asbestos Type:** Chrysotile  
**Homogeneous Area:** Apartment 205 Kitchen  
**Total Approximate Quantity:** 400 SF  
**Condition:** Damaged  
**Material Type:** Misc.  
**NESHAP Category:** N/A  
**Notes:** Not Applicable

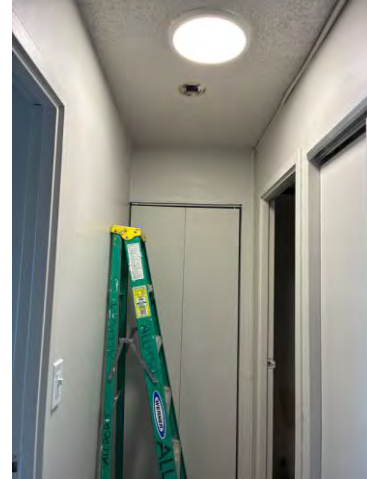
**Sample Numbers:** FSA-021826-34A  
**Material Description:** Acoustic Ceiling Finish  
**Material Color:** Tan White  
**Accessible Material:** Accessible  
**Reason Inaccessible:** N/A  
**Asbestos Detected:** Positive  
**Asbestos Type:** Chrysotile  
**Homogeneous Area:** Apartment Unit 205  
**Total Approximate Quantity:** 400 SF  
**Condition:** Damaged  
**Material Type:** Surfacing  
**NESHAP Category:** RACM  
**Notes:** Not Applicable

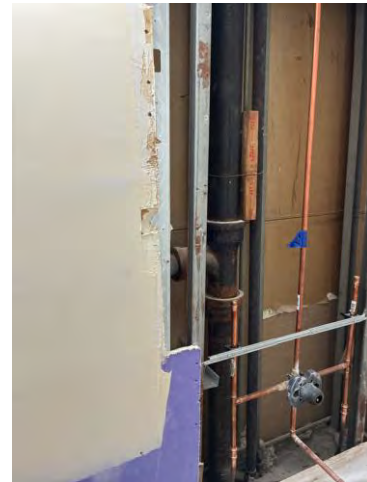
**Sample Numbers:** FSA-021826-35A  
**Material Description:** Wallboard Gypsum With Joint Compound  
**Material Color:** Tan White  
**Accessible Material:** Accessible  
**Reason Inaccessible:** N/A  
**Asbestos Detected:** Trace  
**Asbestos Type:** Chrysotile  
**Homogeneous Area:** Apartment Unit 208 Bathroom  
**Total Approximate Quantity:** 400 SF  
**Condition:** Damaged  
**Material Type:** Misc.  
**NESHAP Category:** N/A  
**Notes:** Not Applicable

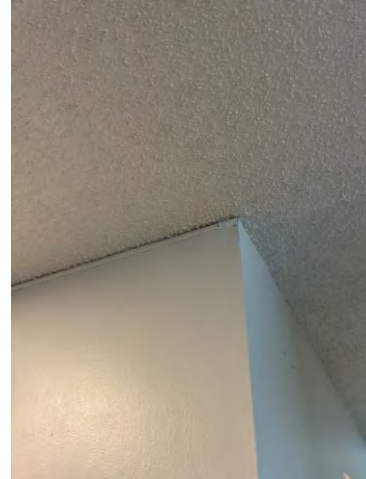
Asbestos Positive Materials Fox Shore Apartments					
Samples	Material	Location	Percentage/ Type	Approx. Quantity	Condition / Material Type / NESHAP Category
FSA-021826-36A	White Acoustic Ceiling Finish	Apartment Unit 208 Living Room Area	3% Chrysotile	400 SF	Good Surfacing RACM

**Sample Numbers:** FSA-021826-36A  
**Material Description:** Acoustic Ceiling Finish  
**Material Color:** White  
**Accessible Material:** Accessible  
**Reason Inaccessible:** N/A  
**Asbestos Detected:** Positive  
**Asbestos Type:** Chrysotile  
**Homogeneous Area:** Apartment Unit 208 Living Room Area  
**Total Approximate Quantity:** 400 SF  
**Condition:** Good  
**Material Type:** Surfacing  
**NESHAP Category:** RACM  
**Notes:** Not Applicable

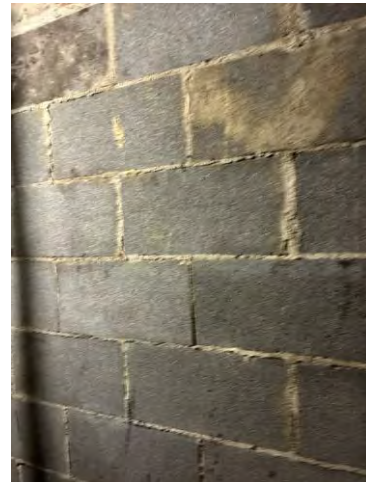
**Sample Numbers:** FSA-021826-37A, FSA-021826-37B, FSA-021826-37C  
**Material Description:** Mortar  
**Material Color:** Grey  
**Accessible Material:** Accessible  
**Reason Inaccessible:** N/A  
**Asbestos Detected:** Negative  
**Asbestos Type:** No Asbestos Detected  
**Homogeneous Area:** Third Floor Meter Room  
**Total Approximate Quantity:** 20 SF  
**Condition:** Good  
**Material Type:** Misc.  
**NESHAP Category:** N/A  
**Notes:** Not Applicable
