# Illinois Environmental Protection Agency

BOW ID: W1010150002

NPDES Permit No: IL0029467

SUBJECT: Lawrence County – Lawrenceville WWTP  
Investigation follow-up – 10/09/25

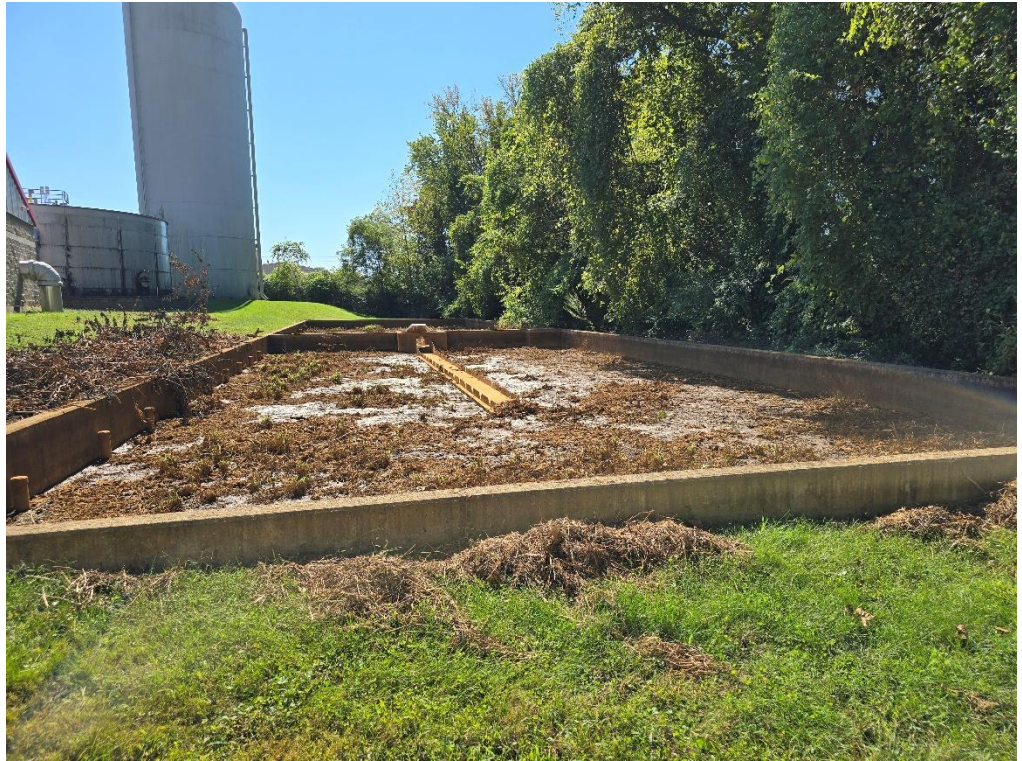
- The sewer/water department has increased from three to five employees.
- Vegetation in the public water supply sand filter has been removed, and the media will be replaced. The sand filter was photographed (see attached photographs).
- Collapsed sewer on Springfield Street will be replaced next week.
- John Weiter, HMG Engineers, submitted NARP for wastewater plant and is the Principal Engineer for the wastewater plant.
- HLR Engineers is handling the collection system repairs.

Photo # Lawrenceville PWS-001  
Date: October 9, 2025  
Time: 1:09 PM  
Taken By: Bruce Rodely DWPC/FOS  
Facility: Lawrenceville PWS  
Location: Sand Filter  
Notes: Note the removed  
vegetation from the PWS  
sand filter.
