TO: Todd Bennett, Manager, BOW/DWPC/FOS

FROM: Joseph D. Stitely, P.E., BOW/DWPC/FOS – Marion & Collinsville

NPDES Permit No: IL0029467

SUBJECT: City of Lawrenceville  
April 2, 2026 Reconnaissance Inspection

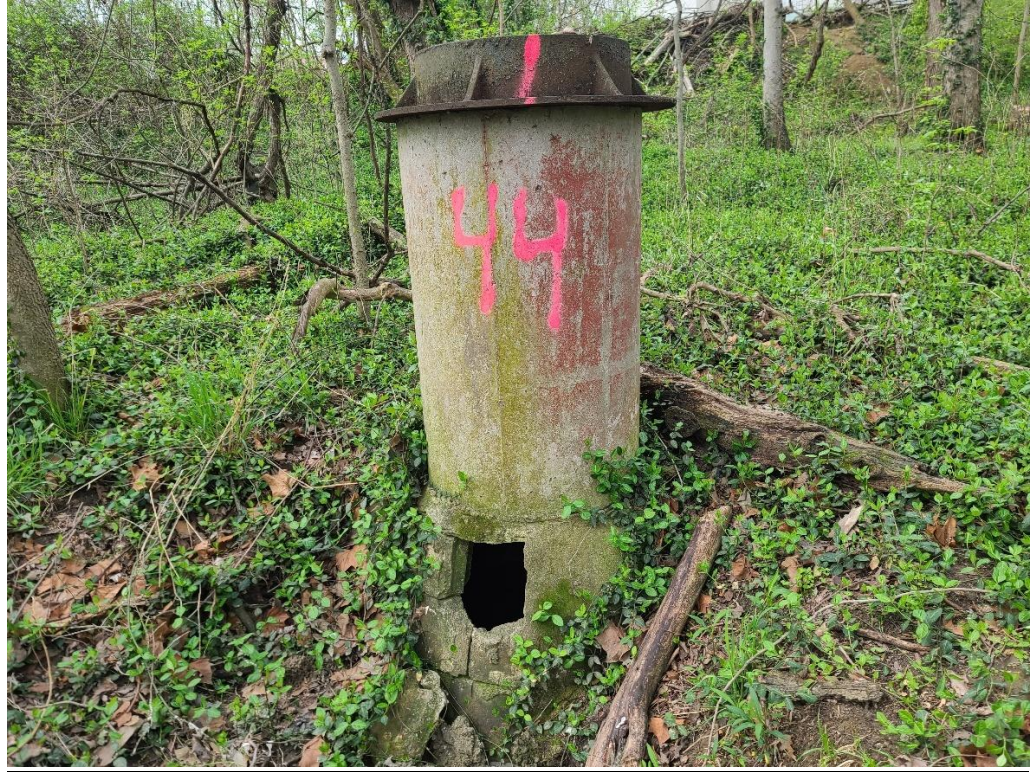
Initially, we stopped and observed the two elevated manholes just south of Cemetery Road between 20<sup>th</sup> Street and 18<sup>th</sup> Street. The two manholes are known as Manhole #51 and #50. We noted no overflows were observed from either of the two manholes at the time of our visit. At this time, Aaron Tipsword arrived and accompanied us. We crossed 18<sup>th</sup> Street and observed another manhole adjacent to the municipal garage. No overflows were observed. We continued to walk east and observed Manhole #44. No overflows were occurring at the time of the visit; however, a large hole was observed in the concrete collar for the manhole. We also observed an eroded channel from the manhole to the creek with toilet paper and grit in the channel (see attached photograph).

Photo # 001  
Date: April 2, 2026  
Time: 10:27 a.m.  
Taken By: Brian Rodely, BOW  
Facility: City of Lawrenceville  
Location: 38.732250,-87.688318  
Notes: This is a photograph of  
Manhole #44. Note that  
the large hole in the  
concrete manhole collar.  
There was an eroded  
channel with toilet paper  
and grit adjacent to the  
manhole to the creek.

7. Permanently repair the broken concrete collar on Manhole #44. At the time of the visit, the concrete collar had a significant hole in its side which could allow SSOs to occur during periods of high flow.

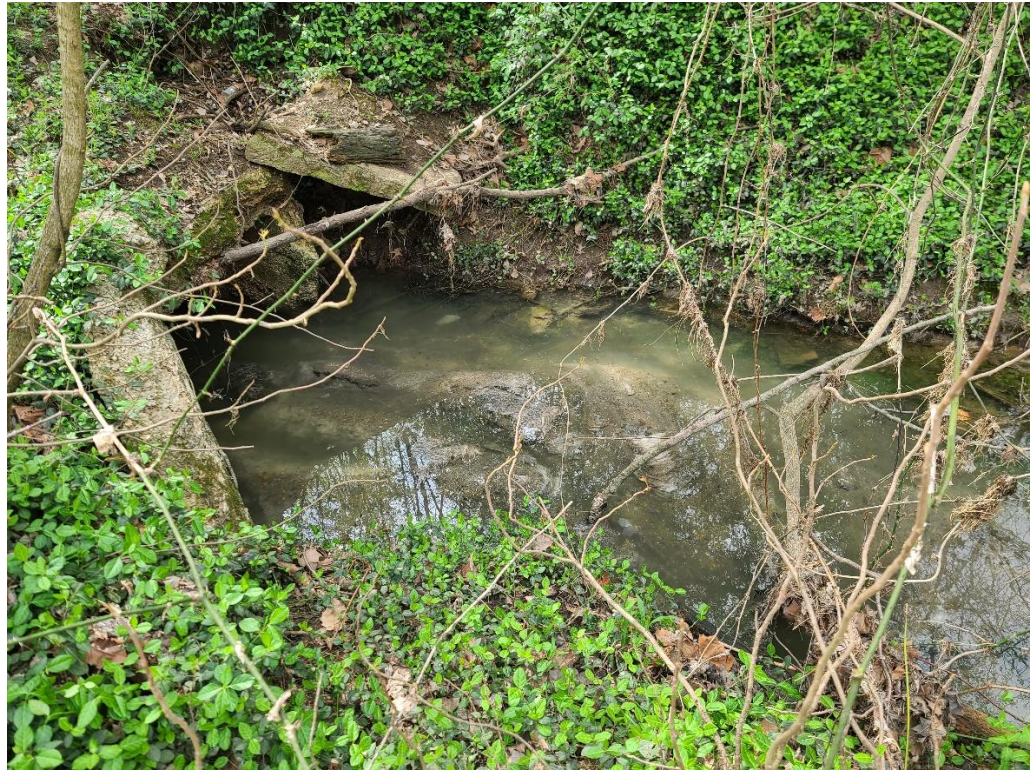
Rodely and I then drove to Manhole #43. Adjacent to the manhole, we observed that the creek was discolored with what appeared to be sewage. The creek also smelled of raw sewage. We noted that there was flow and toilet paper discharging into the creek immediately south of the manhole. We called Tipsword to have him remove the manhole lid. Once removed, we observed that there was a main entering the manhole from the south. We placed green dye tablets into Manhole #43. Within minutes, we observed that there was green dye in the creek (see attached photograph). It was apparent that there was a sewage main break discharging into the creek.

Photo #: 002  
Date: April 2, 2026  
Time: 10:52 a.m.  
Taken By: Brian Rodely, BOW  
Facility: City of Lawrenceville  
Location: 38.732219,-87.687574  
Notes: This is a photograph of  
creek adjacent to  
Manhole #43. Sewage  
and toilet paper were  
observed discharging into  
the creek.

1. Immediately cease all sanitary sewer overflows (SSOs) from the city's collection system. At the time of the visit, a dry weather SSO was occurring from the 10-inch clay main at Manhole #43.

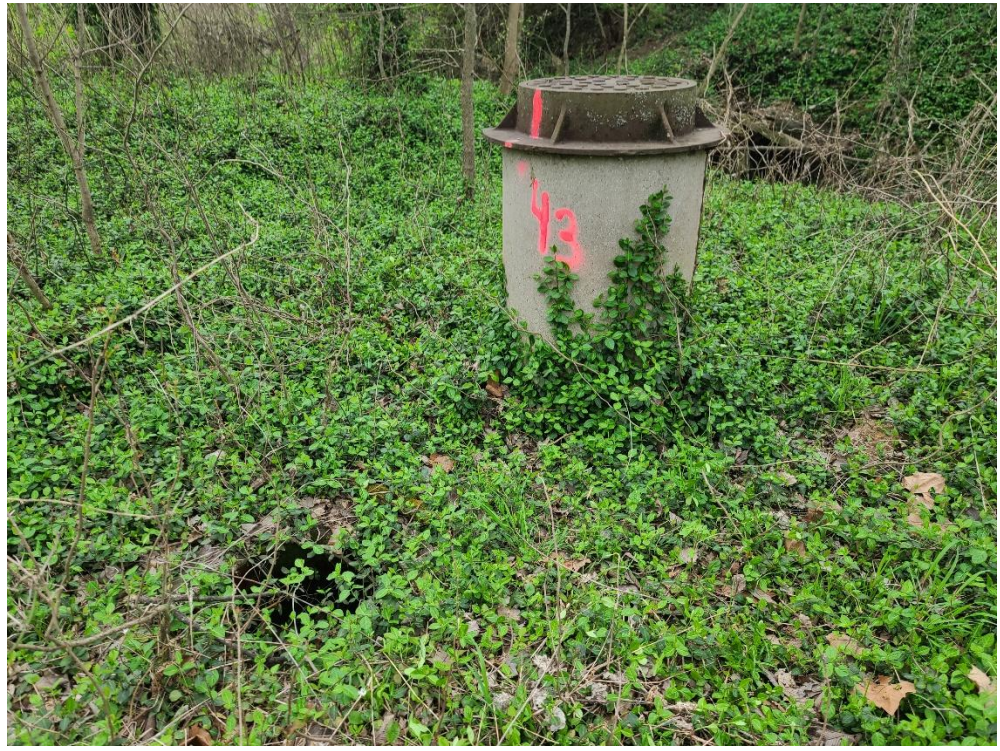
Photo # 003  
Date: April 2, 2026  
Time: 10:55 a.m.  
Taken By: Brian Rodely, BOW  
Facility: City of Lawrenceville  
Location: 38.732219,-87.687574  
Notes: This is a photograph of  
Manhole #43. Note the  
abandoned brick manhole  
adjacent to Manhole #43.

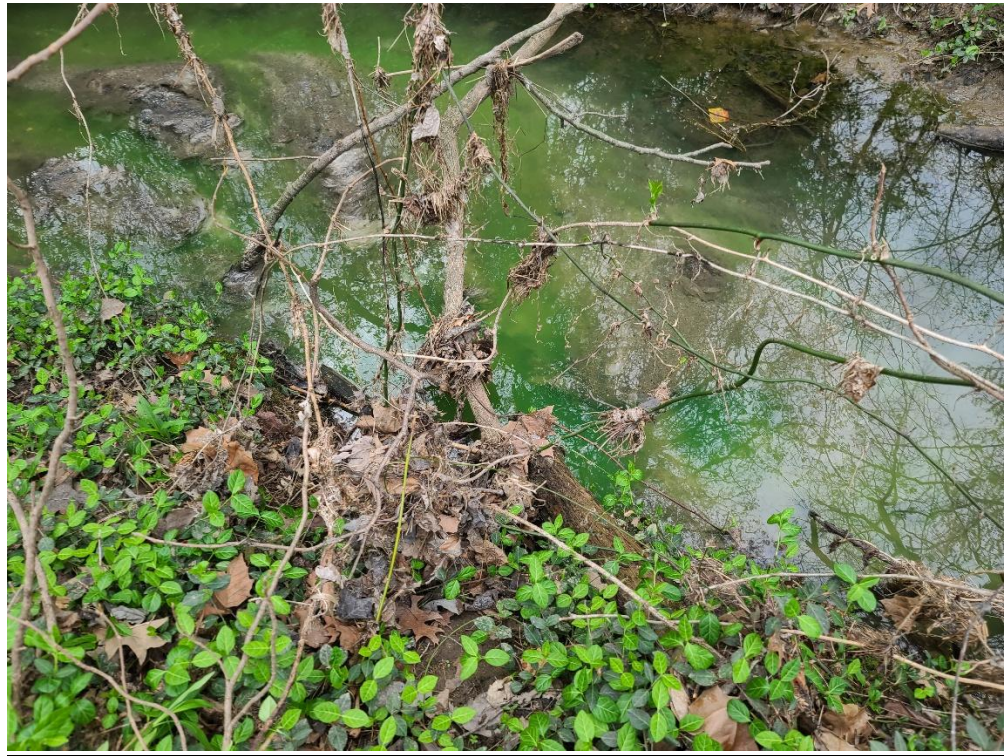
Photo #: 004  
Date: April 2, 2026  
Time: 11:29 a.m.  
Taken By: Brian Rodely, BOW  
Facility: City of Lawrenceville  
Location: 38.732222,-87.687588  
Notes: This is a photograph of  
creek after placing green  
dye tablets into Manhole  
#43.

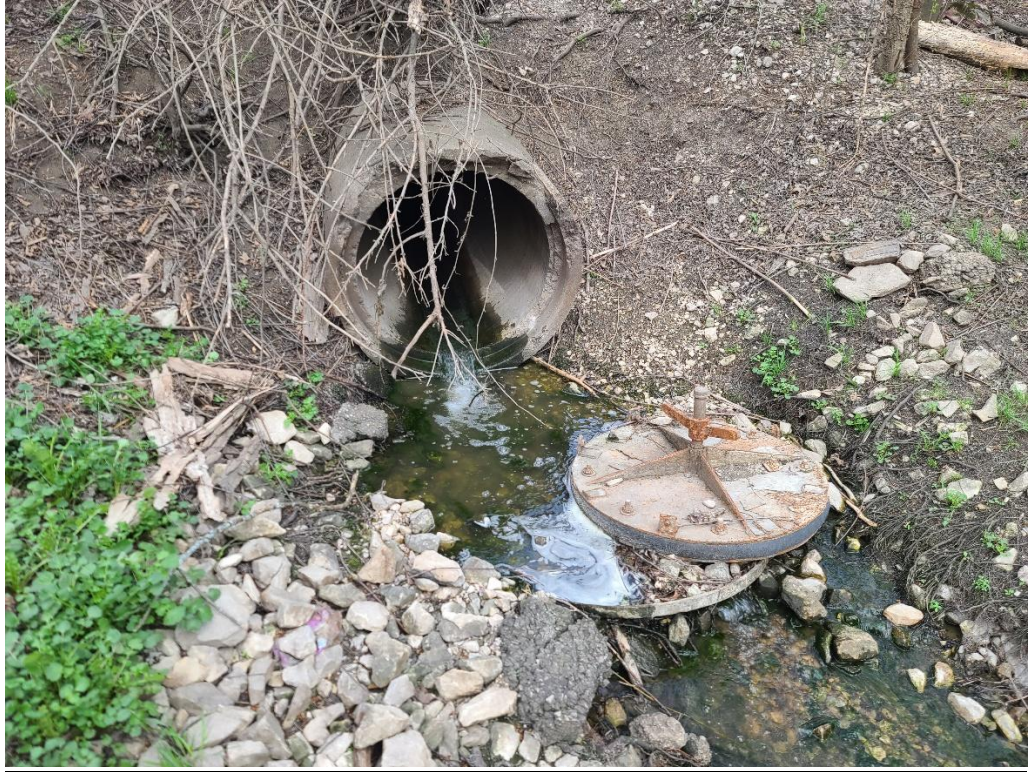
of the visit, we estimated that the sludge lagoon only had 3-4 inches of freeboard available. Then we drove to the excess flow lagoon. At the time of the visit, the lagoon had about 10 feet of freeboard. We drove around the south side of the lagoon and observed Outfall 002. The outfall was actively discharging about 50 gpm (see attached photograph). We observed the outfall's cap was laying adjacent to the outfall (see attached photograph). The cap was originally installed to prevent the outfall from discharging. It appeared that the cap had been missing from the outfall for an extended period due to the cap's deteriorated condition. We also observed the outfall's concrete gabion structure. The upper slide gate was broken, allowing effluent to discharge through the outfall. Due to the deteriorated condition of the slide gate, it appeared to have been broken for an extended amount of time. Therefore, we called Tipsword to meet us at the excess flow lagoon. Upon his arrival, we asked that he remove the manhole lid adjacent to gabion structure. We placed green dye tablets into manhole. Within minutes, the discharge from Outfall 002 was green in color (see attached photographs). Tipsword indicated that he was not aware Outfall 002. We also asked how long it had been since he pulled excess flow from the lagoon back to the plant. He indicated that he has never pulled excess flow from the lagoon back to the plant. We explained that when Outfall 002 is discharging, the city has to sample the effluent as required by their expired NPDES Permit. I further explained that their expired NPDES Permit has fecal concentration limits for Outfall 002, but they have no disinfection at the lagoon. We recommended that the broken slide gate be replaced as soon as possible, an inflatable plug be installed at Outfall 002, and initiate pulling excess flow from the lagoon back to the WWTP. We also explained to Tipsword that the sludge lagoon at the wastewater treatment plant needed to be pumped down immediately. We explained that the lagoon only has about 3-4 inches of freeboard but they are still pumping stormwater from the north Schrieber Unit to the lagoon which rain in the forecast. We suggested that the lagoon supernatant and the Scheiber Unit stormwater be pumped to the plant headworks.

Photo # 005  
Date: April 2, 2026  
Time: 12:53 p.m.  
Taken By: Brian Rodely, BOW  
Facility: City of Lawrenceville  
Location: 38.724310,-87.670582  
Notes: This is a photograph of  
Outfall 002 for the  
WWTP's excess flow  
lagoon. Outfall 002 was  
discharging about 50  
gallons per minute. Note  
the outfall's cap adjacent  
to the outfall.

2. Immediately discontinue discharging effluent from Outfall 002 until the main treatment facility is receiving its design maximum flow, which is flow in excess of 1500 gpm.

4. Initiate efforts to replace the broken upper slide gate for the excess flow lagoon gabion structure.
5. Initiate efforts to install a cap on the the excess flow lagoon outfall structure (Outfall 002).

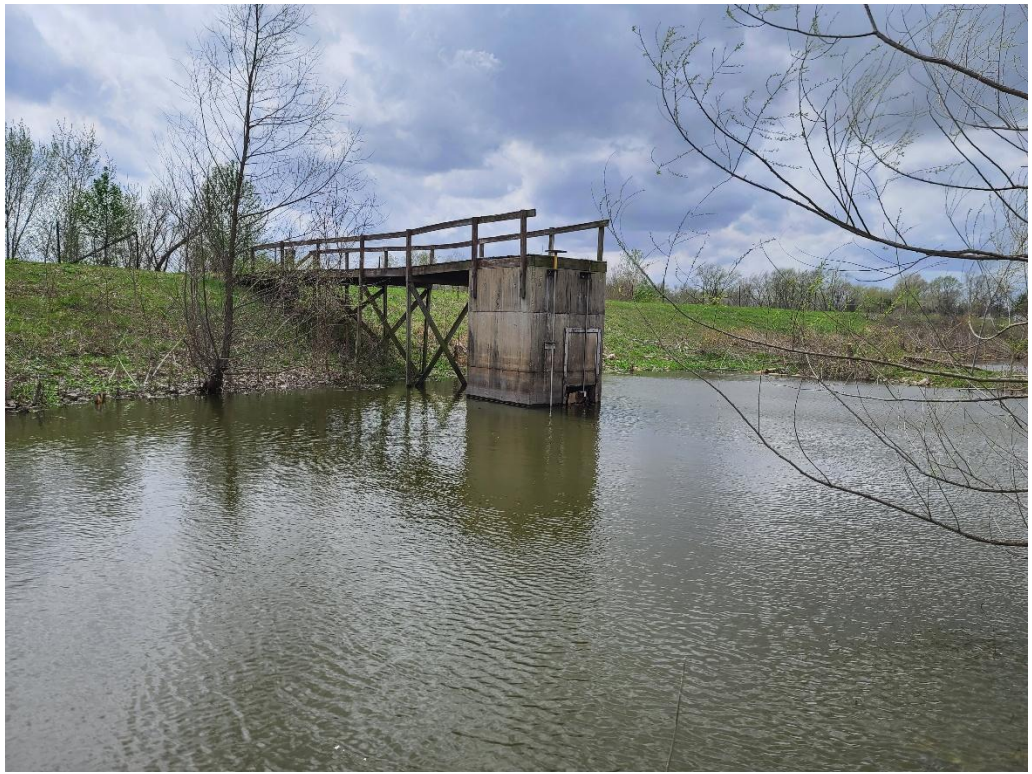
Photo #: 006  
Date: April 2, 2026  
Time: 12:58 p.m.  
Taken By: Brian Rodely, BOW  
Facility: City of Lawrenceville  
Location: 38.724763,-87.670413  
Notes: This is a photograph of  
Outfall 002 gabion  
structure. The upper slide  
gate was broken, allowing  
lagoon effluent to  
discharge through Outfall  
002.

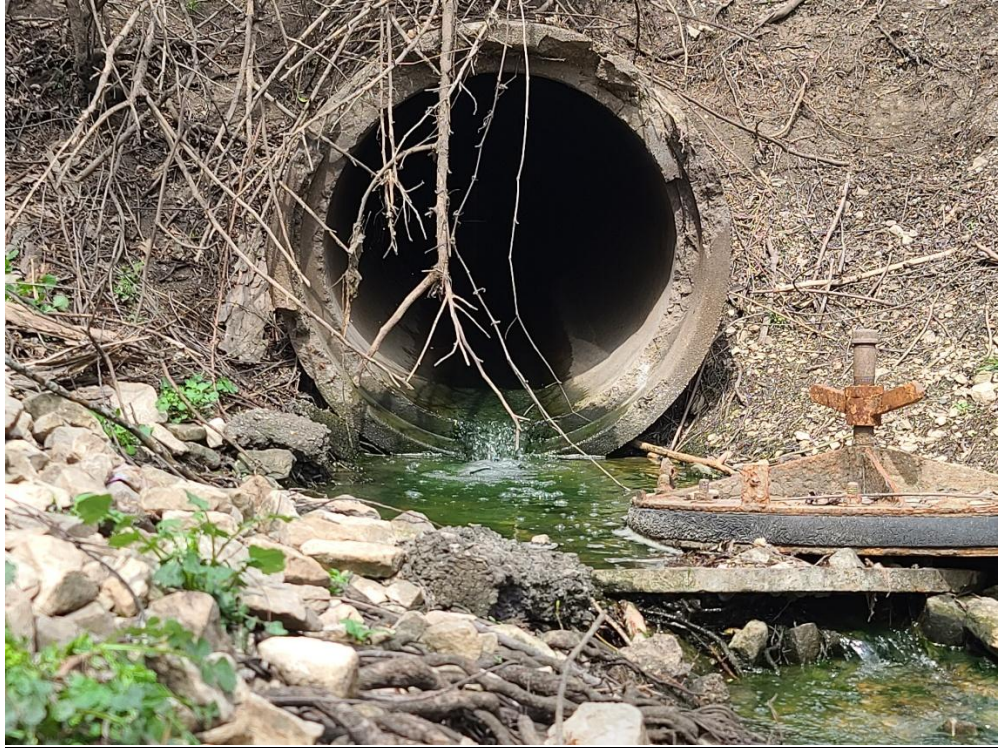
Photo # 007  
Date: April 2, 2026  
Time: 1:19 p.m.  
Taken By: Brian Rodely, BOW  
Facility: City of Lawrenceville  
Location: 38.724253,-87.670420  
Notes: This is a photograph of the Outfall 002 discharge following after placing the green dye tablets in the manhole for the concrete gabion.

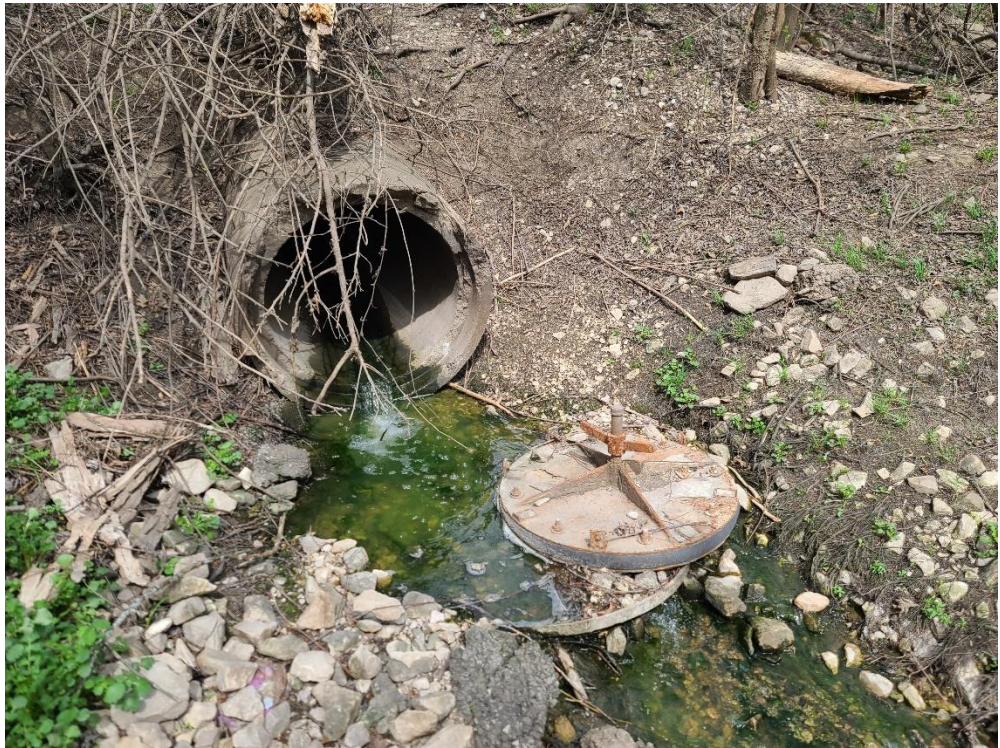
Photo #: 008  
Date: April 2, 2026  
Time: 1:19 p.m.  
Taken By: Brian Rodely, BOW  
Facility: City of Lawrenceville  
Location: 38.724253,-87.670420  
Notes: This is another photograph of the Outfall 002 discharge following after placing the green dye tablets in the manhole for the concrete gabion.

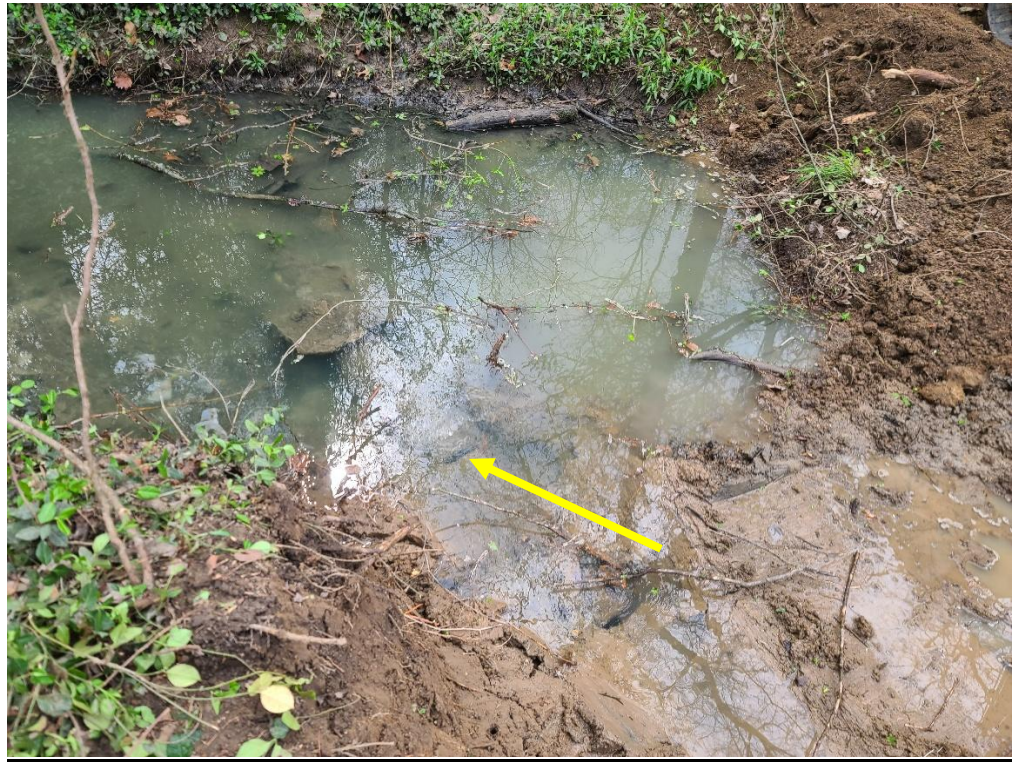
Finally, we returned to Manhole #43 as city crews were excavating the area south of the manhole. They built earthen dams immediately upstream and downstream of the sewer main and pumped the water within the dams to expose the sewer main. It was a broken section of 10-inch clay pipe which received flow from a PVC sewer lateral for an apartment complex (see attached photographs).

Photo # 009  
Date: April 2, 2026  
Time: 1:55 p.m.  
Taken By: Brian Rodely, BOW  
Facility: City of Lawrenceville  
Location: 38.732216,-87.687686  
Notes: This is a photograph of the broken clay sewer main that discharged to Manhole #43. Note the clay pipe is broken allowing sewage to discharge to the creek.

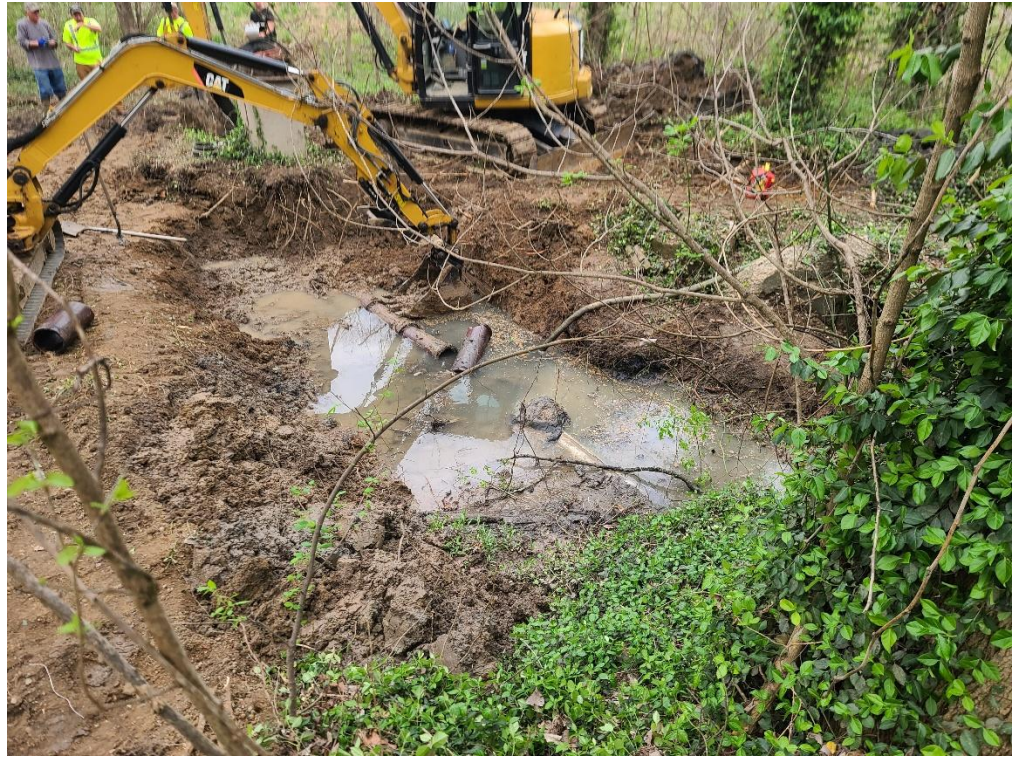
Photo #: 010  
Date: April 2, 2026  
Time: 4:07p.m.  
Taken By: Brian Rodely, BOW  
Facility: City of Lawrenceville  
Location: 38.732197,-87.6877  
Notes: This is a photograph of the broken clay sewer main that discharged to Manhole #43. The broken clay sewer main received flow from a PVC sewer lateral for an apartment complex.
