# NONPOINT SOURCE SUCCESS STORY

### Stabilizing and Vegetating Streambanks on Cahokia Creek at Roxanna Landfill to Improve Stream Quality

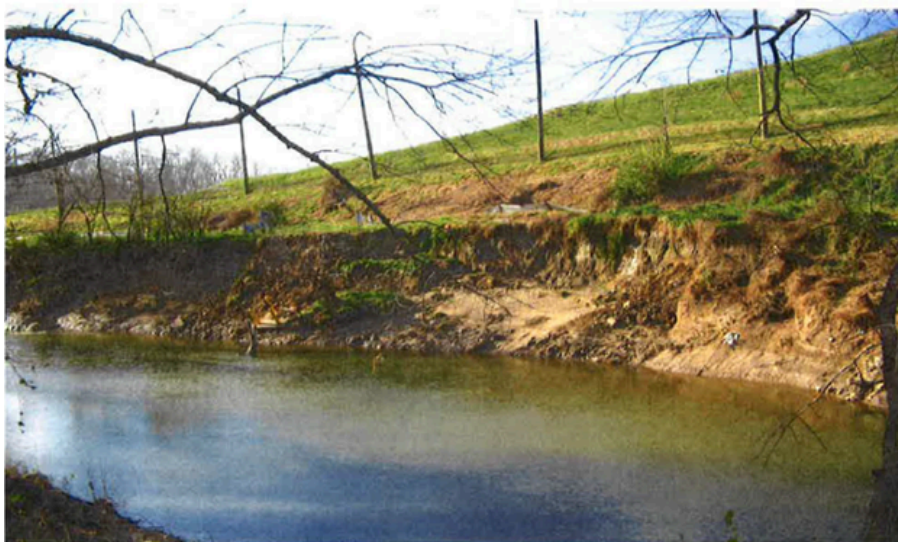
The Burrough's Branch–Cahokia Creek watershed is in Madison County, Illinois. Cahokia Creek flows southwest to the Mississippi River. Agriculture is the watershed's primary land use. The creek's streambanks were severely eroding due to a lack of vegetation (Figures 1 and 2). As a result, the stream was listed as impaired for loss of in-stream cover, alteration in streamside or littoral vegetative cover, and flow alteration in 2006.

Figure 1. Typical bank erosion before project

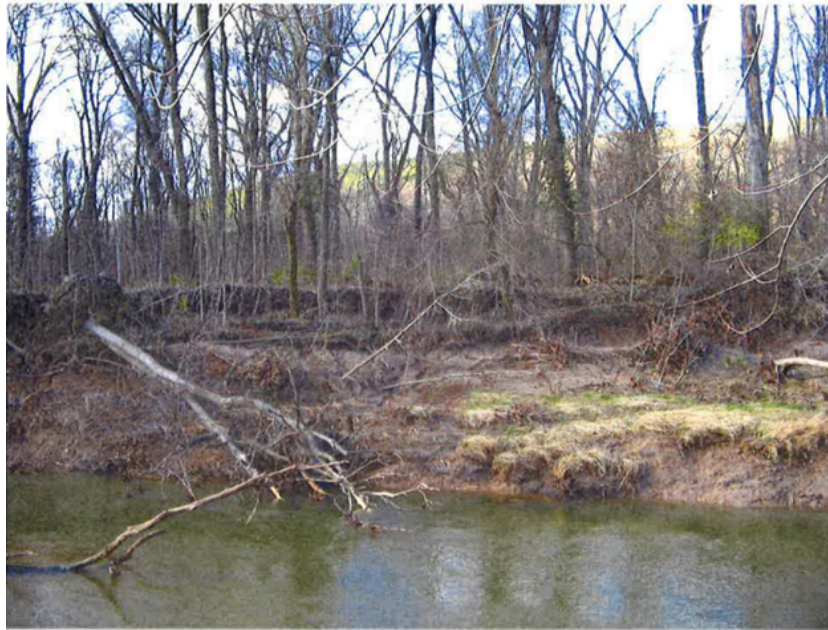
Typical bank erosion before project with mass wasting and fallen trees

Figure 2. Erosion before project

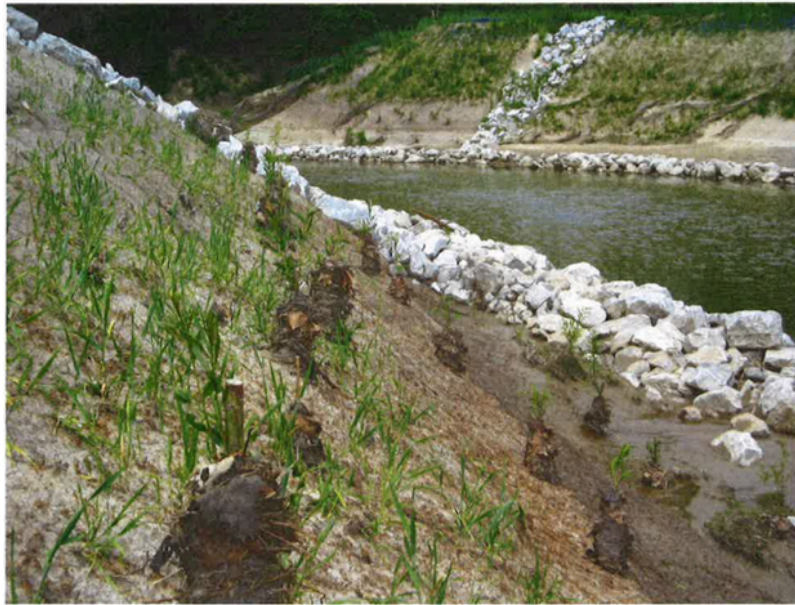
Willow stakes planted March 2014 growing on streambank May 22, 2014. Notice leaves and debris around willow stakes left by spring floods.

Figure 3. Streambank restoration in progress

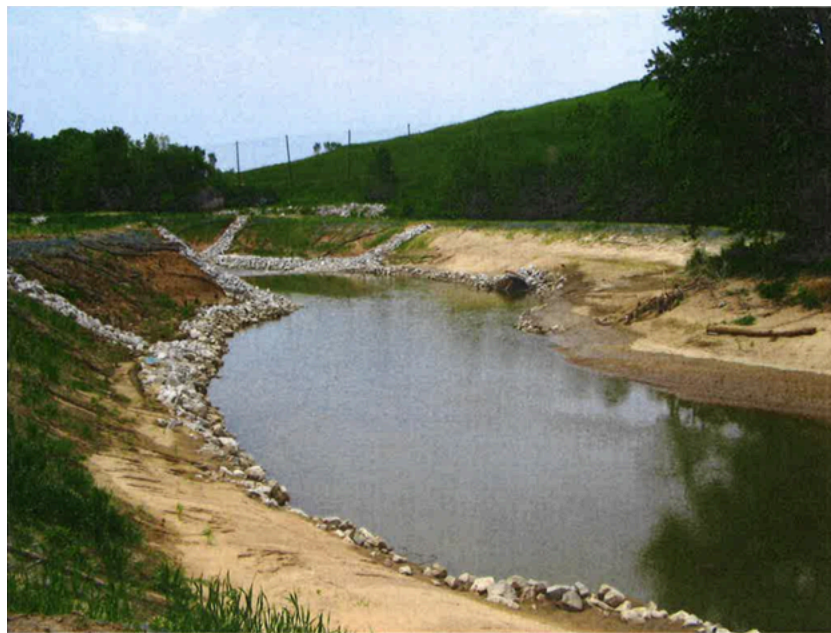
Looking downstream at lower Rock Riffle structure and Fish Passage Structure on May 22, 2014

Figure 4. Restored streambank in progress

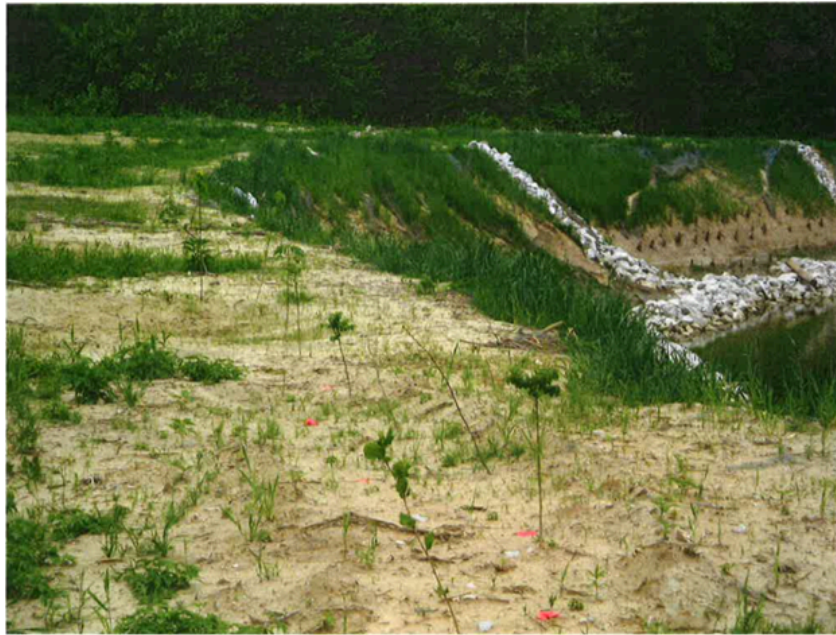
5 rows of tree seedlings leafed out on riparian area, May 22, 2014

Figure 5. Riparian restoration in progress

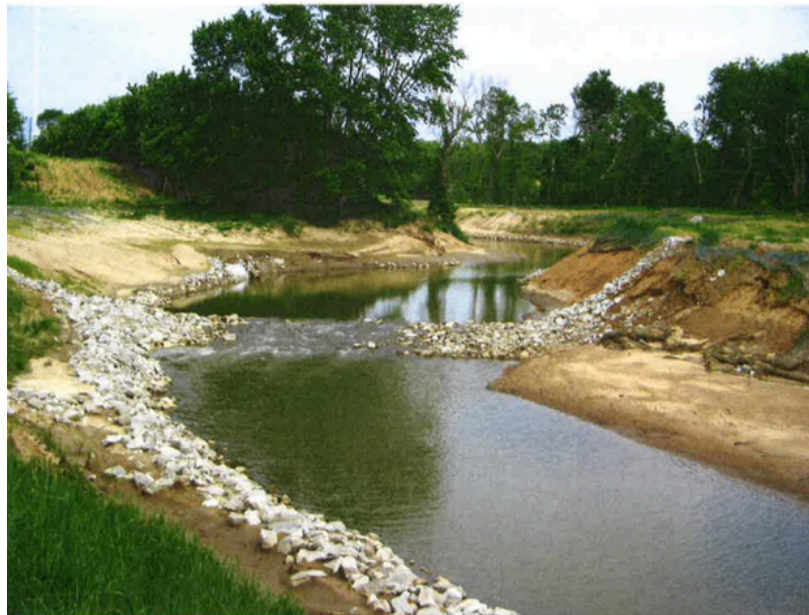
Looking upstream at upper Rock Riffle structure and Fish Passage structure spring 2014

Figure 6. Post-construction restoration
