Groundwater Conditions in Residential Roxana, Illinois

April 23, 2013

Illinois Environmental Protection Agency

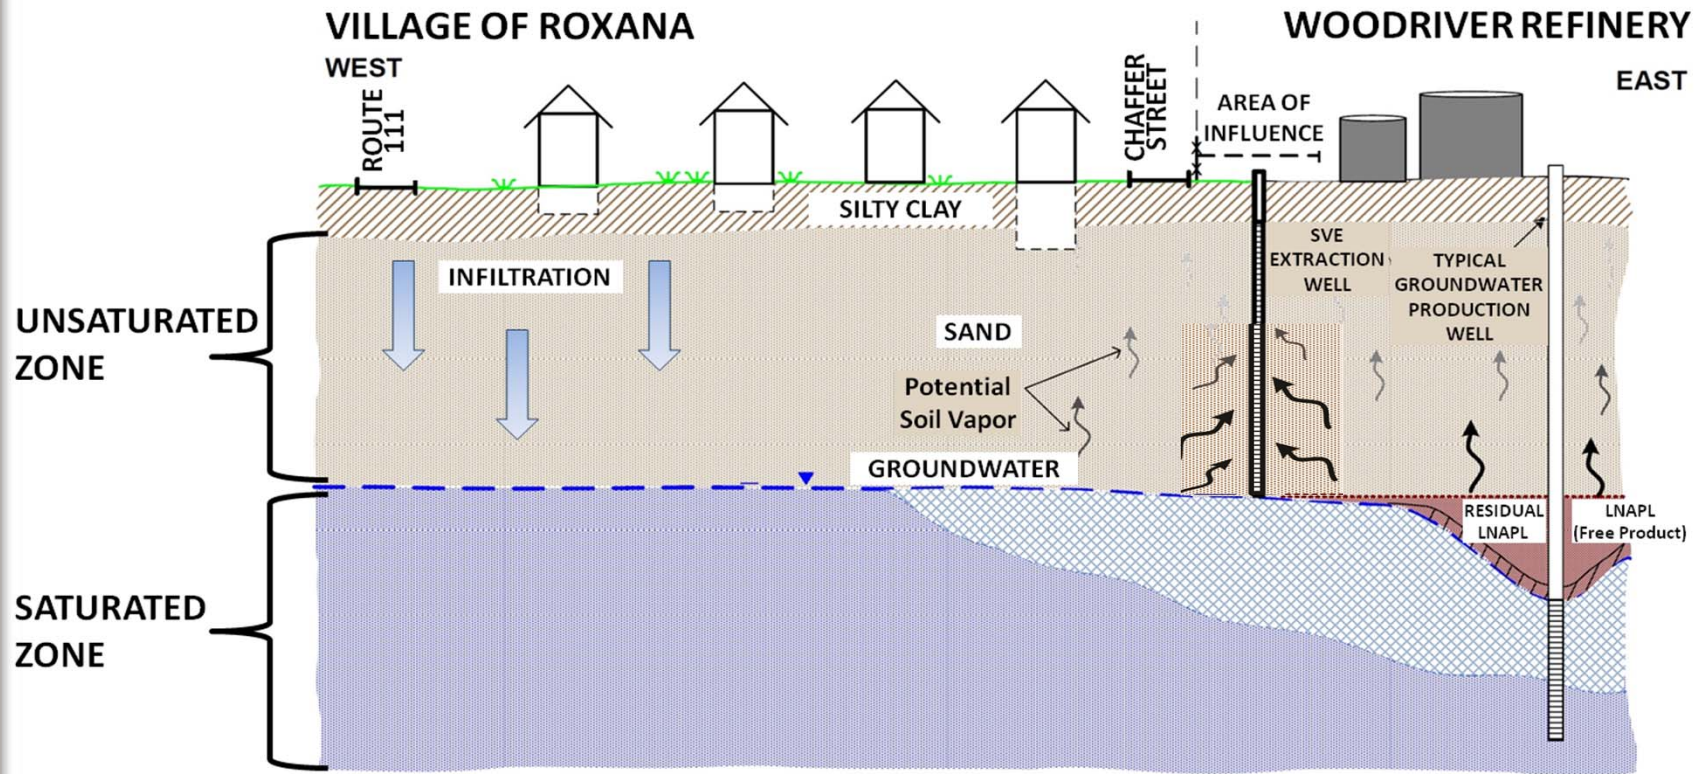
Free Product and Dissolved Groundwater Contamination

Free Product measured in Roxana is a result of historically released petroleum products and has been measured in 3 groundwater monitoring wells in Roxana. These products are lighter than groundwater so they will typically be found near the top of the groundwater.

Dissolved Groundwater Contamination is found in the zone around the release areas. In Roxana, we primarily see a groundwater plume, not free product.

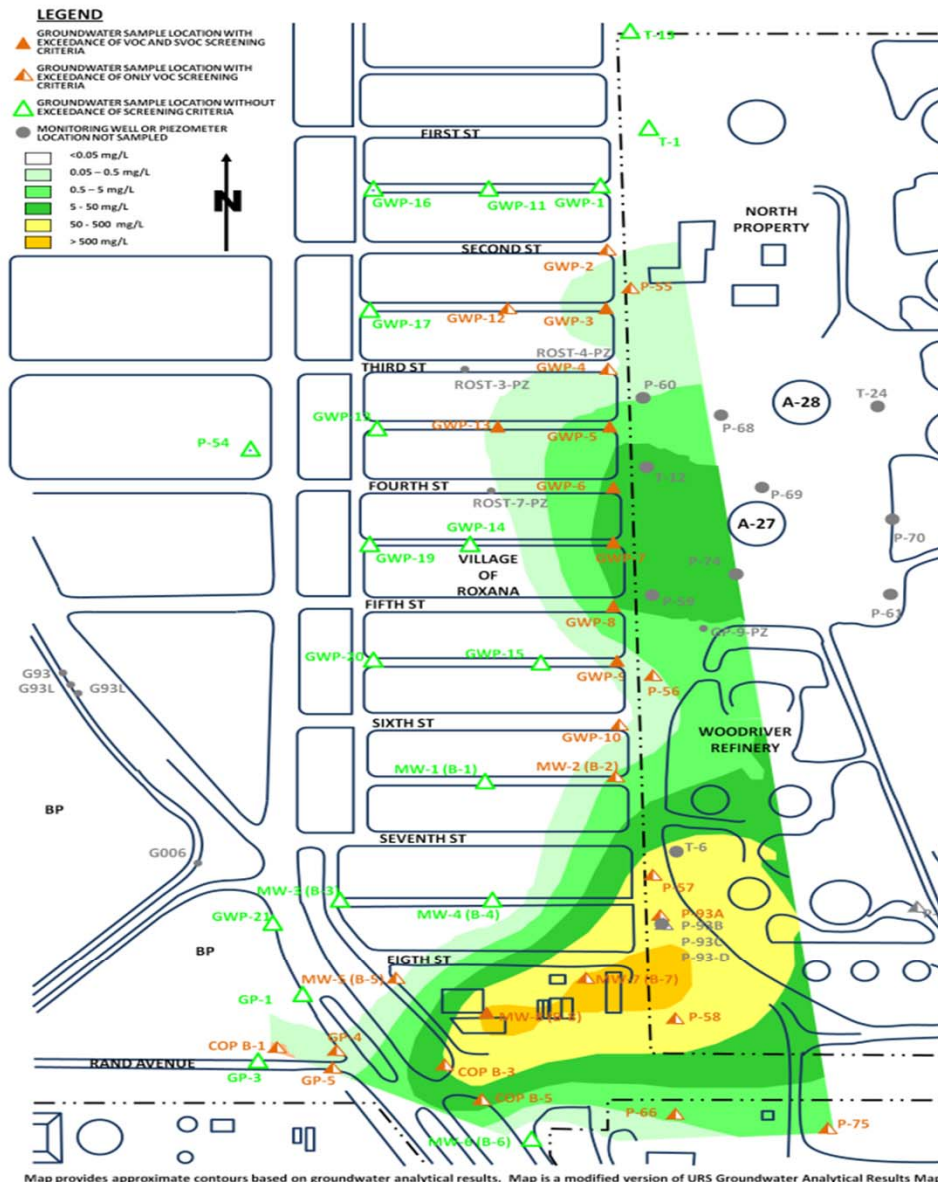
Water Well Survey

No private water supply wells are within 2500 feet of the Study Area.

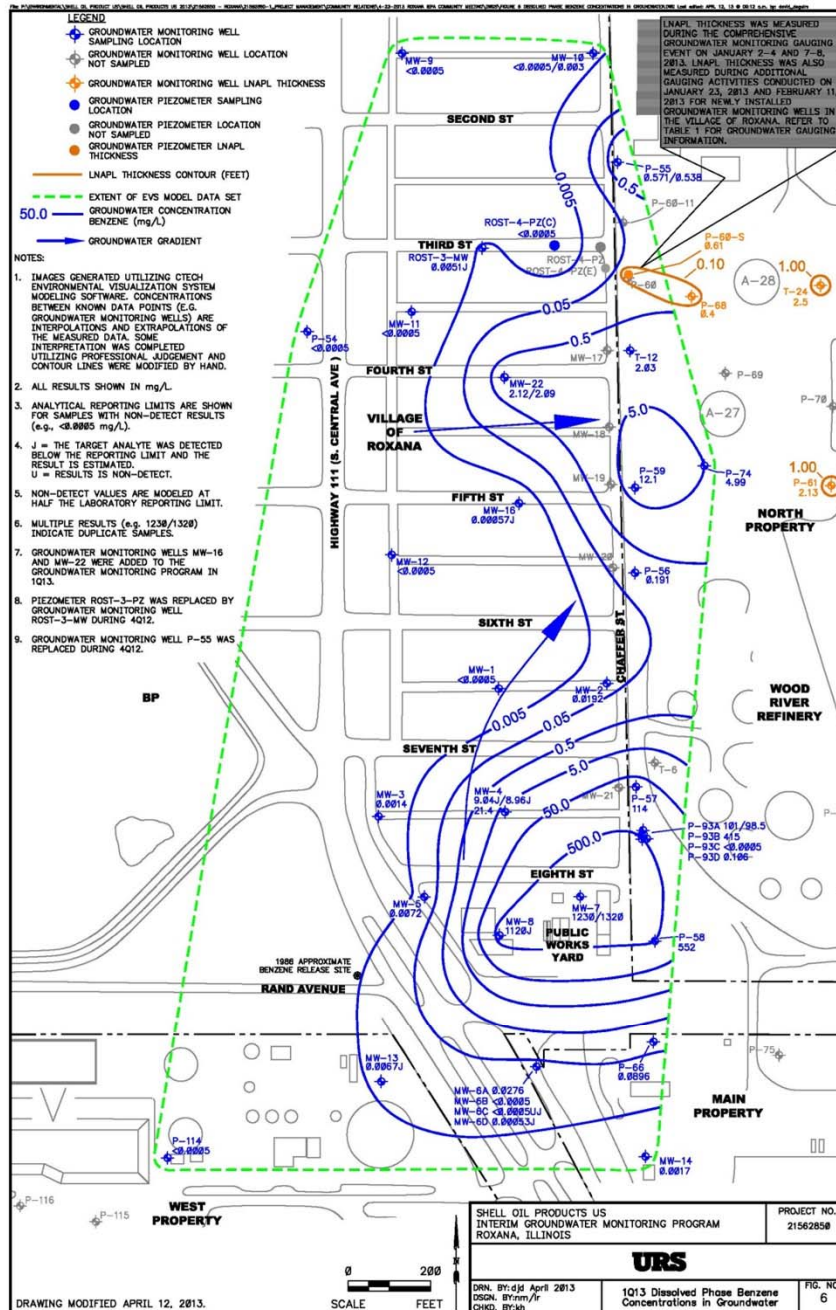
Groundwater & Product Conditions

Blue contours represent the extent of groundwater contamination

The monitoring wells in Roxana have been measured routinely for groundwater elevations and possible free product. A limited amount of product has been found intermittently in 3 wells near 3rd and Chaffer.

How deep is the product? The product is at or near the groundwater surface, which is approximately 40 feet below the ground surface.

● = Location where Free Product detected

When detected, the wells are bailed to remove product. This approach is used because of the small amount of product. The bailing occurs at that measuring event until product is no longer detected. The wells are measured again each week and the process is repeated if needed.
