MEMORANDUM

Subject: Spanish Needle Creek near Carlinville, Illinois
(Macoupin County)
To: Brian Koch, DWPC, Water Quality Standards Section, Springfield
From: Jim Hefley, DWPC, SWS, Springfield RO
Date: April 4, 2011

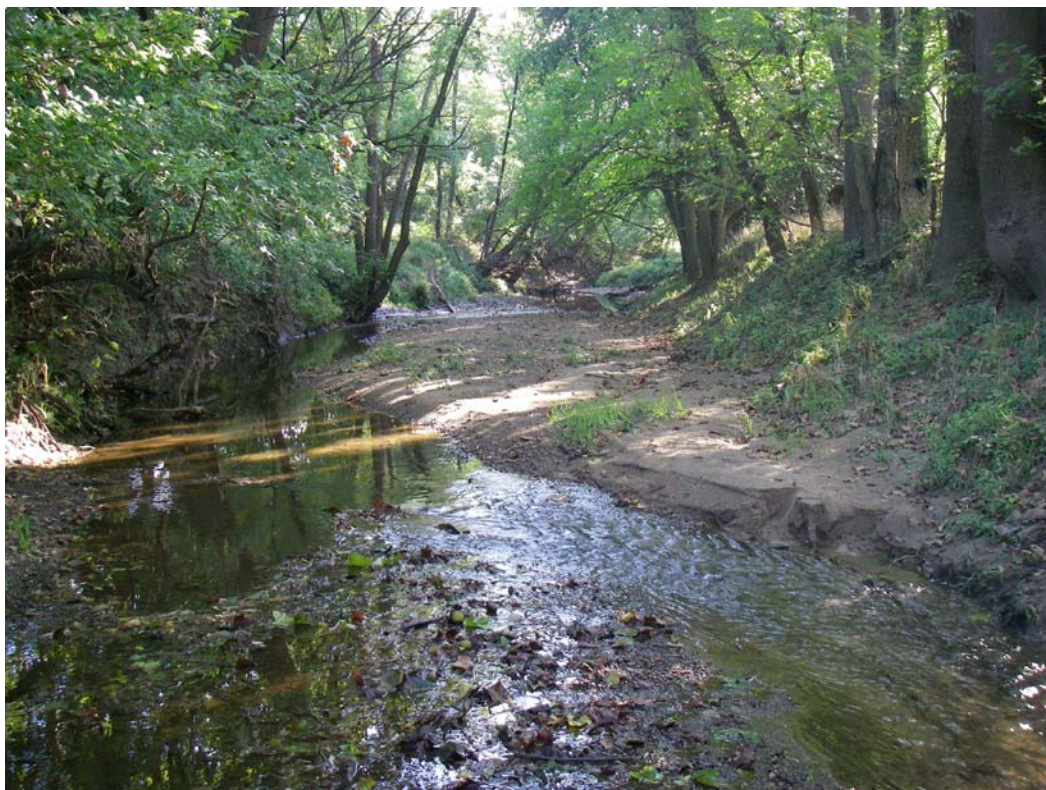
Station: DAZL-SM-A1
Date: 09/28/2010
Road: Wheeler Road
Direction: Looking US
Location: Upstream from mine property. Access at bridge and walk upstream.
Photo by: MBS
Legal :
Lat/Long DD:
39.19719 / 89.85551
Gazetteer Page # : 68

Comments: A segment during normal low flow with wooded riparian. Predominately sandy substrate with gravel and cobble in riffle areas.

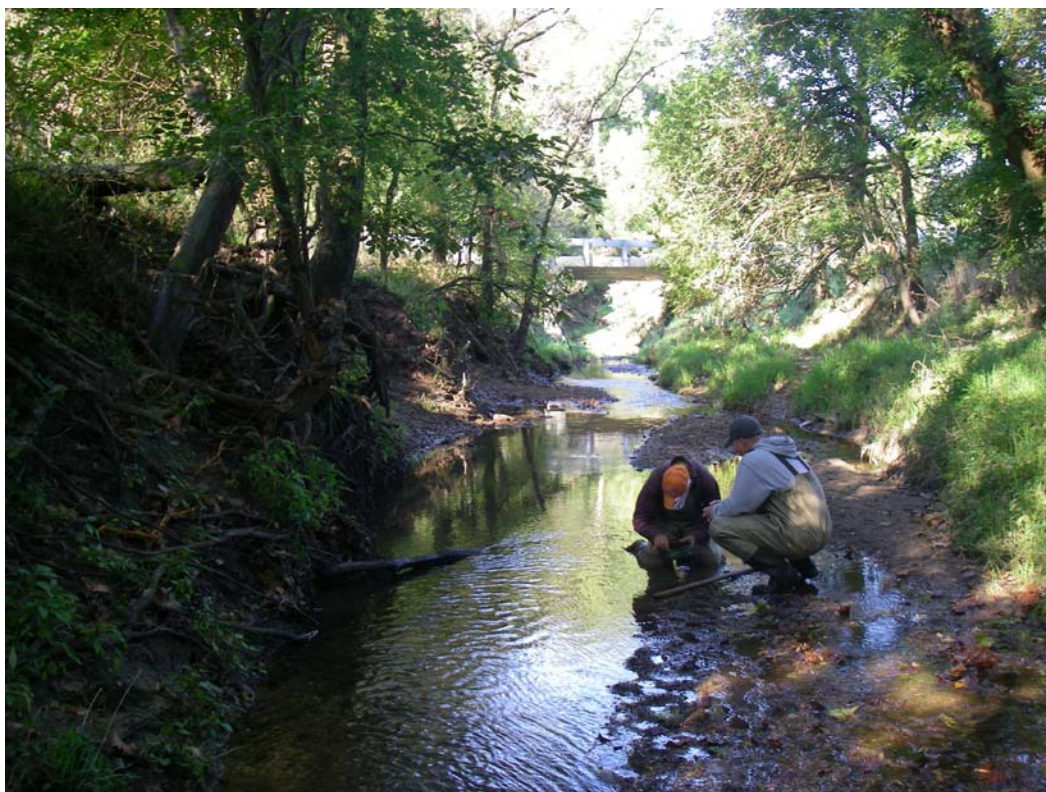
Station: DAZL-SM-A1
Date: 09/28/2010
Road: Wheeler Road
Direction: US looking DS
Location: Access at bridge and walk upstream.
Photo by: MBS
Legal :
Lat/Long DD:
39.19719 / 89.85551
Gazetteer Page # : 68

Comments: A segment during normal low flow with wooded riparian. Predominately sandy substrate with gravel and cobble in riffle areas.

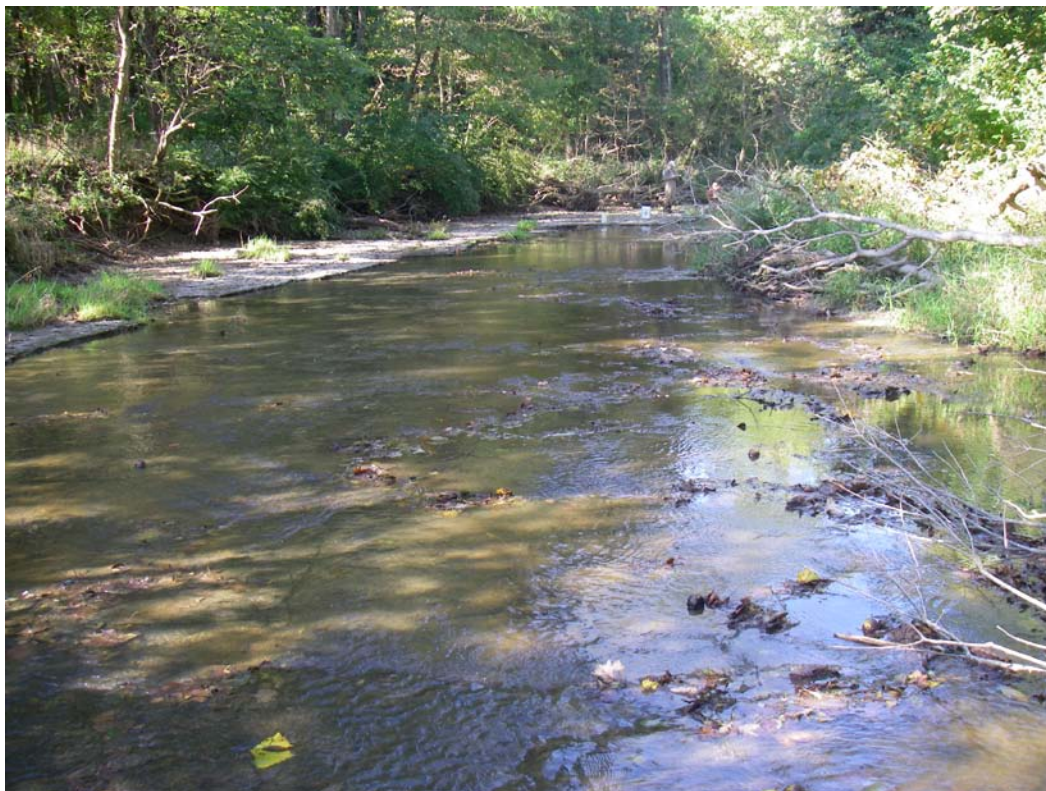
Station: DAZL-SM-C1
Date: 09/28/2010
Road: Mine Property fair weather access road.
Direction: Looking downstream.
Location: West edge of mine DS of 002 outfall. Access creek down a path from road. Sample US of waterfall.
Photo by: MBS
Legal :
Lat/Long DD:
39.20242 / 89.87286

Comments: A segment with wooded riparian during normal low flow. A shallow reach with bedrock substrate.

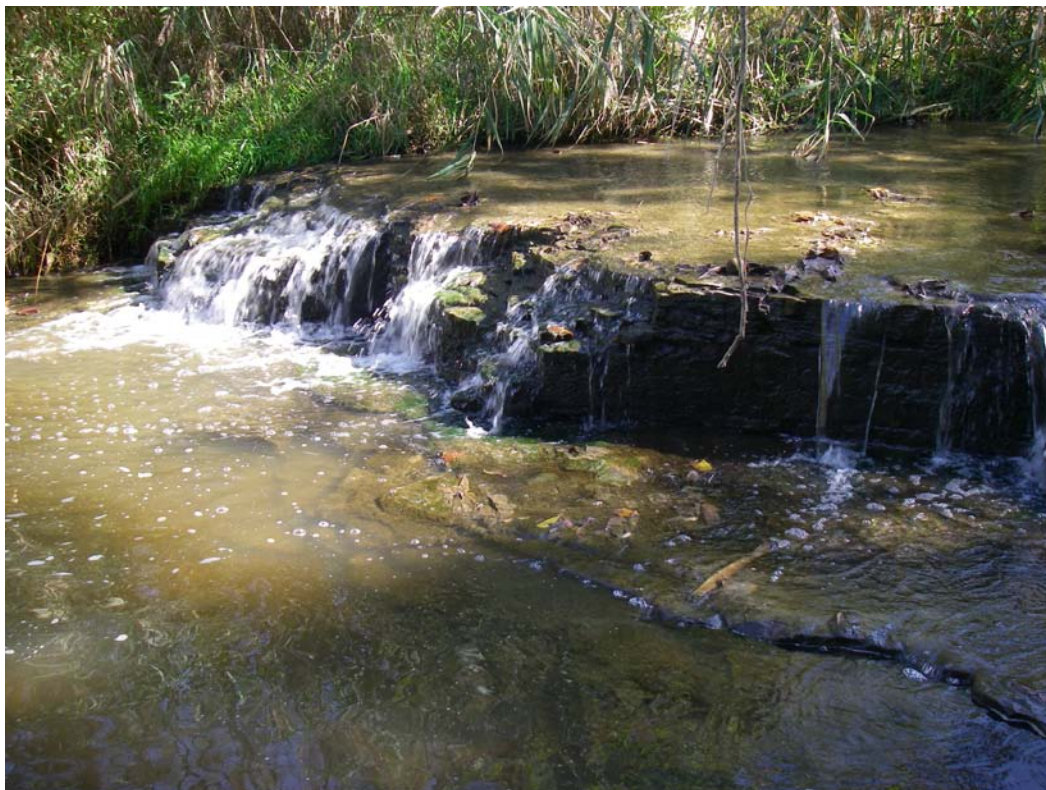
Station: DAZL-SM-C1
Date: 09/28/2010
Road: Mine Property fair weather access road.
Direction: Waterfall at lower end of reach.
Location: West edge of mine DS of 002 outfall. Access creek down a path from road. Sample US of waterfall.
Photo by: MBS
Legal :
Lat/Long DD:
39.20242 / 89.87286

Comments: A segment with wooded riparian during normal low flow. A shallow reach with bedrock substrate.

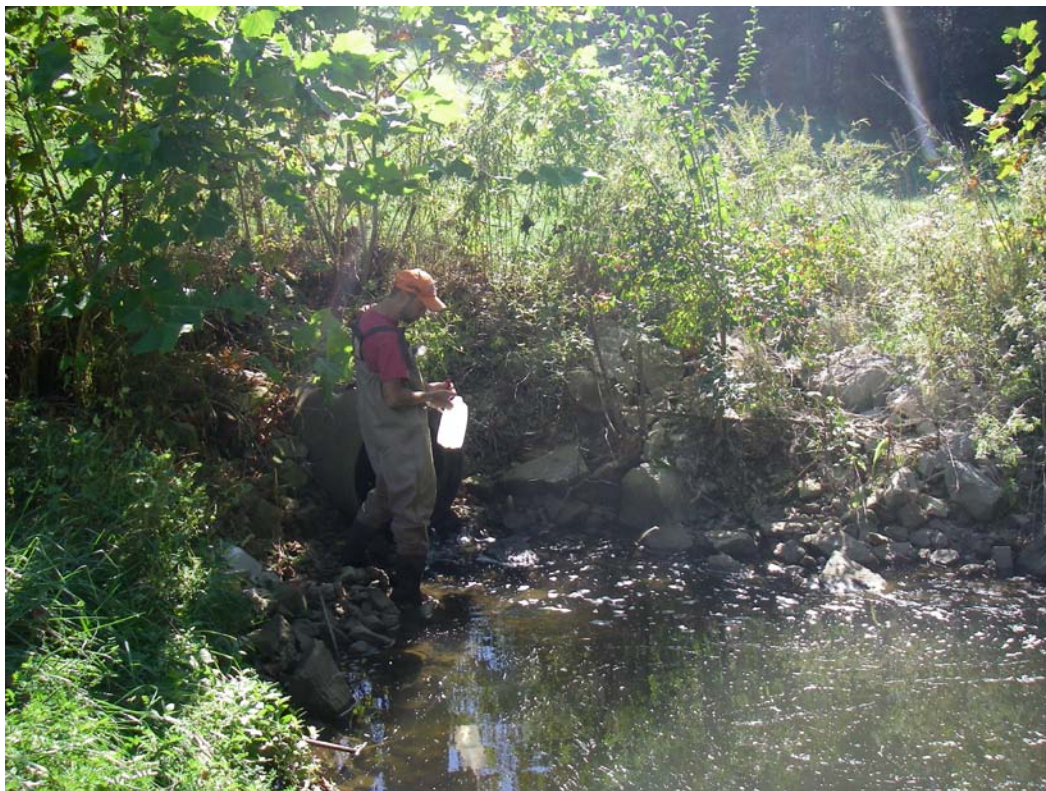
Station: DAZL-SM-E1
Date: 09/28/2010
Road: Smith Lake Dam
Direction: DS of Dam
Location: 007 outfall
Photo by: MBS
Legal :
Lat/Long DD:
39.21715 / 89.87956

Comments: Walk down
backside of Smith Lake
dam to 007 outfall pipe.

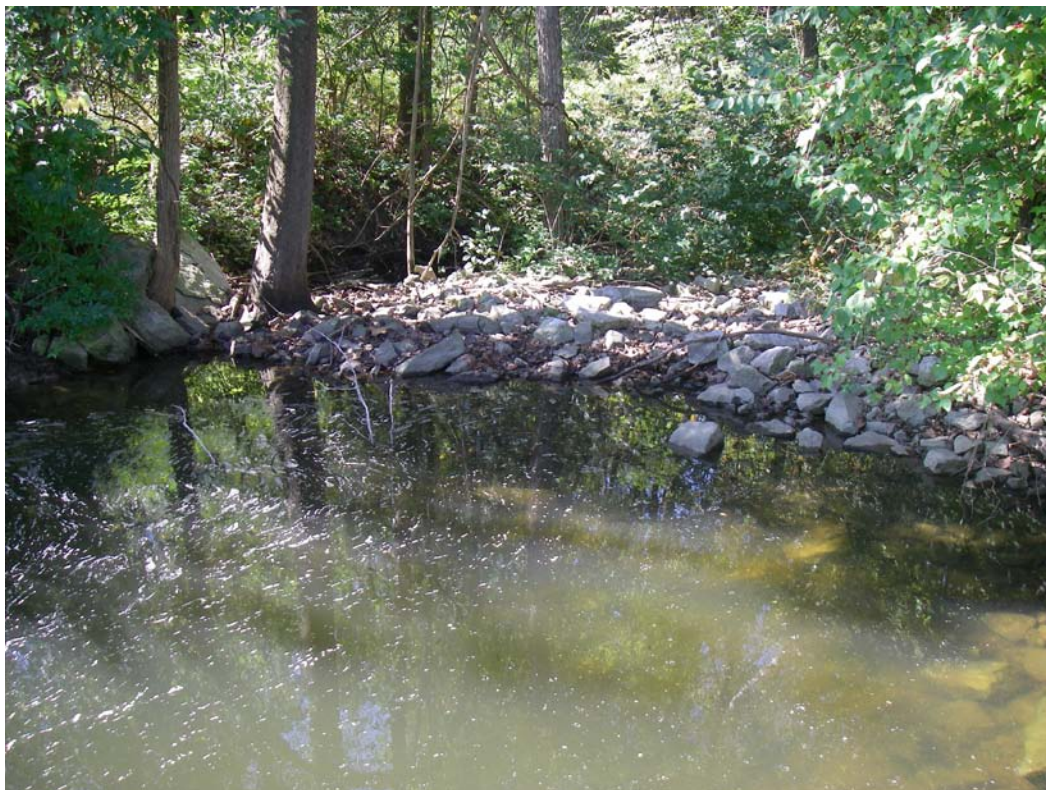
Station: DAZL-SM-E1
Date: 09/28/2010
Road: Smith Lake Dam
Direction: Looking DS of
007
Location: 007 outfall
Photo by: MBS
Legal :
Lat/Long DD:
39.21715 / 89.87956

Comments: Pooled
area below outfall.

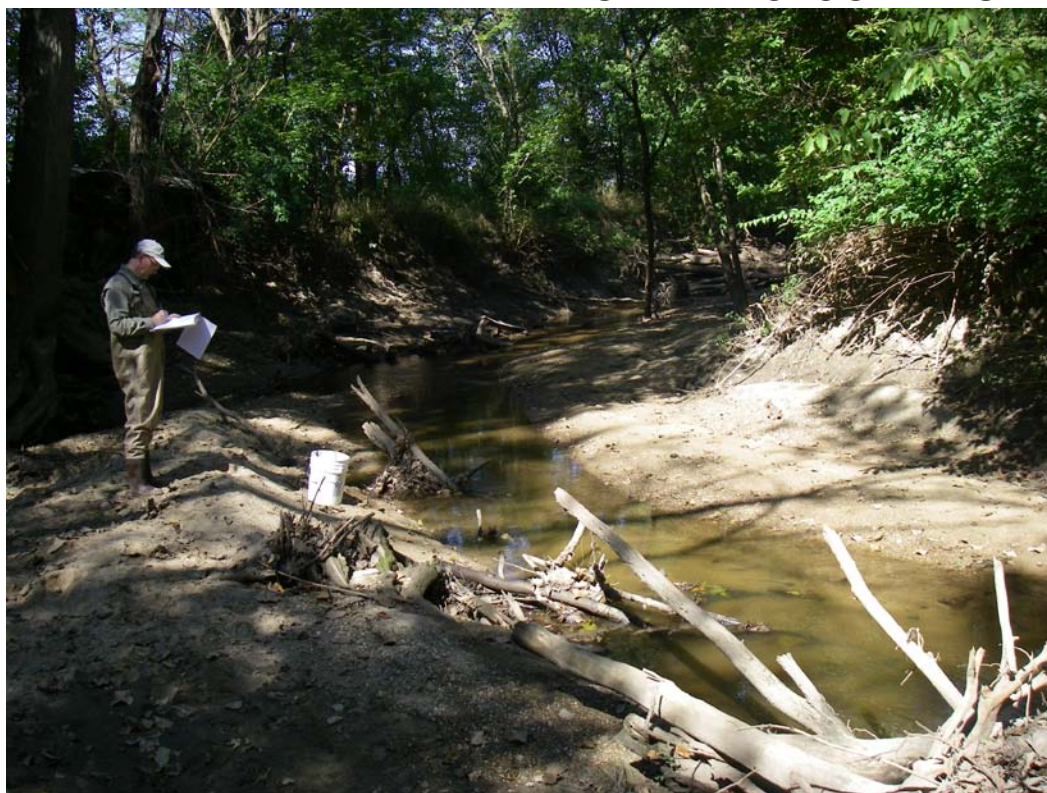
Station: DAZL-SM-C2

Comments: Access
from grassy pull-off
approx. 0.3 mi USSB.
Mostly run with various
sized pools. Wooded
riparian with sand and
fine gravel substrate.

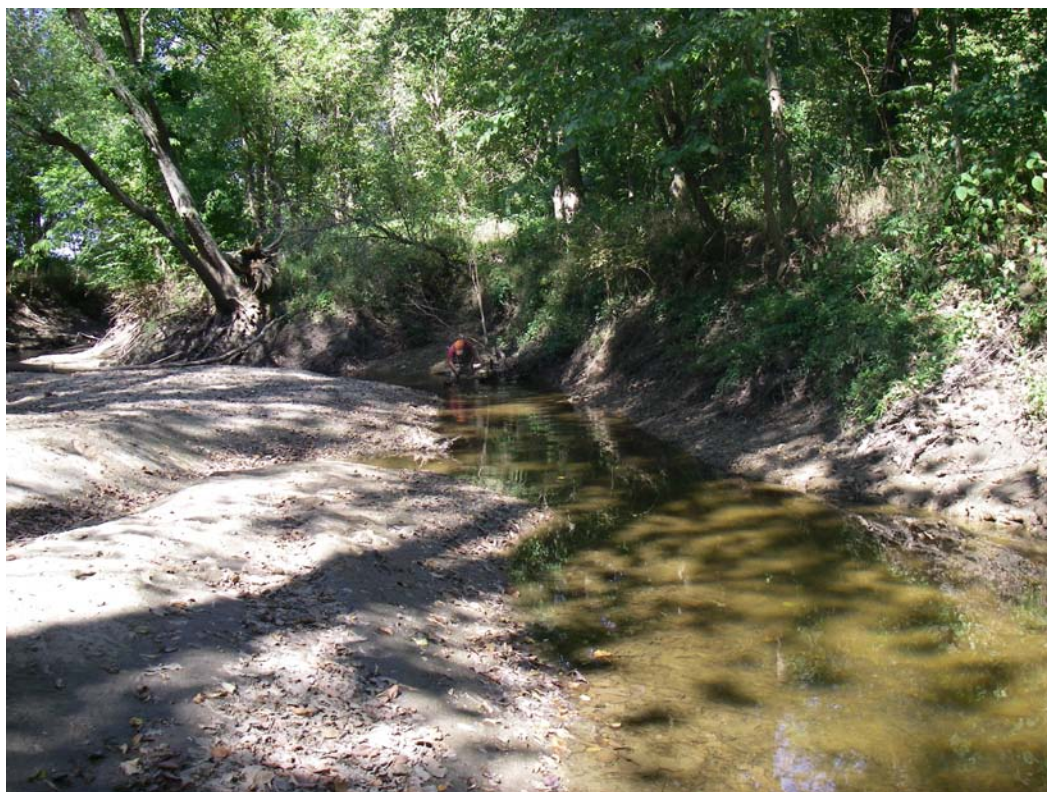
Station: DAZL-SM-C2

Comments: Access
from grassy pull-off
approx. 0.3 mi USSB.
Mostly run with various
sized pools. Wooded
riparian with sand and
fine gravel substrate
