PROJECT EVALUATION AND FINAL REPORT

**KINKAID LAKE TMDL BEST MANAGEMENT PRACTICES
IMPLEMENTATION**

FINANCIAL ASSISTANCE AGREEMENT NO. 3190521

Report Submitted by:
Kinkaid-Reed's Creek Conservancy District
1763 Water Plant Road
Murphysboro, Illinois 62966

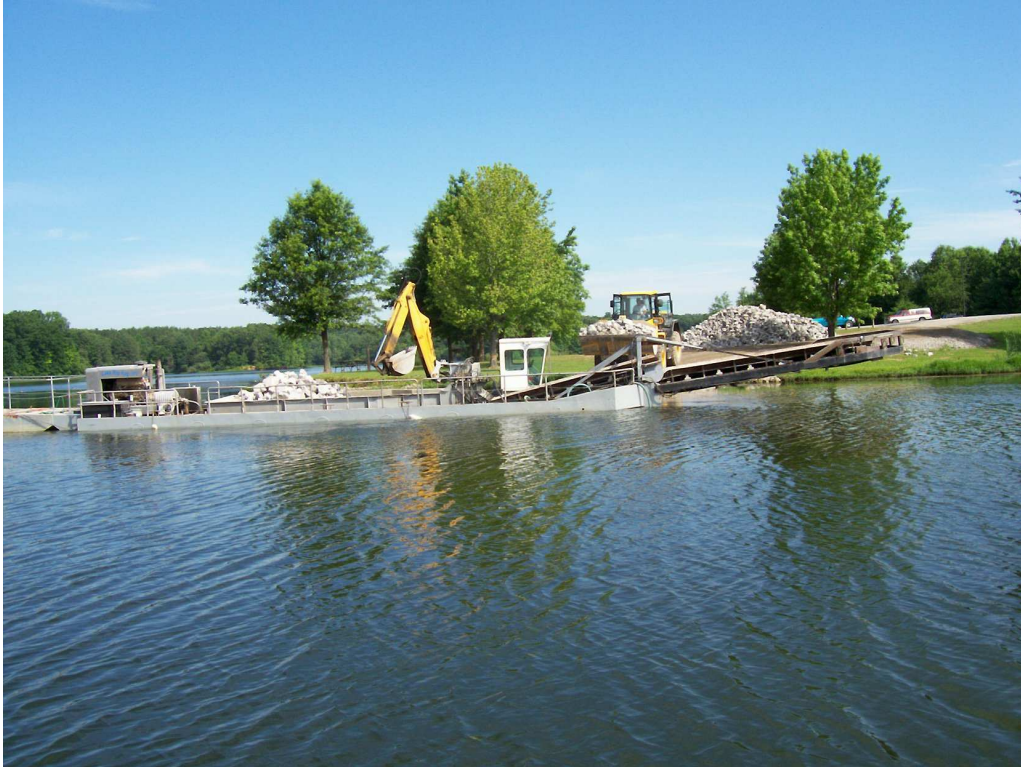
ENDLOADER LOADING RR 4 RIPRAP ON MECHANICAL BOAT

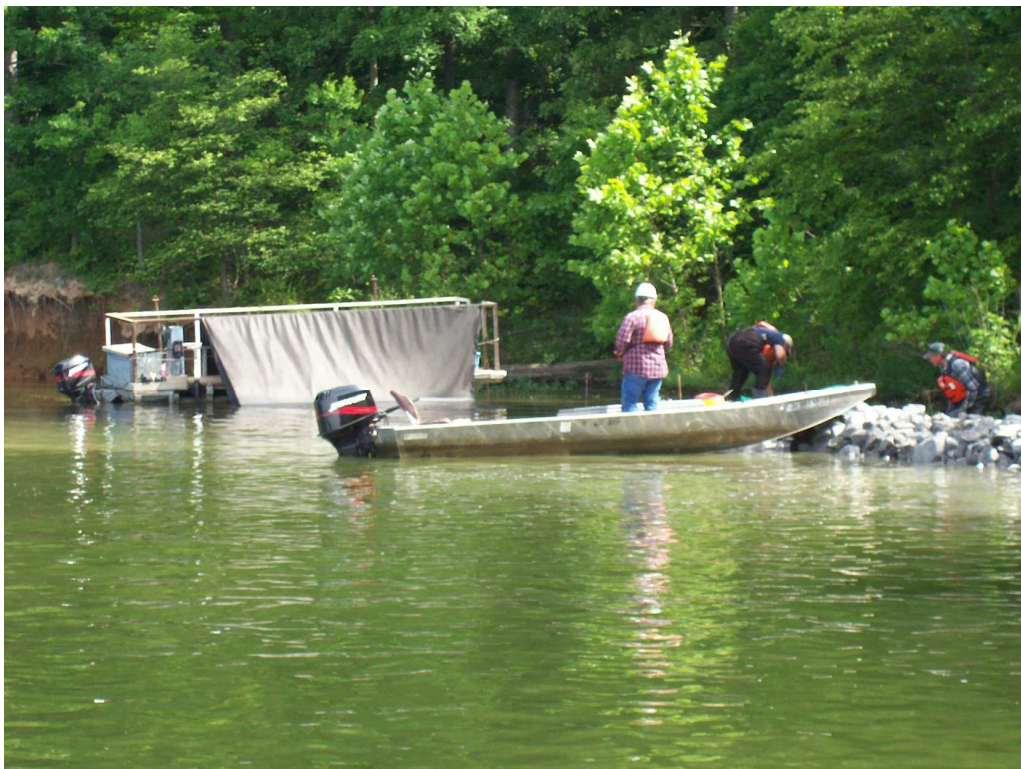
CREW PLACING FILTER FABRIC IN ADVANCE OF RIPRAP PLACEMENT

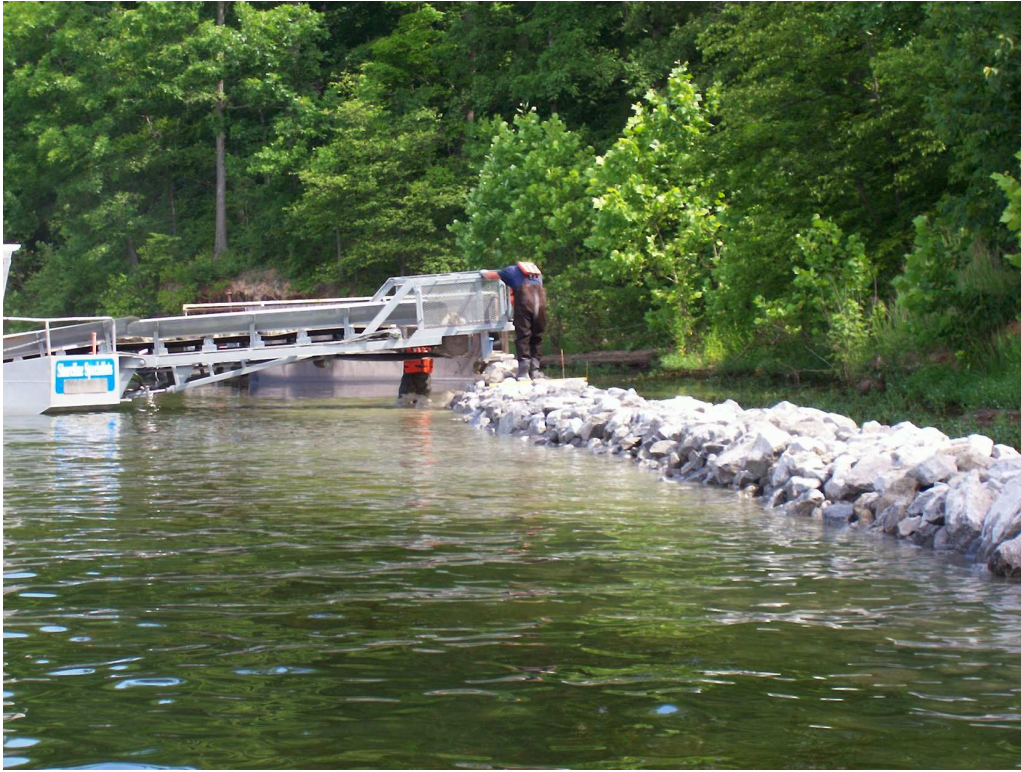
RIPRAP PLACEMENT ON INSTALLED FILTER FABRIC

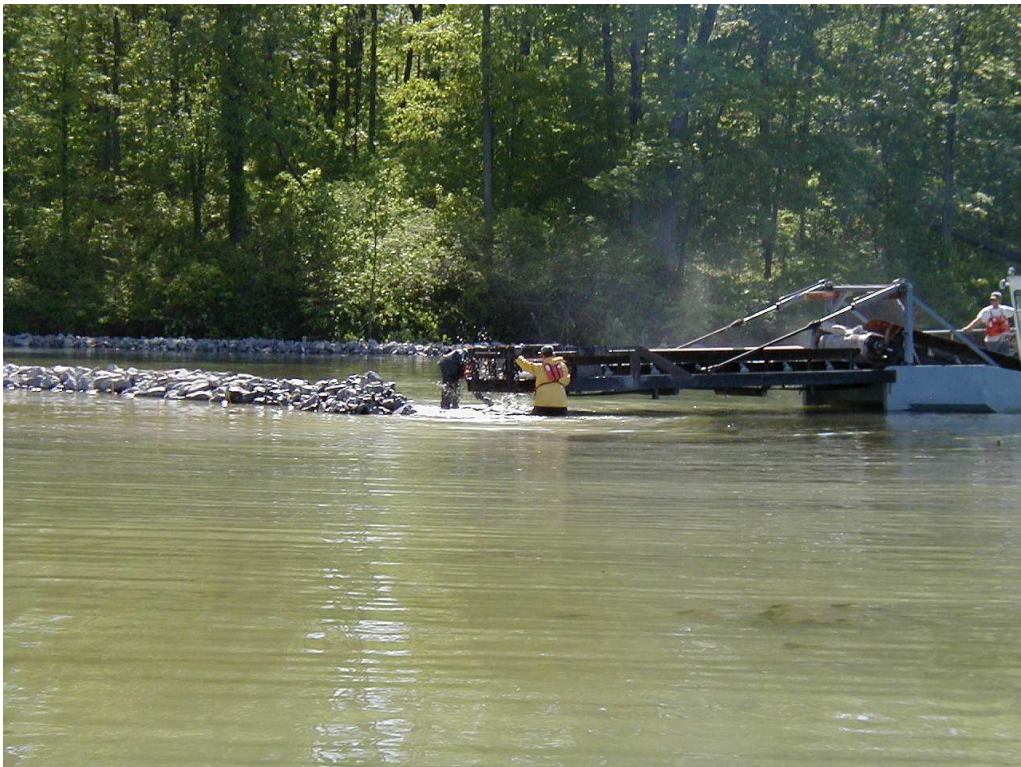
RIPRAP PLACEMENT USING MECHANICAL BOAT

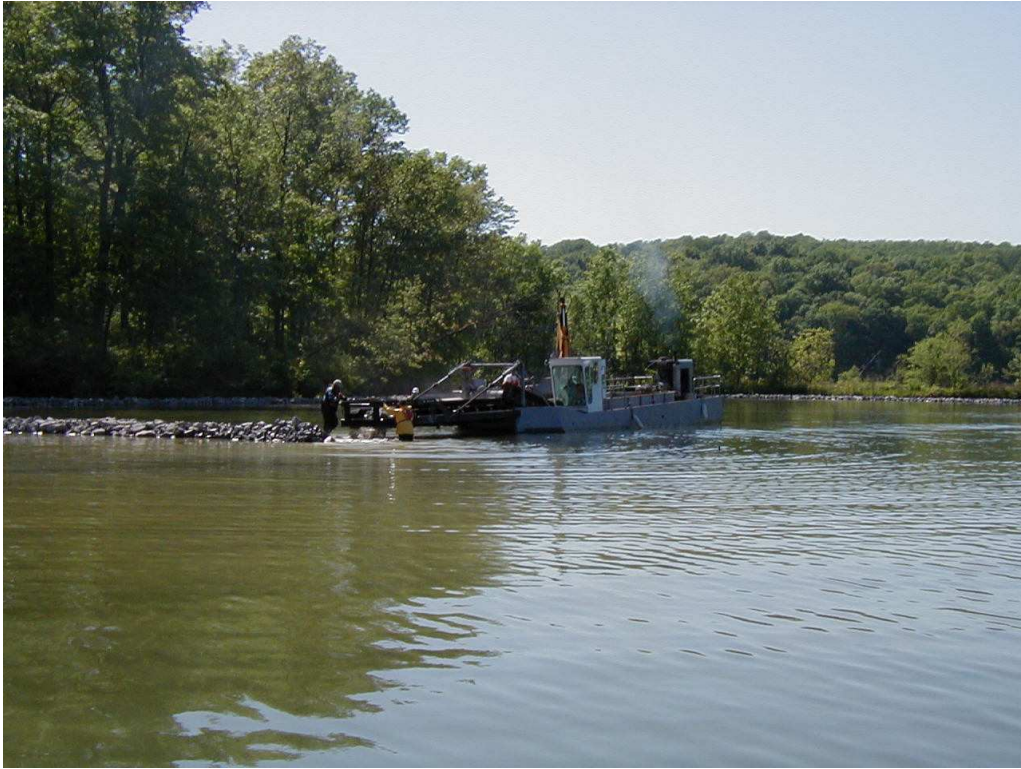
SAME PROCESS, DIFFERENT PERSPECTIVE

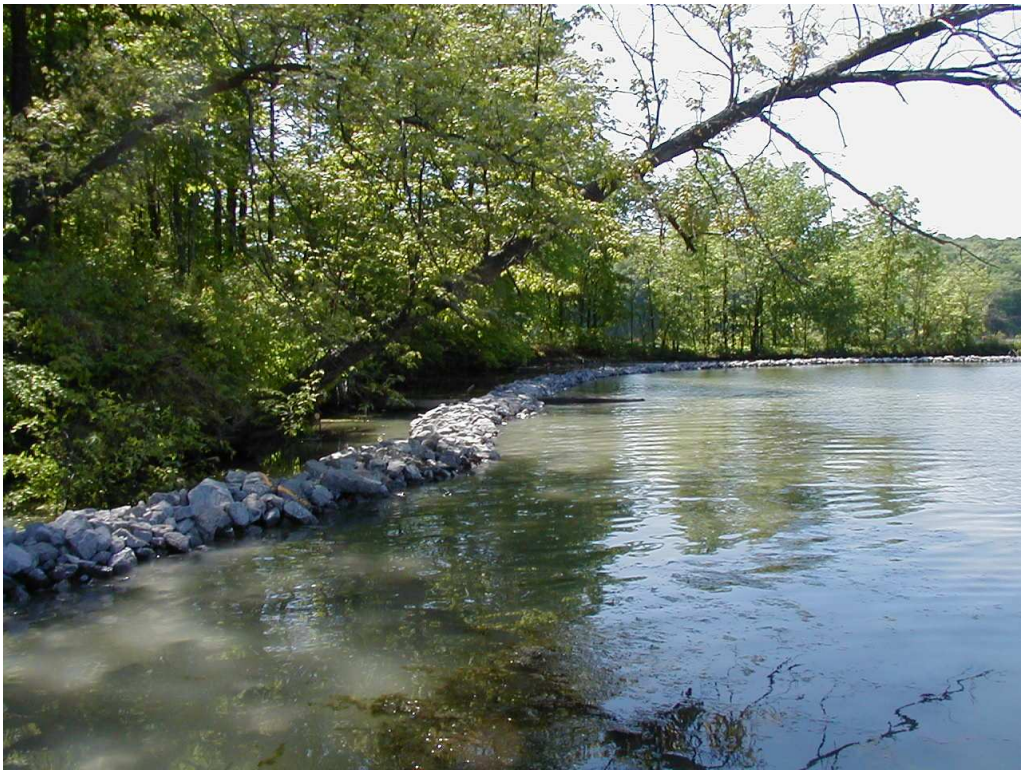
FINISHED PRODUCT: OFFSHORE BREAKWATER USING RR 4 RIPRAP

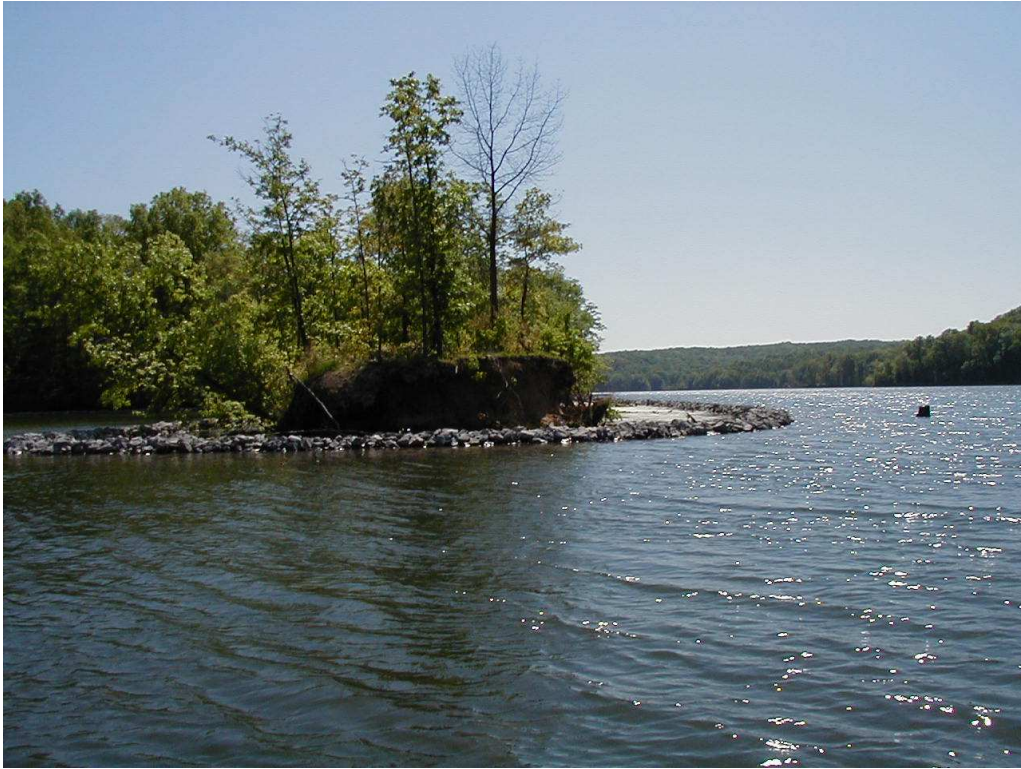
EXAMPLE OF FINISHED WORK

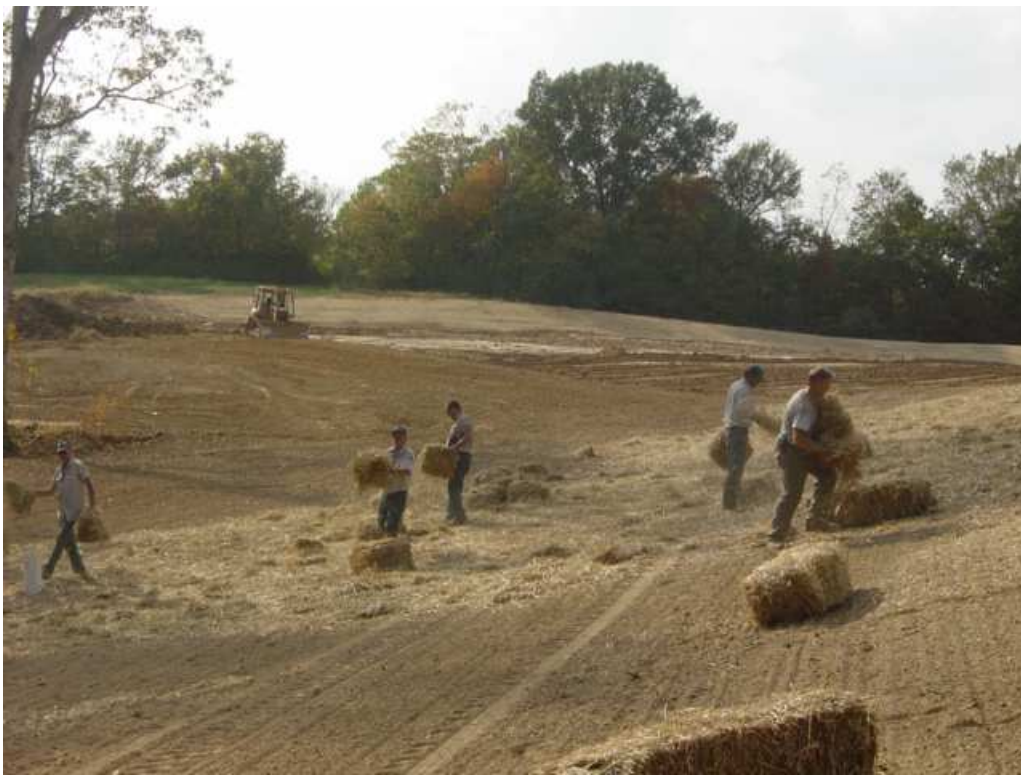
SEDIMENT / NUTRIENT DETENTION BASIN #1: STRAW MULCH APPLICATION

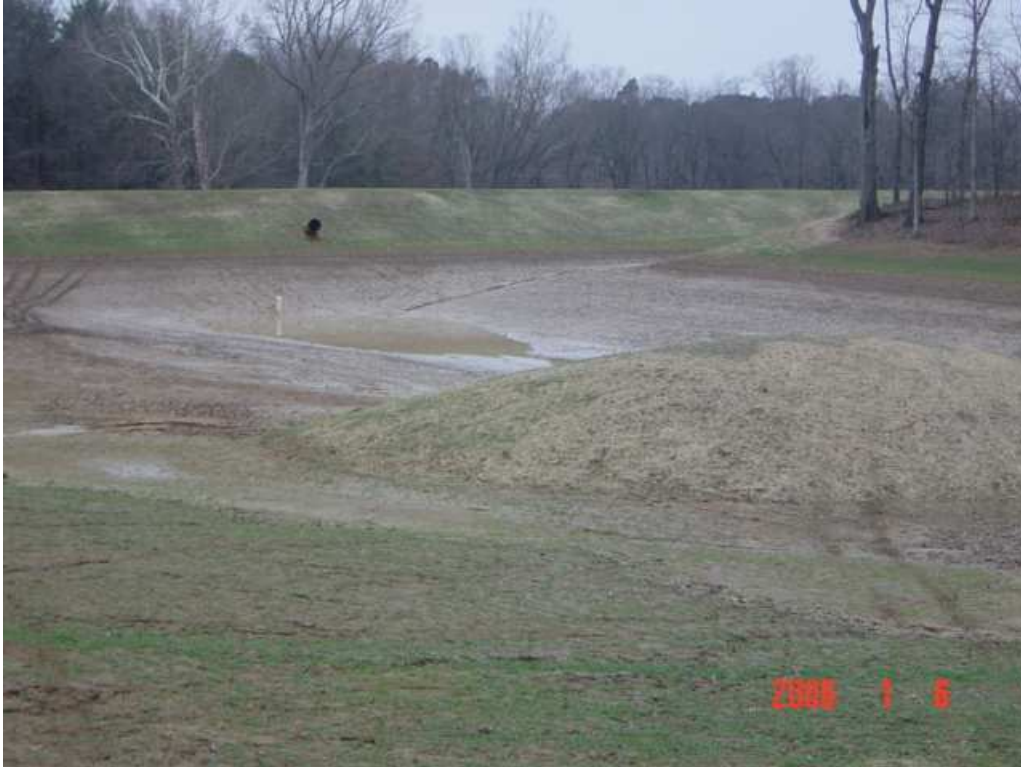
**SEDIMENT / NUTRIENT DETENTION BASIN #1: BASIN AND UPSTREAM
FACE OF DAM PRIOR TO FILLING**

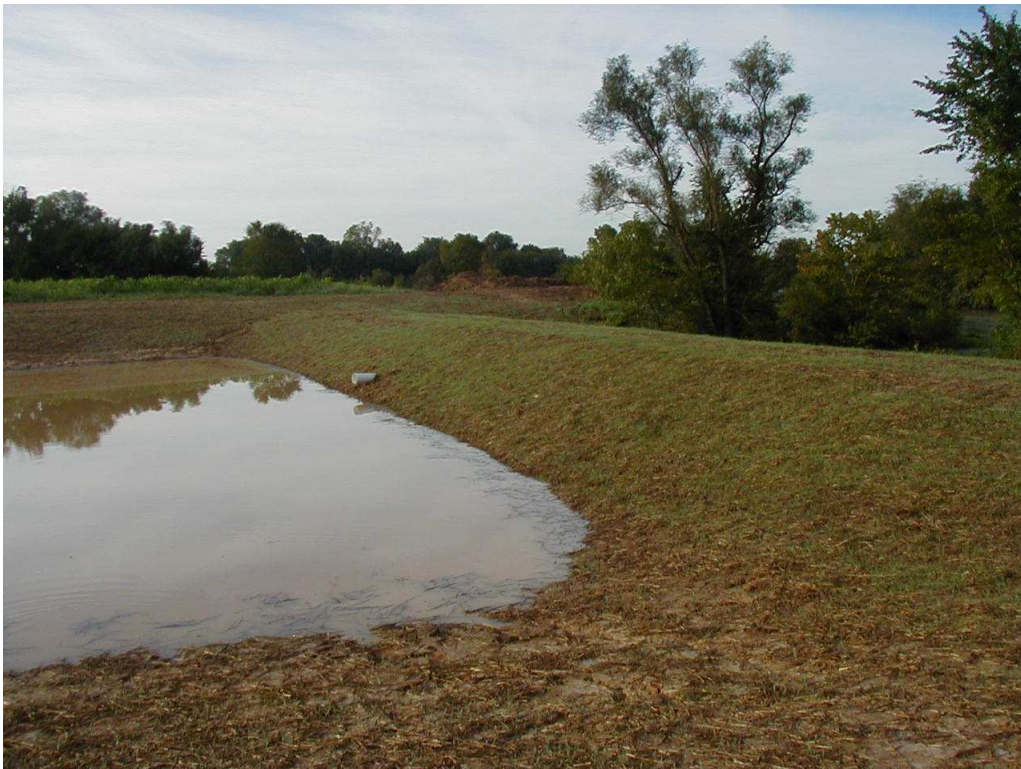
**SEDIMENT / NUTRIENT DETENTION BASIN #2: UPSTREAM SLOPE OF
DAM**

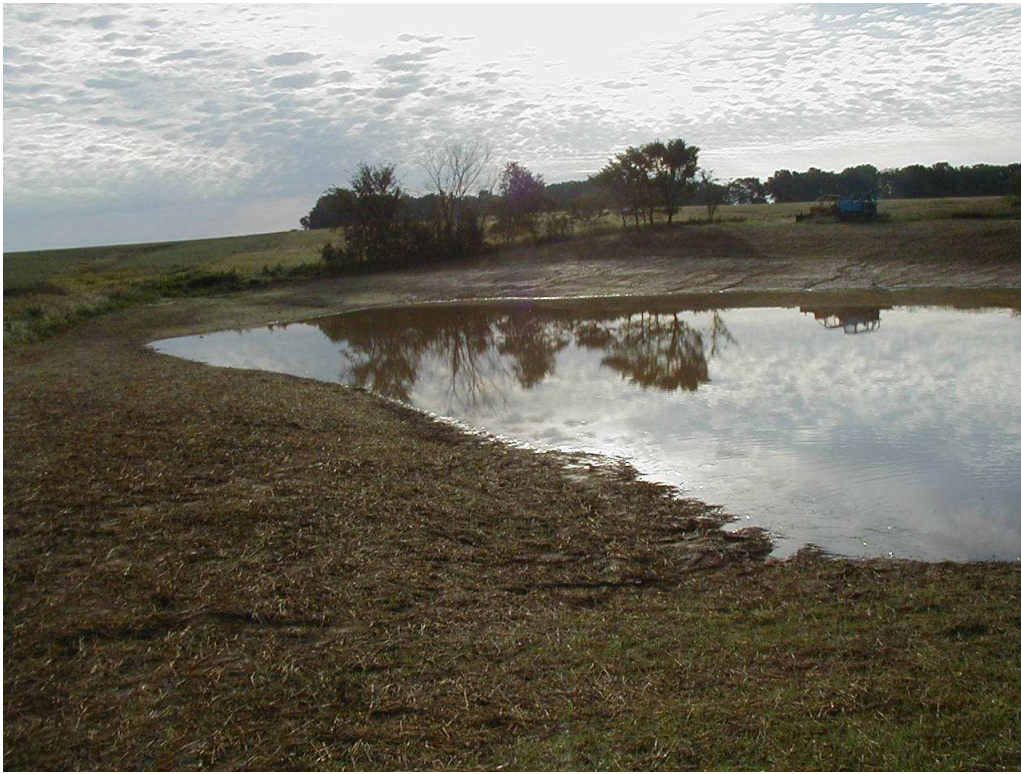
SEDIMENT / NUTRIENT DETENTION BASIN #2: PRIOR TO FILLING

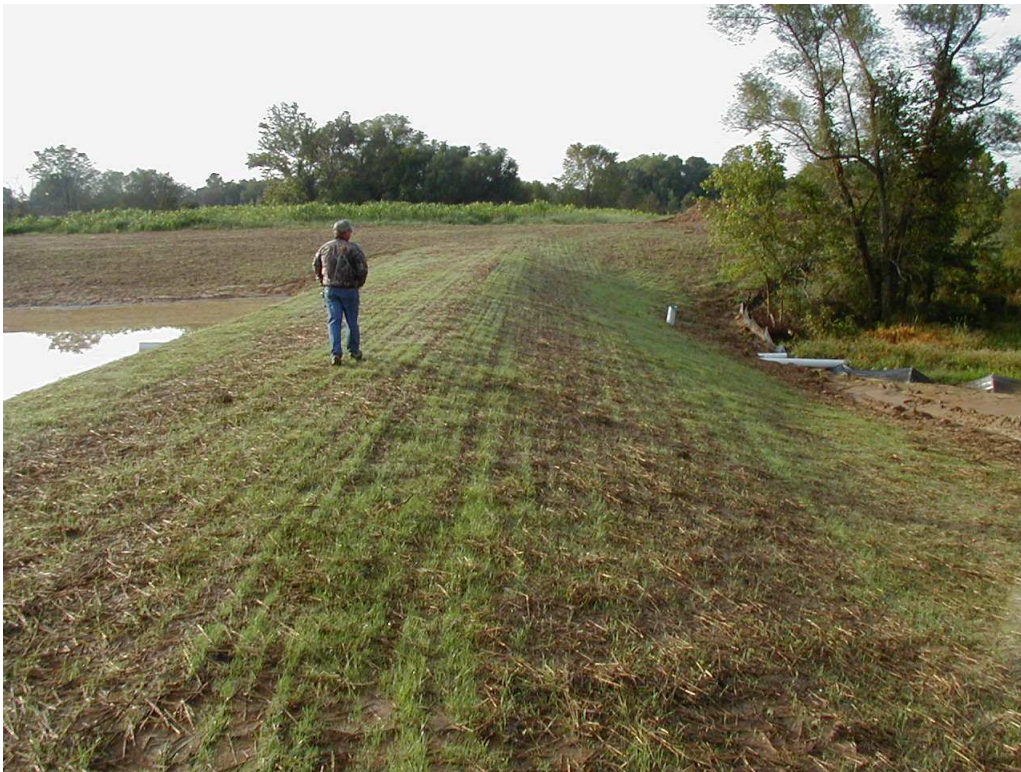
SEDIMENT / NUTRIENT DETENTION BASIN #2: DOWNSTREAM SLOPE OF DAM

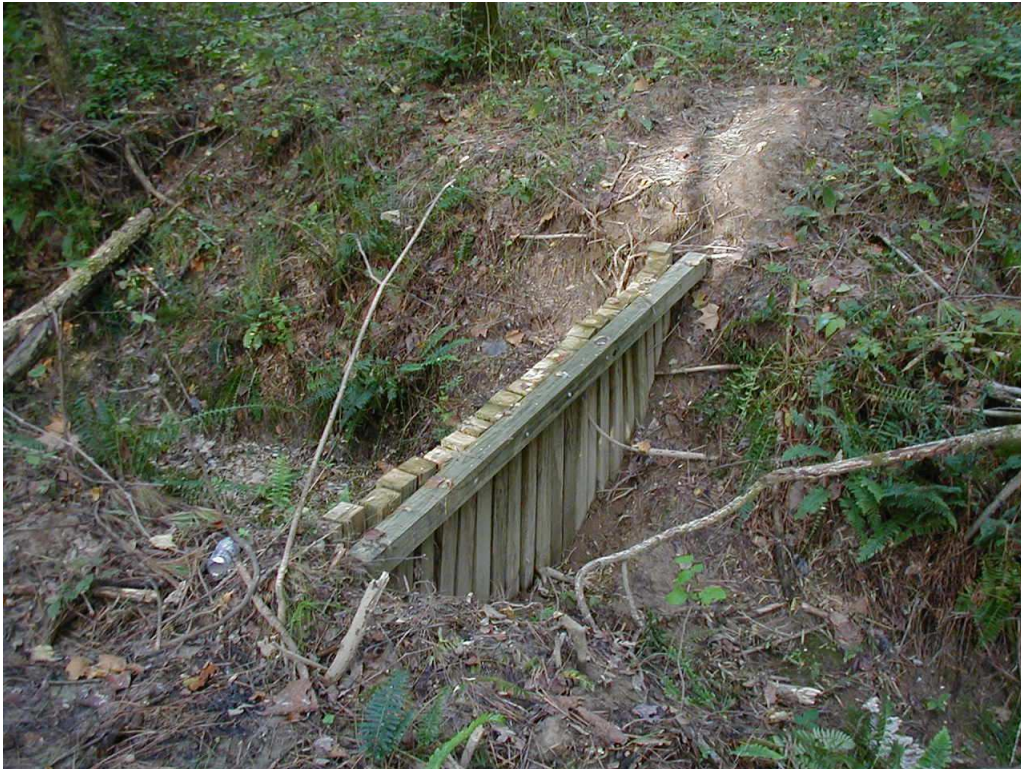
GULLY STABILIZATION – STRUCTURE TYPE 1

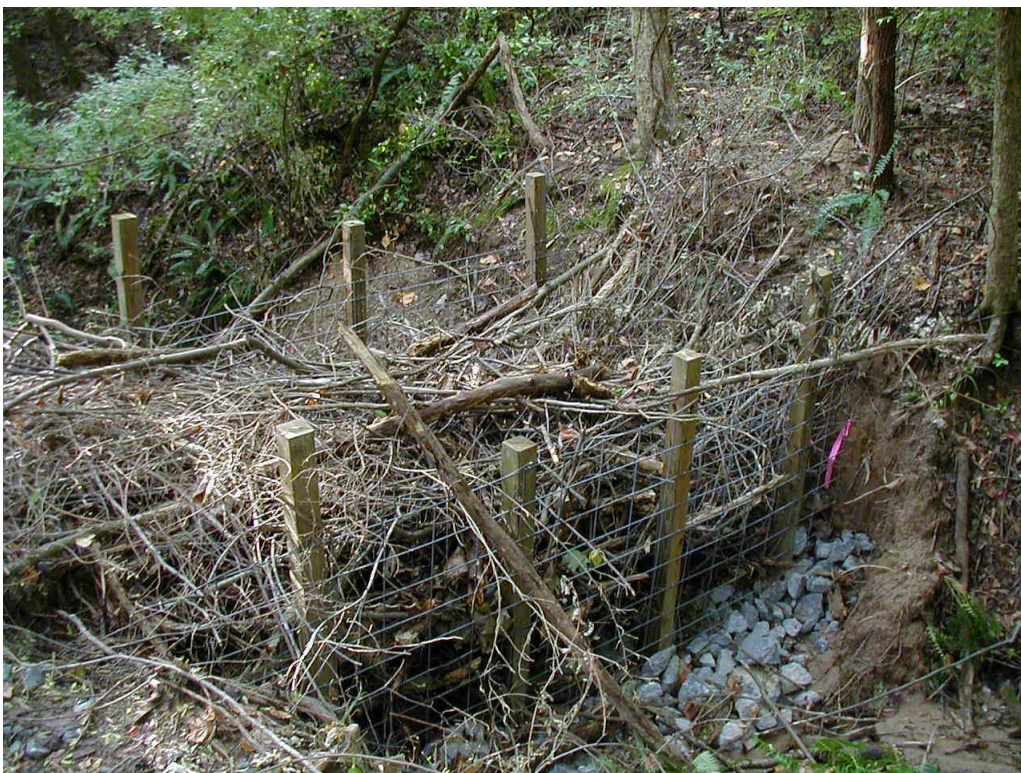
GULLY STABILIZATION – STRUCTURE TYPE 2

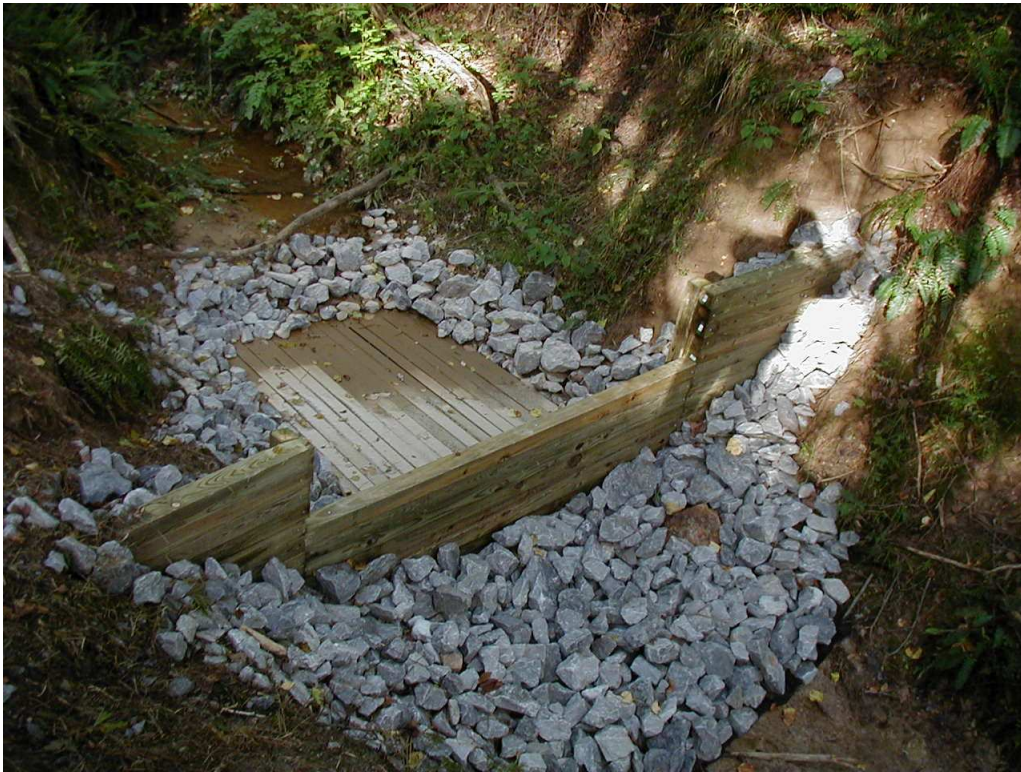
GULLY STABILIZATION – STRUCTURE TYPE 3

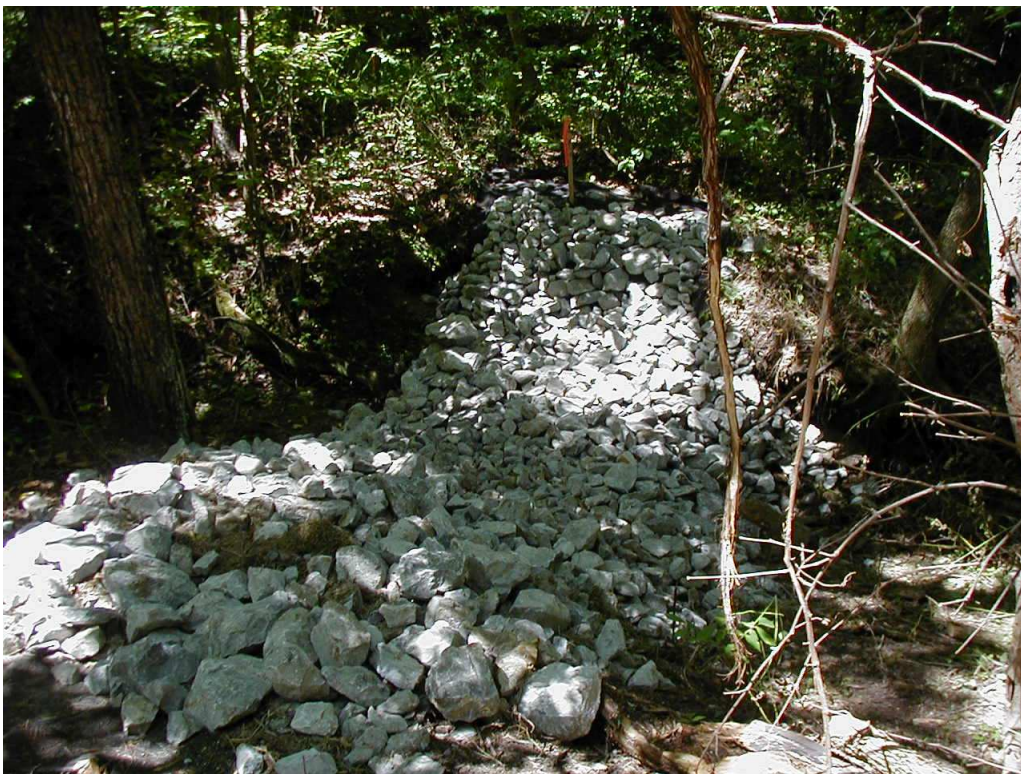
GULLY STABILIZATION – STRUCTURE TYPE 4
