ILLINOIS ENVIRONMENTAL PROTECTION AGENCY 811 Solid Waste Landfill Inspection Checklist

County: DeWitt LPC#: 039005	Region: 4 - Champaign				
Location/Site Name: Clinton/Clinton Landfill #3					
Date: 08/26/2015 Time: From 11:30A To	12:30P Previous Inspection Date: 06/03/2015				
Inspector(s): Dustin Burger	Weather: Cloudy, dry, mild sw winds, 70s				
No. of Photos Taken: # 9	Samples Taken: Yes # No 🗵				
Interviewed: Dave Byrant, Manager	Facility Phone No.: 217/935-8028				
Permitted Owner Mailing Address	Permitted Operator Mailing Address				
Clinton Landfill 3	Clinton Landfill 3				
4700 Sterling Ave. P.O. Box 9071	9550 Heritage Road-C SEP 2 3 2015				
Peoria, IL 61612-9071	Clinton, IL 61727				
Chief Operator Mailing Address	Certified Operator Mailing Address				
Ron Welk	Ron Welk				
4700 Sterling Ave. P.O. Box 9071	4700 Sterling Ave. P.O. Box 9071				
Peoria, IL 616-9071	Peoria, IL 616-9071				
AUTHORIZATION: OPERATIONAL STA Significant Modification Permit Initial: 2005-070-LF Closed-Not Certified.	TUS: TYPE OF OPERATION: ⊠ Existing Landfills 814-Subpart C □ 814-Subpart D

LPC#0390055036—DeWitt County Clinton/Clinton Landfill #3 FOS File August 26, 2015 Inspection Inspector:

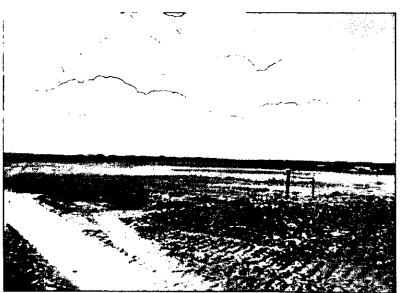
There are a total of six leachate recirculation wells. LRW-101 and LRW-131 are on the north side and connected to leachate manhole L301. LRW-133, 134, and 135 are in the middle section and are connected to manhole L303. LRW-172 is connected to manhole 305 on the south end. The wells are pictured in photos 1-3.

DATE August 26, 2015
TIME 11:30 A.M.-12:30 P.M.
DIRECTION: Southwest
PHOTO by: Dustin Burger
PHOTO FILE NAME:
0390055036~08262015-002.jpg
COMMENTS: leachate

COMMENTS: leachate recirculation wells

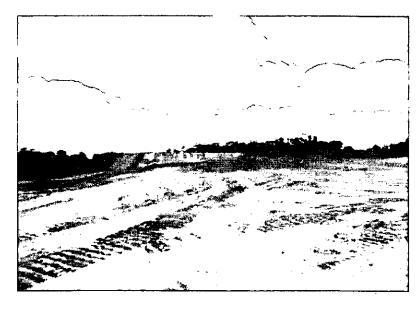
The Chemical Waste Unit was open but no trucks were present dumping waste at the time of the inspection. The CWU is currently taking two types of waste, a salt waste from 3M mentioned in previous inspections, and coal combustion ash from Archer, Daniels, Midland in Decatur. The floor of the eastern portion of the CWU was now fully covered with ash (photo 5).

DATE August 26, 2015
TIME: 11:30 A.M.-12:30 P.M.
DIRECTION: South
PHOTO by: Dustin Burger
PHOTO FILE NAME:
0390055036~08262015-005.jpg
COMMENTS: Coal ash side of CWU

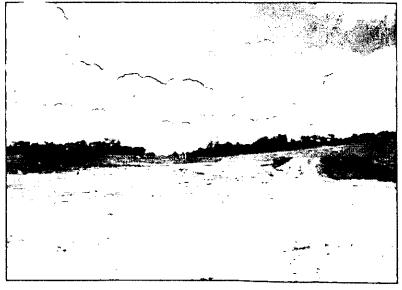
DATE: August 26, 2015
TIME: 11:30 A.M.-12:30 P.M.
DIRECTION: Southwest
PHOTO by: Dustin Burger
PHOTO FILENAME:
0390055036~08262015-006.jpg
COMMENTS: MGP waste is
underneath this area
