ILLINOIS ENVIRONMENTAL PROTECTION AGENCY

Re: LPC#0390055036—DeWitt County
Clinton/Clinton Landfill #3
Compliance File

**ILLINOIS ENVIRONMENTAL PROTECTION AGENCY
811 Solid Waste Landfill Inspection Checklist**

Narrative Inspection Report

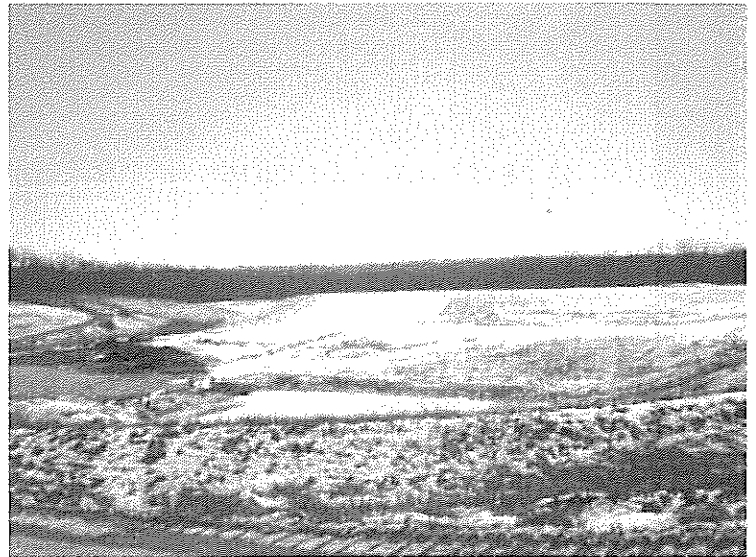
After checking paperwork we first drove to the Chemical Waste Unit (CWU). The east half of the CWU was receiving coal ash waste. Part of the plastic used to keep stormwater from entering the leachate collection system had been pulled back and the ash was being dumped at the edge and pushed out onto the floor of the cell. Two piles of soil to be used for daily cover were staged at the area (photo 3), and drivers were instructed to dump between them so the waste could be pushed out into the cell. When waste is first placed into a cell, the initial lift of ten feet of waste is used to protect the liner from the movement of heavy equipment.

DATE: February 24, 2015
TIME: 10:50-11:45 A.M.
DIRECTION: South
PHOTO by: Dustin Burger
PHOTO FILE NAME:
0390055036~02242015-001.jpg
COMMENTS: Chemical Waste Unit

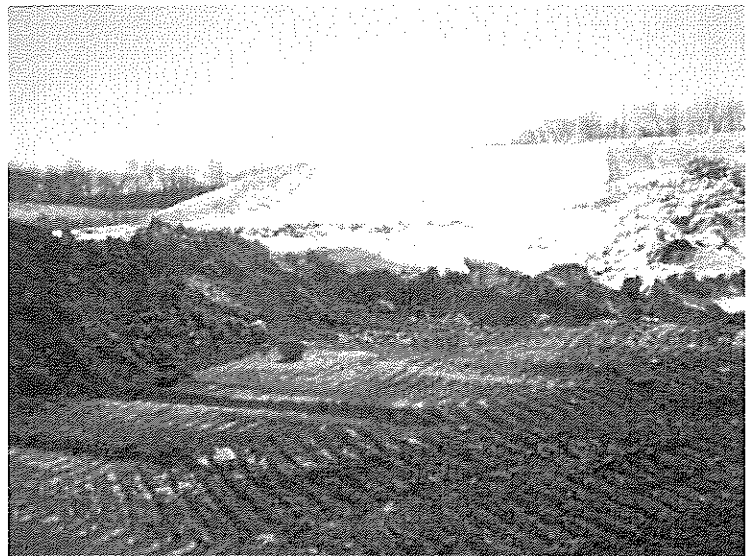
While we were at the CWU, the driver we had seen at the scalehouse dumped one load of ash between the two piles of soil.

DATE: February 24, 2015
TIME: 10:50-11:45 A.M.
DIRECTION: South
PHOTO by: Dustin Burger
PHOTO FILE NAME:
0390055036~02242015-003.jpg
COMMENTS: CWU Cover soil
stockpiled

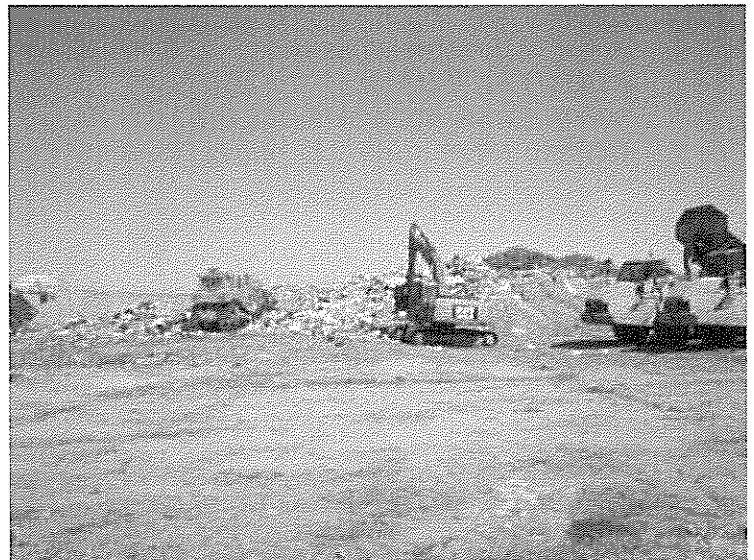
From the CWU, we then drove to the active area, where I took one photo. Several trucks were lined up to dump. The area was busy, with several trucks actively dumping while I watched. The areas around the active area were well covered. The strong south wind was blowing considerable amounts of litter to the mobile fences erected around the active area. No banned waste, such as tires, landscape waste, or electronics were found.

DATE: February 24, 2015
TIME: 10:50-11:45 A.M.
DIRECTION: East
PHOTO by: Dustin Burger
PHOTO FILE NAME:
0390055036~02242015-004.jpg
COMMENTS: active area

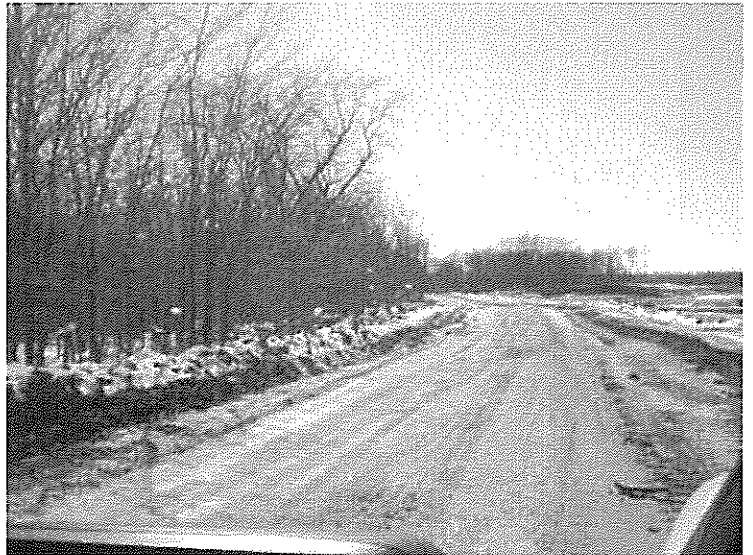
When we drove to the east side of the landfill, I saw large amounts of litter in the trees that line the edge of the landfill (photo 7). The landfill rents a man-lift for employees to use to retrieve litter from the trees (photo 8). Several dozen bags of litter were observed on the east side. The bags contained litter that had been collected (photo 9).

Both the Environmental Protection Act and facility's permit require that all litter be collected at the end of the operating day. There is circumstantial evidence that the litter on the east side was present from the previous day since the winds were from the south during my visit, but were from the west the previous day. Legally, however, it would be difficult to prove that a gust from the west on the day of the inspection did not cause the litter on the east side.

This was the first time I had seen excessive litter at this landfill in the many years I have inspected the site. Two days of strong winds were the main issue. Clinton Landfill does not have a condition in its permit or local siting agreement to close down when certain wind speeds are exceeded. Ideally, the manager would like to work in the new cell, which is below grade and sheltered from strong winds.

DATE: February 24, 2015
TIME: 10:50-11:45 A.M.
DIRECTION: South
PHOTO by: Dustin Burger
PHOTO FILE NAME:
0390055036~02242015-007.jpg
COMMENTS: east side of landfill

While no violations were noted at the time of this inspection, excessive litter was noted along the northern and eastern edges of the landfill. It must be collected by the end of the operating day.

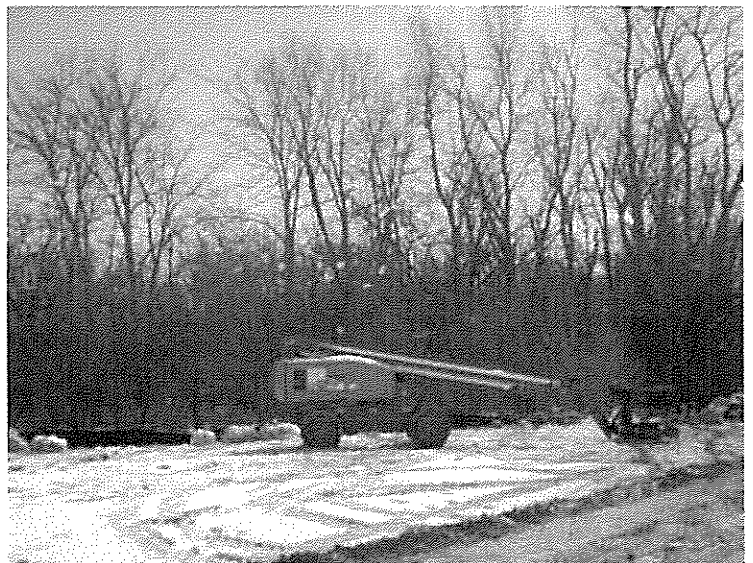
DATE: February 24, 2015
TIME: 10:50-11:45 A.M.
DIRECTION: East
PHOTO by: Dustin Burger
PHOTO FILE NAME:
0390055036~02242015-008.jpg
COMMENTS: man lift for picking litter
from trees

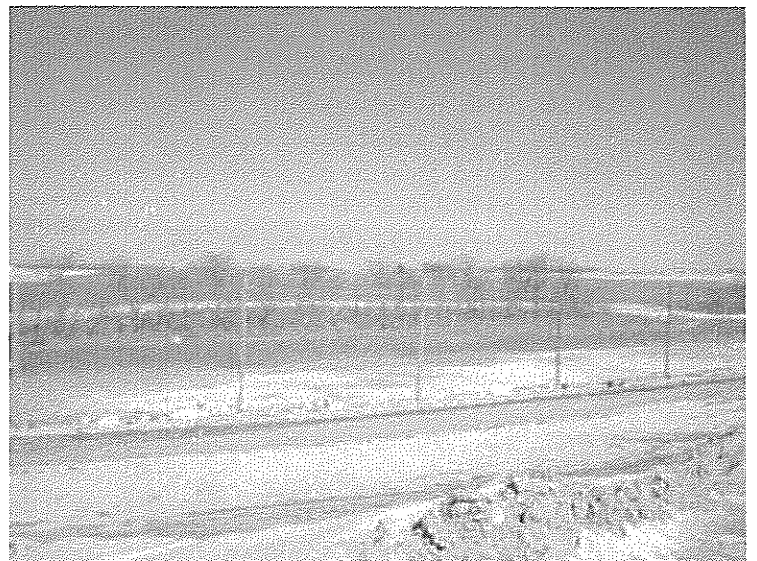
DATE: February 24, 2015
TIME: 10:50-11:45 A.M.
DIRECTION: Northeast
PHOTO by: Dustin Burger
PHOTO FILE NAME:
0390055036~02242015-006.jpg
COMMENTS: north litter fences

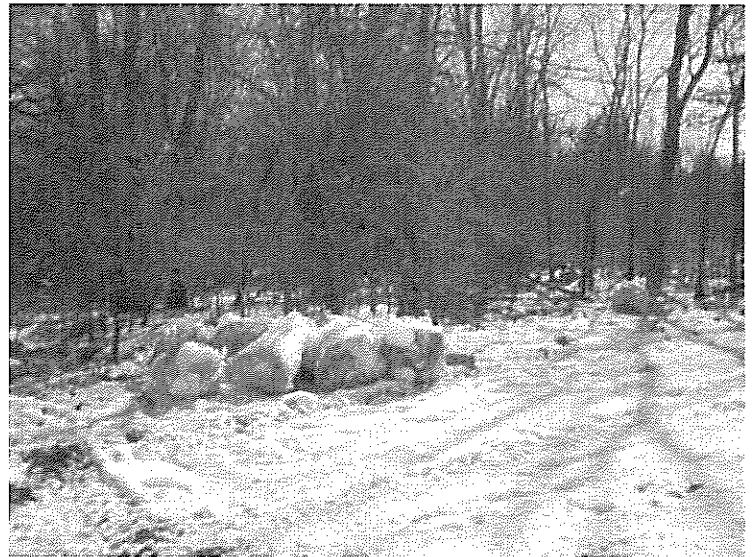
DATE: February 24, 2015
TIME: 10:50-11:45 A.M.
DIRECTION: South
PHOTO by: Dustin Burger
PHOTO FILE NAME:
0390055036~02242015-009.jpg
COMMENTS: bags of litter from
picking up litter from east side of
landfill
