AERIAL ASSESSMENT REPORT FOR Big and Little Muddy Rivers

Jackson County

November 2005

Prepared by Wayne Kinney for IL. Department of Agriculture

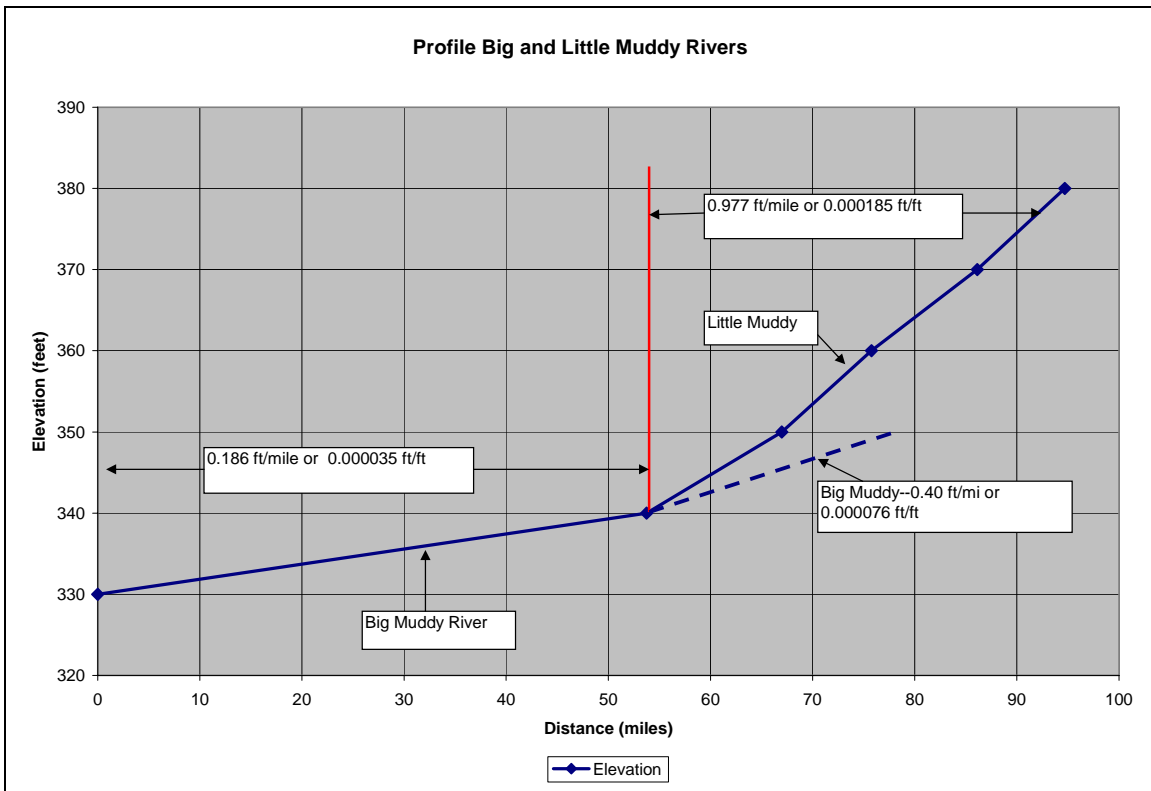
Figure 2 Channel Profile of Big and Little Muddy River
(Profile begins at Elev. 330 near River Mile 68 on the Mississippi River.)

Detailed elevation data is not available; therefore the channel slope is calculated from USGS topo maps by measuring the channel length between contour lines. The report refers to this as “valley profile” although a true valley profile would use a straight line distance down the floodplain rather than channel length. However, this method is used because it incorporates sinuosity into the calculation and allows the channel slope to be assume equal to “valley slope” in order to estimate channel capacity, velocity, etc.,

1. The Big Muddy has a very low gradient at 0.186 ft/mi. as measured from the USGS topographic maps. In fact the profile which begins at elev. 330 is found in the Mississippi River near river mile 68 and contour line 340 is located on the Big Muddy near the Southern Illinois Airport between Murphysboro and U.S. Rte. 50, a distance of over 50 miles.

2. The Little Muddy River has more gradient, however it is still less than 1.0 ft. per mile through the entire reach of the aerial assessment.
3. Re-aeration of the Big and Little Muddy Rivers using in-stream structures is probably not feasible due to the low gradient preventing creation of significant turbulence to re-aerate the water.

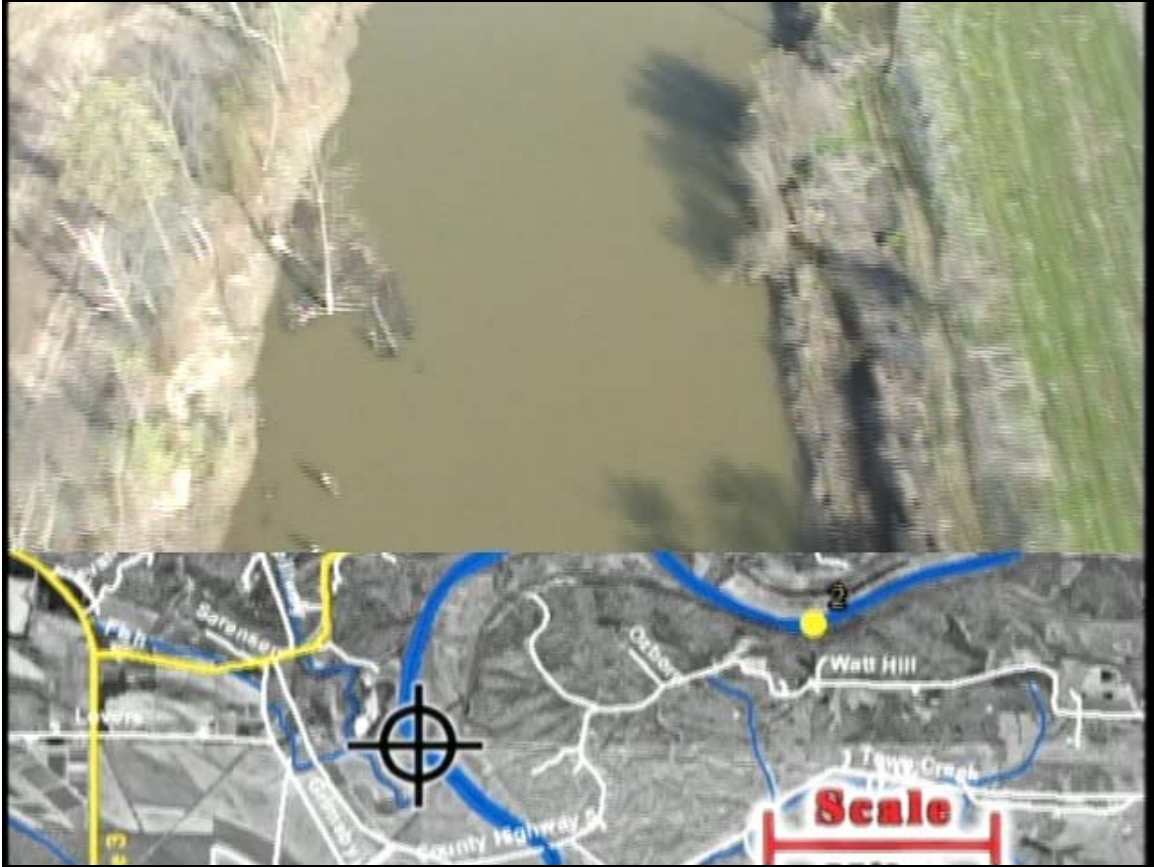
Fig. 4 Geotechnical failure on DVD 1 at 7:29

6. There are 31 identified geotechnical failures in the study reach in addition to 294 erosion sites. Consideration of treatment at these sites should include use of Stream Barbs to trap sediment near the eroding banks and create the maximum turbulence possible at this gradient. Stream Barbs may be especially well adapted for sites with geotechnical failures by trapping sediment near the failed banks and thereby “loading the toe” to help resist future geotechnical failures.

The recommended treatment for this segment is to treat the identified erosion sites and geotechnical failure sites with a series of Stream Barbs. The result of treatment will be the redirection of flow toward the center of the channel causing some re-aeration to occur. The stream barbs will also trap sediment near the failed banks and stop the bank erosion while adding significant sediment which can help prevent future geotechnical failures.

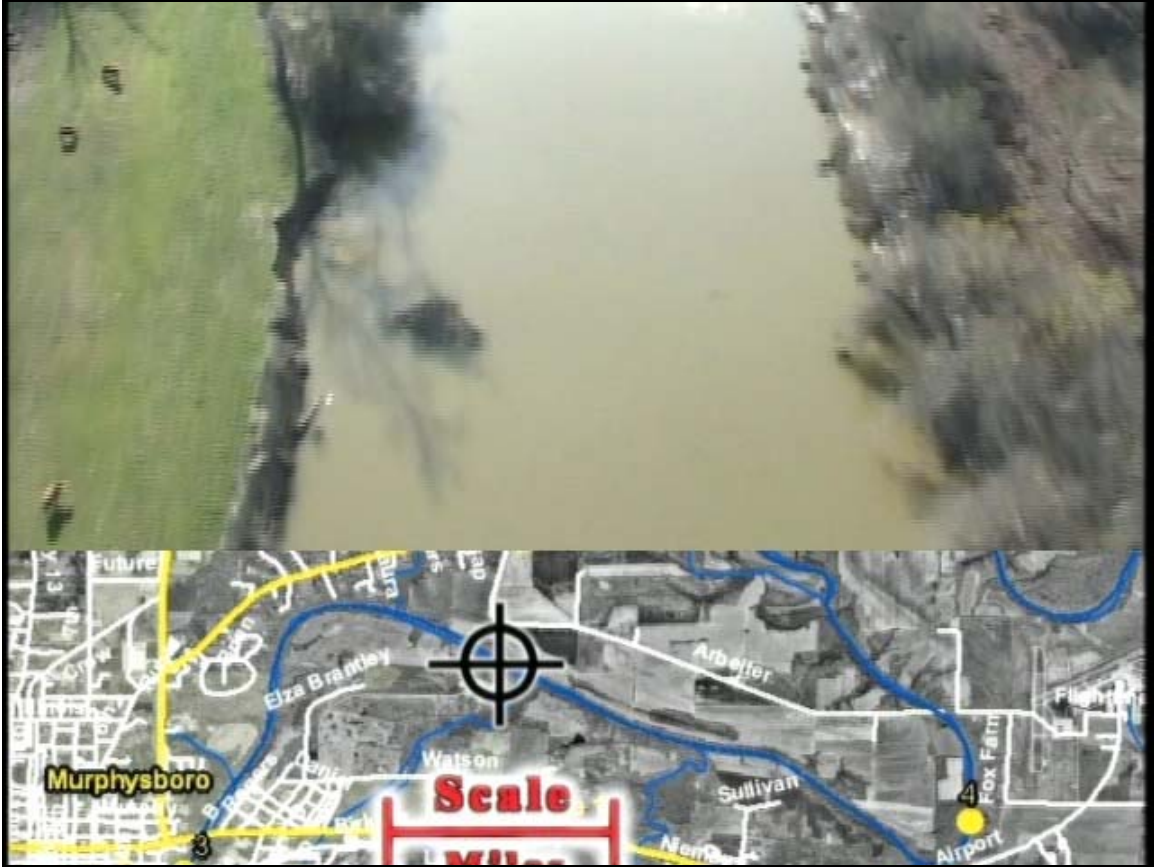
Fig. 7 Bank Erosion in pastured area on DVD 1 at 17:15

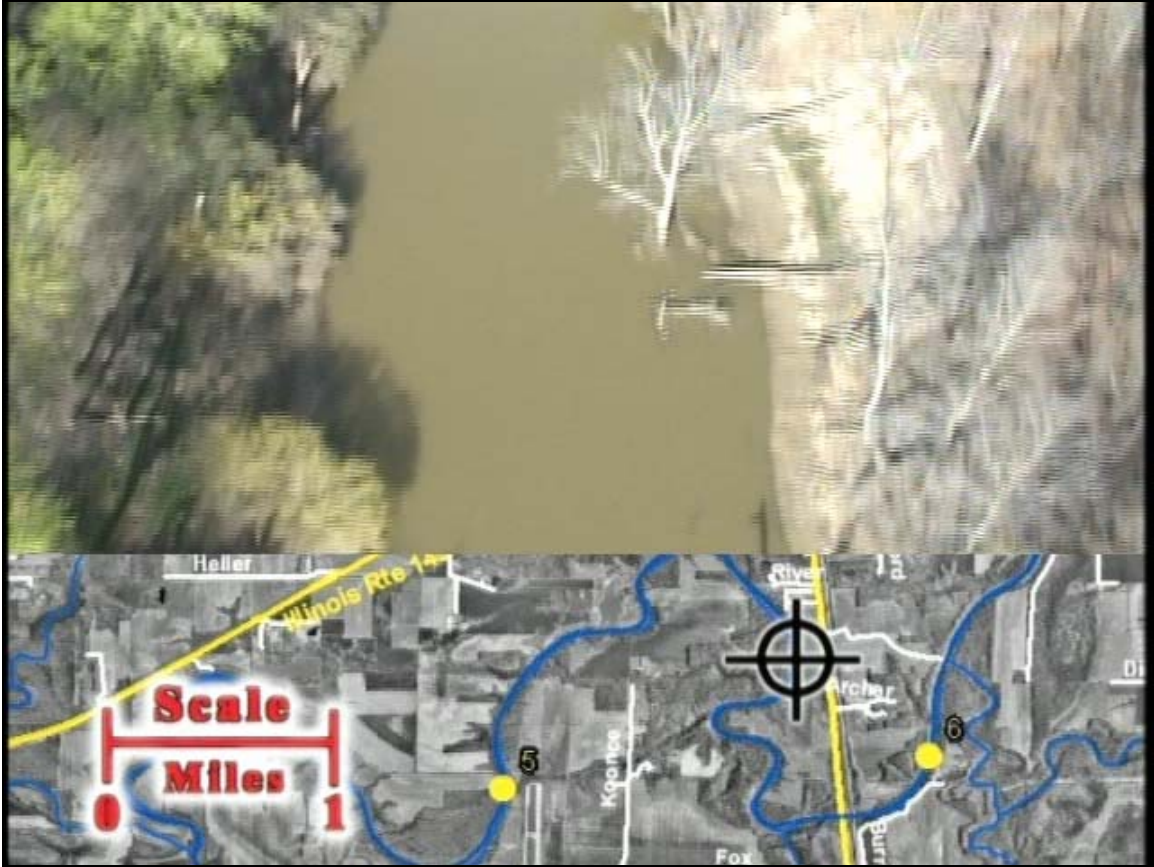
Fig. 10 Geotechnical failure with mature tree standing vertically in channel on DVD 1 at 28:04

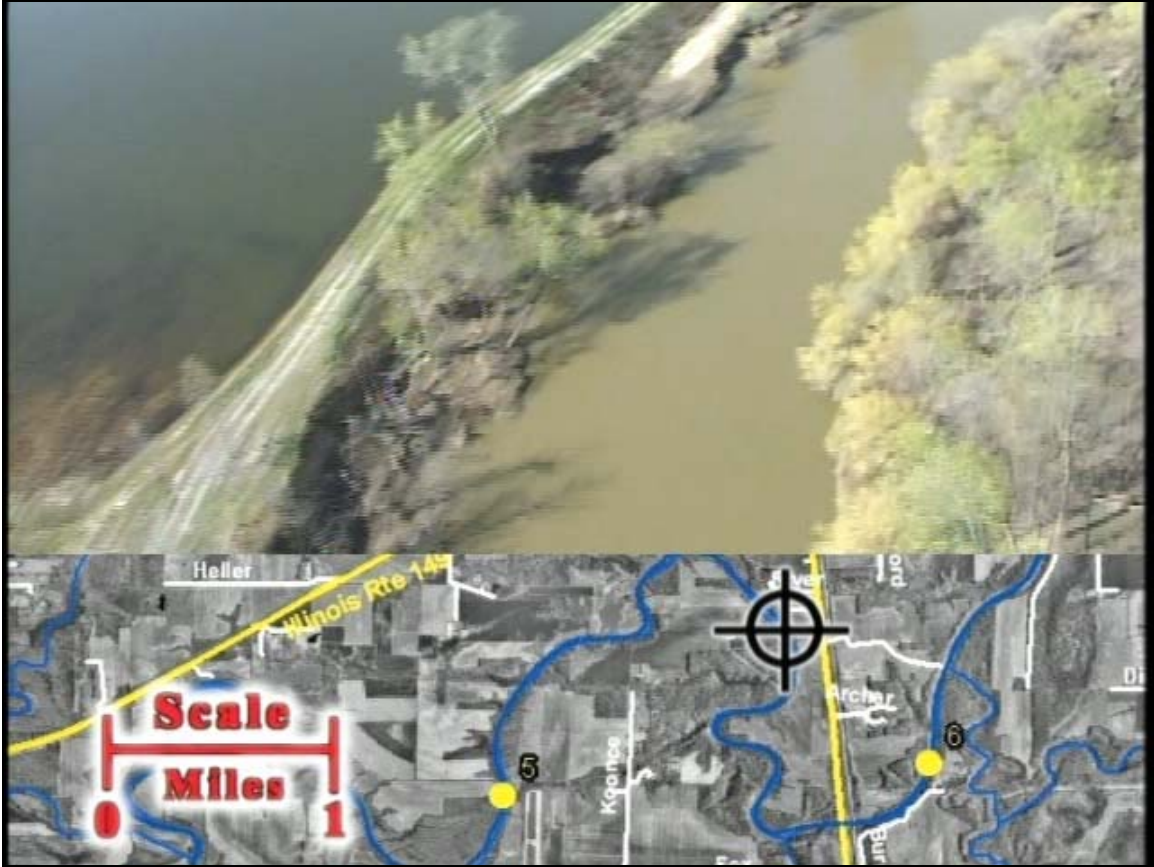
Fig. 11 Geotech failure next to farm pond on DVD 1 at 27:54

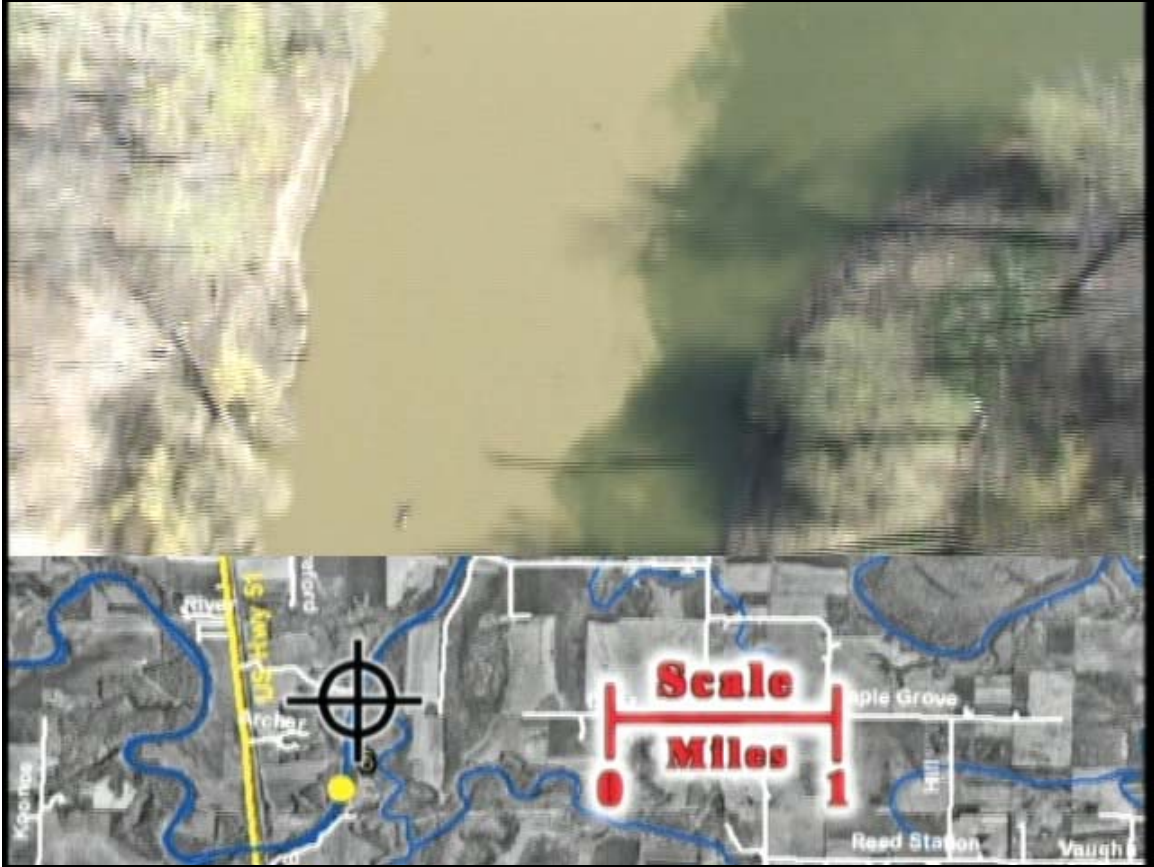
8. At the time of the aerial assessment flight there is a very noticeable difference in water clarity at the confluence with Crab Orchard Creek. This difference can be observed on DVD 1 at 30:22 or in Fig.

Fig. 13 Confluence of Big Muddy River on left and Crab Orchard Creek on right showing water quality differences. (DVD 1 at 30:22)

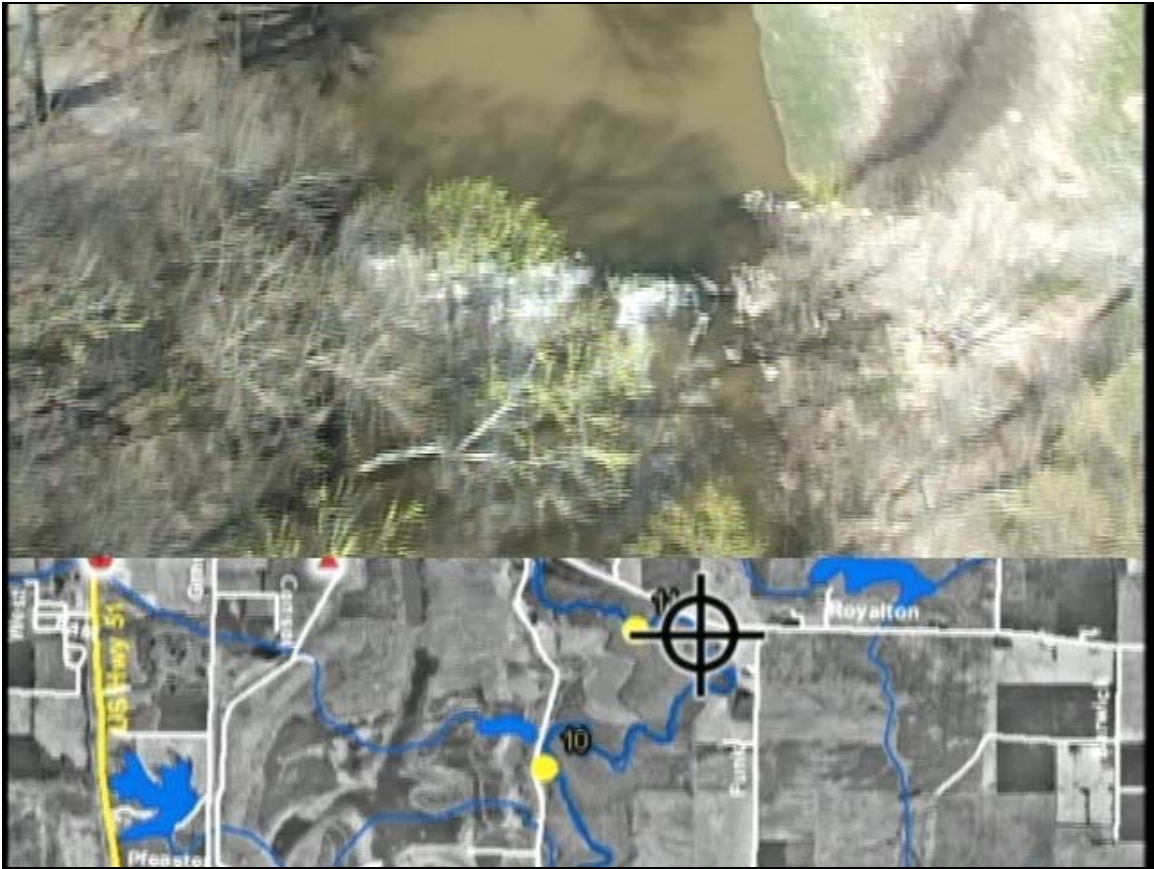
9. There are a series of manmade “riffles” in the Little Muddy River on DVD 2 at 11:20, 13:49 and 14:48 that do provide some re-aeration. However, the gradient in this reach is approx. 5 times that found in the TMDL segment N12.

Fig. 18 Low water crossing on DVD 2 at 14:48 acting as grade control and providing some re-aeration.

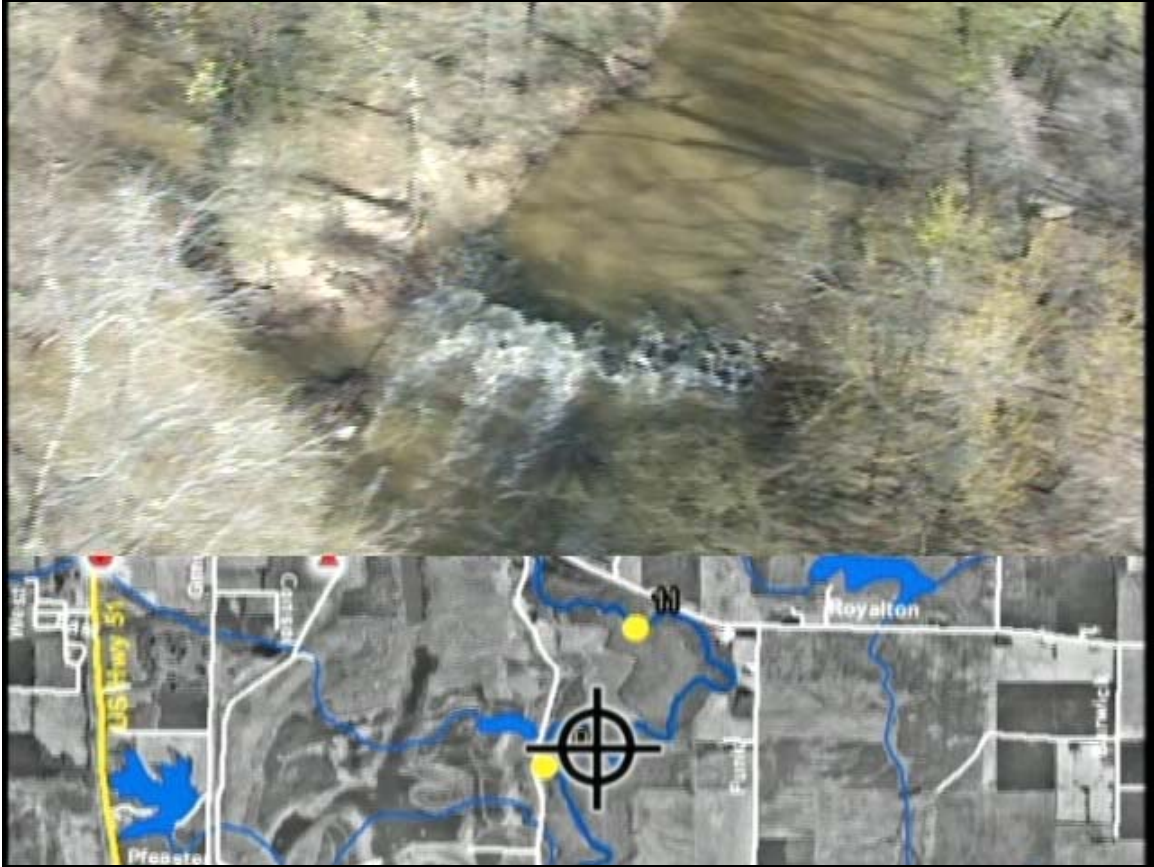
Fig. 19 Grade Control on DVD 2 at 11:20. Provides some re-aeration of flow.

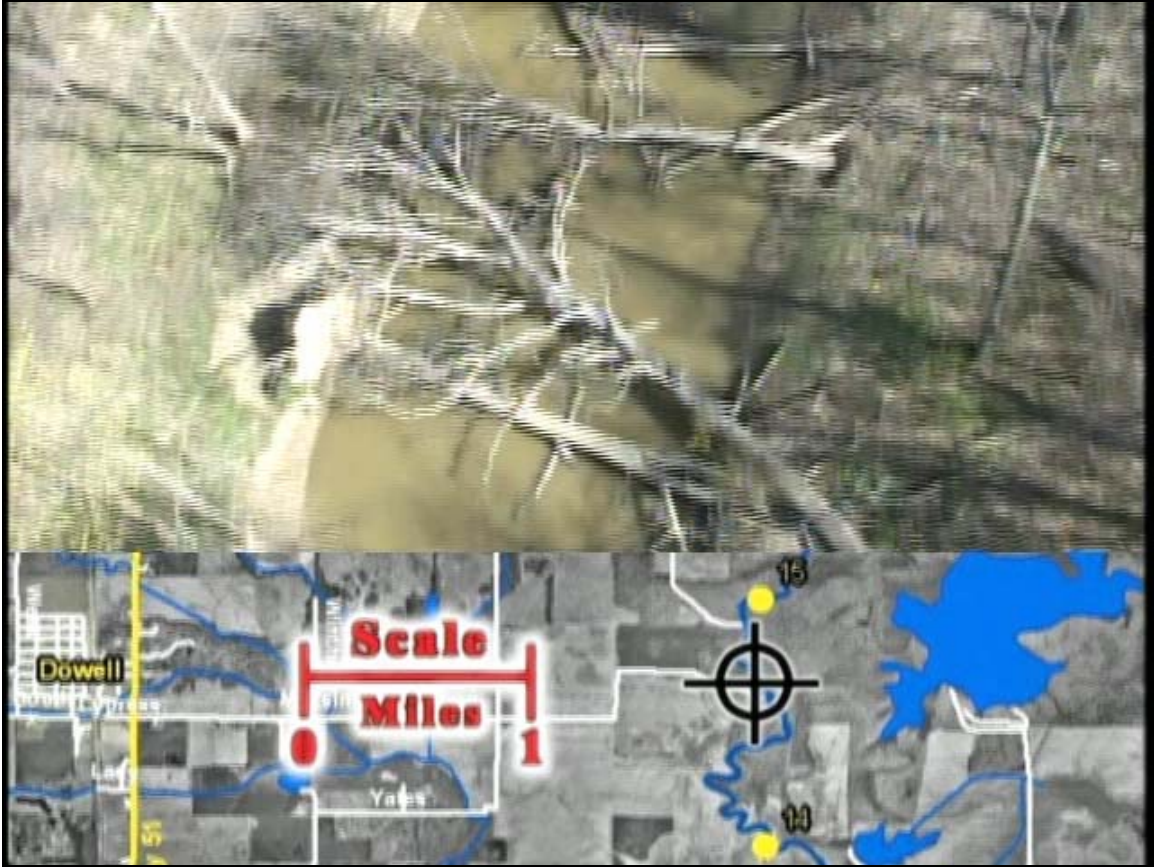
Fig. 25 Woody debris in channel from erosion on DVD tape 2 at 34:06

The recommended treatment for this segment is to treat the identified erosion sites and geotechnical failure sites with a series of Stream Barbs. The result of treatment will be the redirection of flow toward the center of the channel causing some re-aeration to occur. The stream barbs will also trap sediment near the failed banks and stop the bank erosion while adding significant sediment which can help prevent future geotechnical failures.
