**AERIAL ASSESSMENT OF MACOUPIN CREEK:
MACOUPIN AND JERSEY COUNTIES
JULY 2005**

**Prepared by WAYNE KINNEY for IL. DEPARTMENT OF
AGRICULTURE**

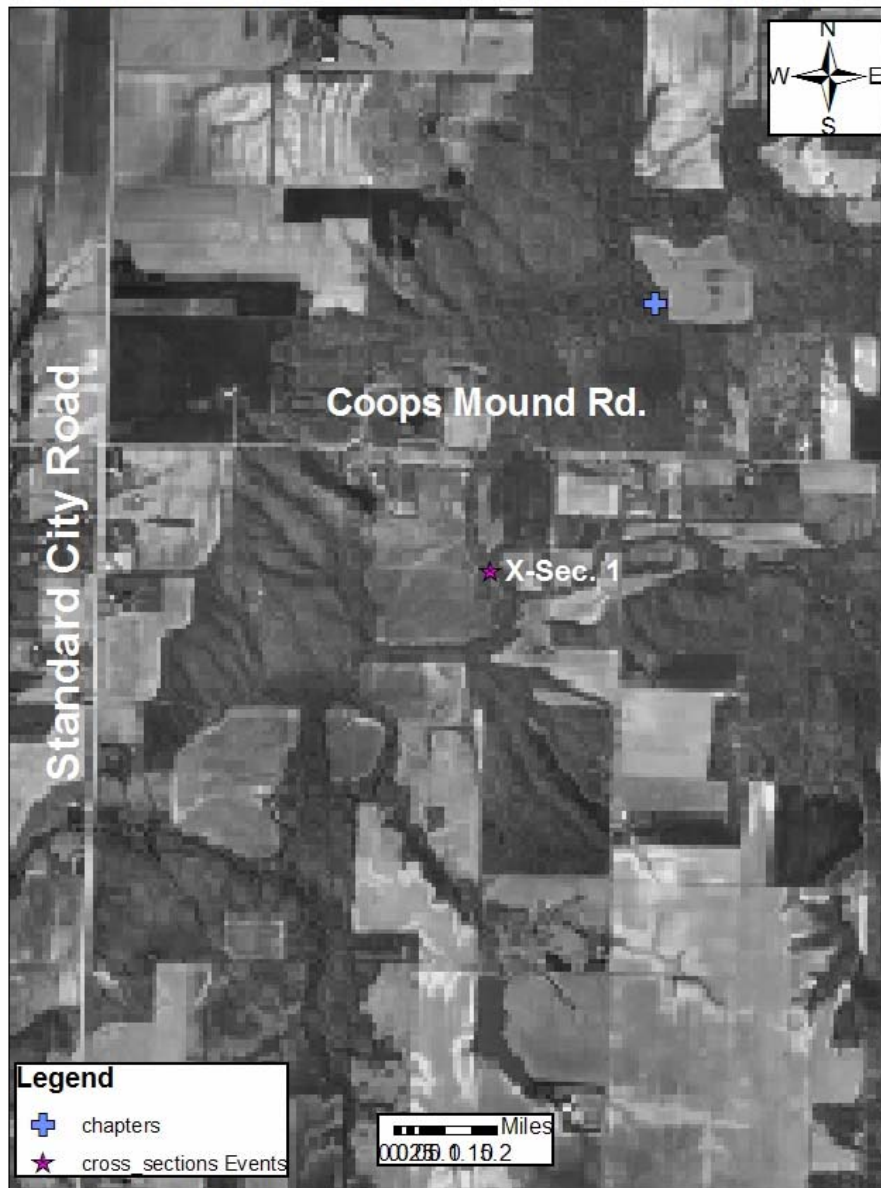
Fig. 4 Cross Section 1 Location

Cross section 1 was chosen due to a stable rock bed that would severely limit the ability of Macoupin Creek to incise at this location. The “bankfull” discharge at this location should therefore be very near to the “top bank” elevation. The data shows that in fact the discharge calculations at top bank allow a discharge of 10.0 cfs/sq. mile which compares favorably with the USGS Gage at Kane for a 1.5 to 2 yr. R.I. discharge. Therefore the “bankfull” discharge at cross section 1 is assumed to be at top bank and has been used as a guide for other bankfull determinations in addition to field indicators.

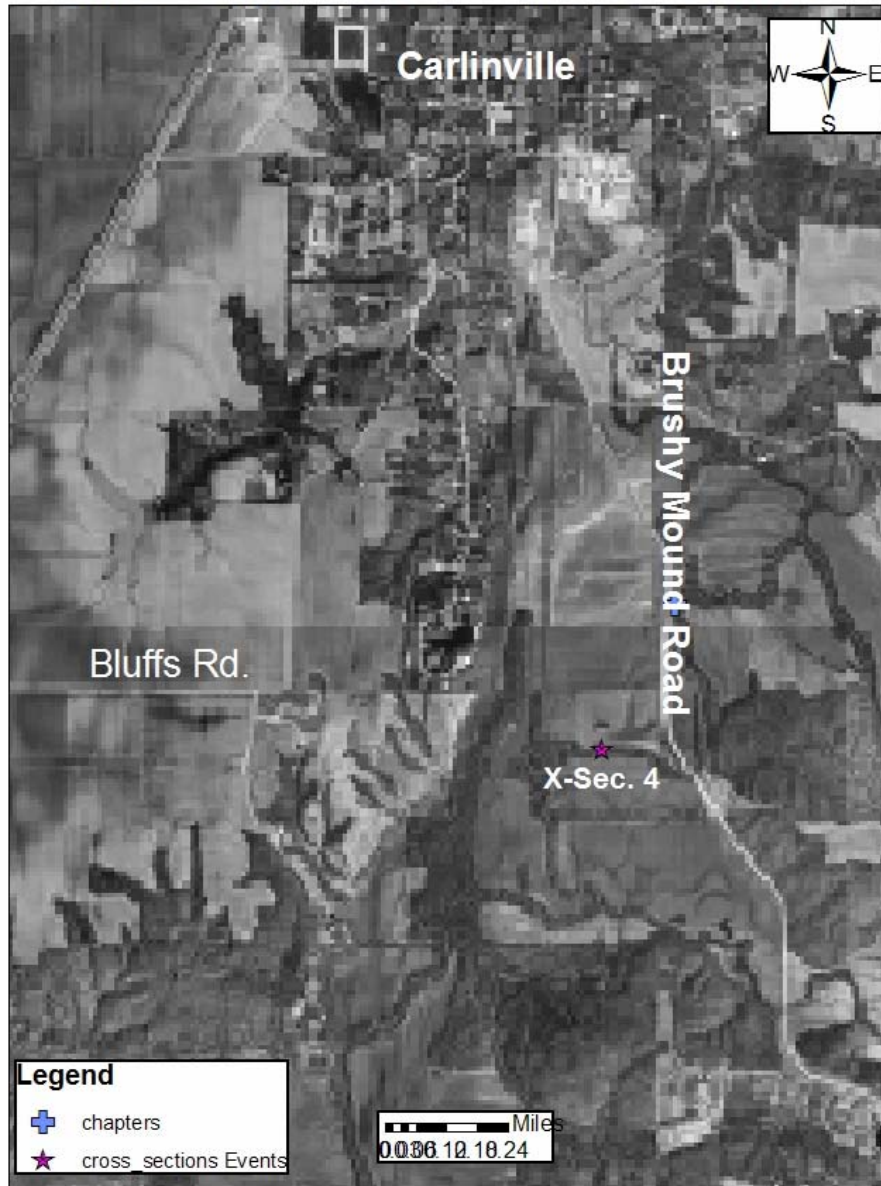
Fig. 7 Cross Section 4 Location

MACOUPIN CREEK--Cross Section 4

Nine cross sections were taken at selected locations on Macoupin Creek after viewing the DVD's. The cross sections are located at "riffle" locations to best represent the channel characteristics and to allow for comparison of width, depth, x-sec. area, etc. along the channel at similar geometric locations. The results of the hydraulic analysis at each site is presented in summary form in Table 2 and each cross section is provided in more detail in Appendix A. Aerial views of cross sections locations are shown in Figs. 4-12. Exact locations as Eastings and Northings can be found in Appendix A

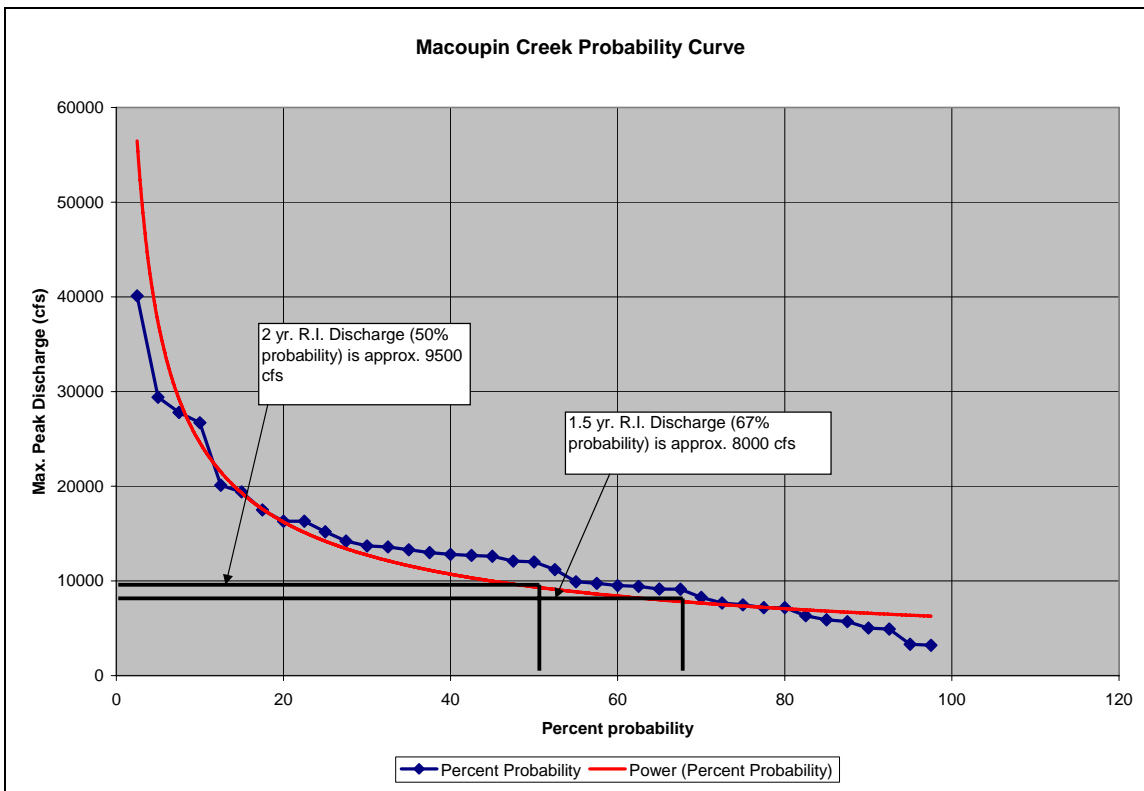
Fig. 13 Macoupin Creek Discharge Probability Curve (USGS Gage # 5587000) for 1965-2004.

A plot of the discharge probability curve from the USGS Gage# 5587000 (Fig. 13) indicates the 2 yr. discharge (50% probability) at approx. 9500 cfs and the 1.5 yr. discharge (67% probability) at approx. 8000 cfs. The drainage area at Gage#5587000 near Kane is 868 sq. miles; therefore the discharge per sq. mile is 10.6 cfs/sq. mi. and 9.2 cfs/sq. mi. respectively for the 2 yr. and 1.5 yr. R.I. discharge. The discharge at the field determined “bankfull” stage in the study reach ranges from 10.0 to 11.9 cfs/sq. mi. (Table 2). The drainage area increases from 104.6 sq. mi. at X-Sec 1 to 400 sq. miles at X-Sec 9 however the discharge per sq. mile remains in a very narrow range. While this is not “typical” of many watersheds, it should be noted that Macoupin Creek has a very uniform valley slope of approx. 2.4 ft per mile throughout the entire study reach that contributes to the similar discharge values.

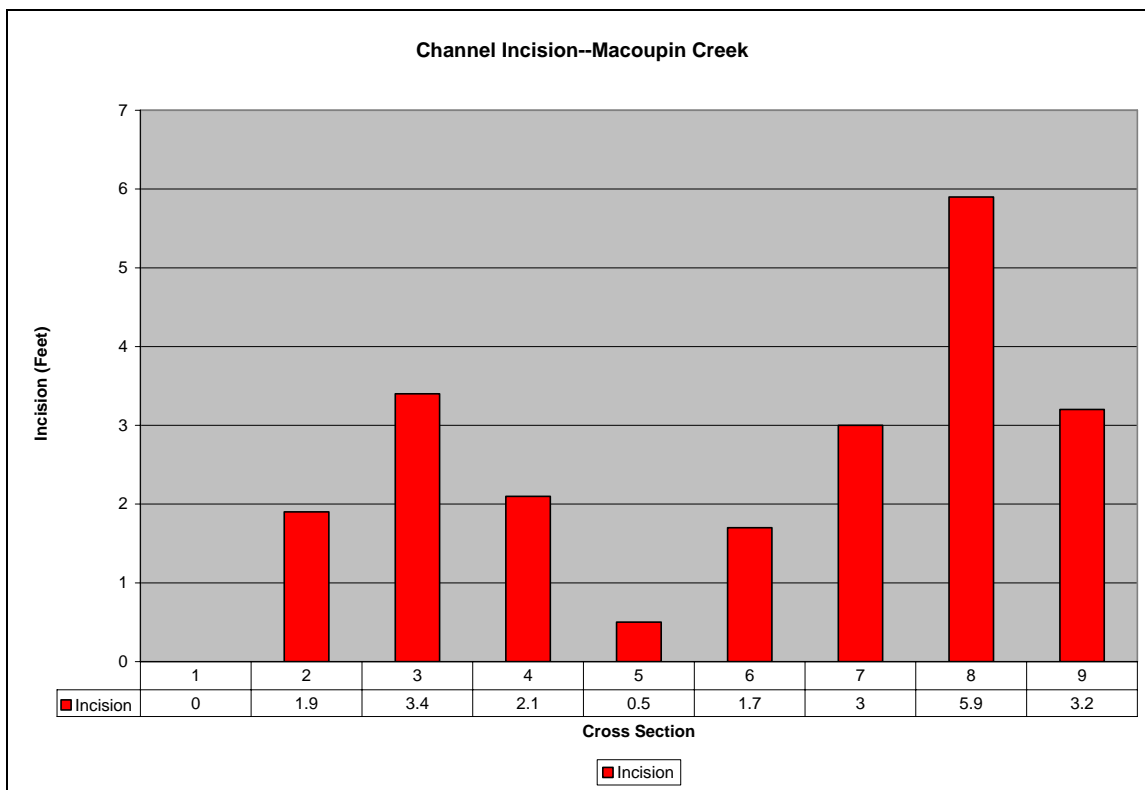
Fig. 16 Incision at cross section locations (riffles) on Macoupin Creek

A comparison of the “Max. Bankfull Depth” at geomorphic bankfull and the “Top Bank Depth” show that cross sections 2 thru 9 are all incised. The amount of incision ranges from 0.5 ft. to 5.9 feet with the most incision occurring at the lower three cross section locations. (Fig. 16) Incision then seems to be a more likely candidate to explain the extensive streambank erosion identified in the aerial assessment.
