Lake Bloomington Watershed Plan

Lake Bloomington Watershed Planning
Committee

McLean County
Soil and Water
Conservation District

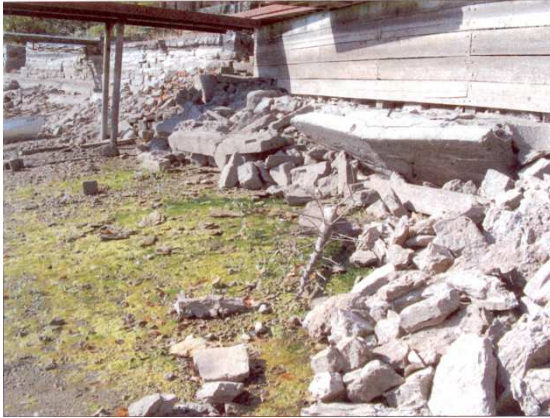
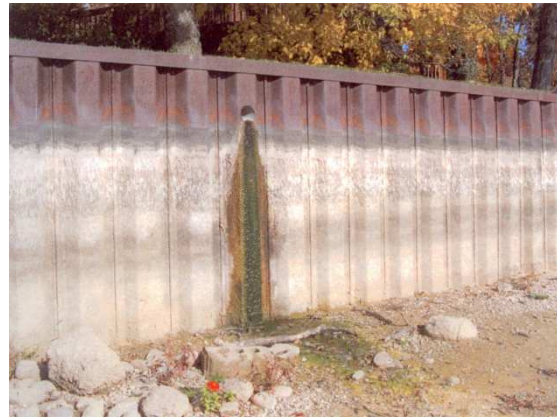
- 1 These seawalls are largely sheet piling, with some timber walls, concrete walls and a
2 few rock bins fashioned with chain link fencing.

7 Each segment of seawall has been inventoried and located using UTM
8 coordinates with a handheld GPS unit. As each segment was located a visual rating was
9 assigned along with a measurement of the sheet piling to check for variation from
10 vertical and has been classified as "Good", "Fair", "Poor" or "Critical". There are no
11 objective standards for these ratings but they are an assessment of the overall condition
12 of the seawall based on the observed condition of material and vertical integrity. A
13 "Good" means that there were no observed concerns with the seawall and "Critical"
14 means that the condition was judged to be near failure. A "Fair" rating was assigned
15 where there were observed deficiencies in the wall that indicate some maintenance is
16 needed. A "Poor" rating was assigned where there were numerous or serious problems
17 developing, but the seawall was not yet in danger of failure.

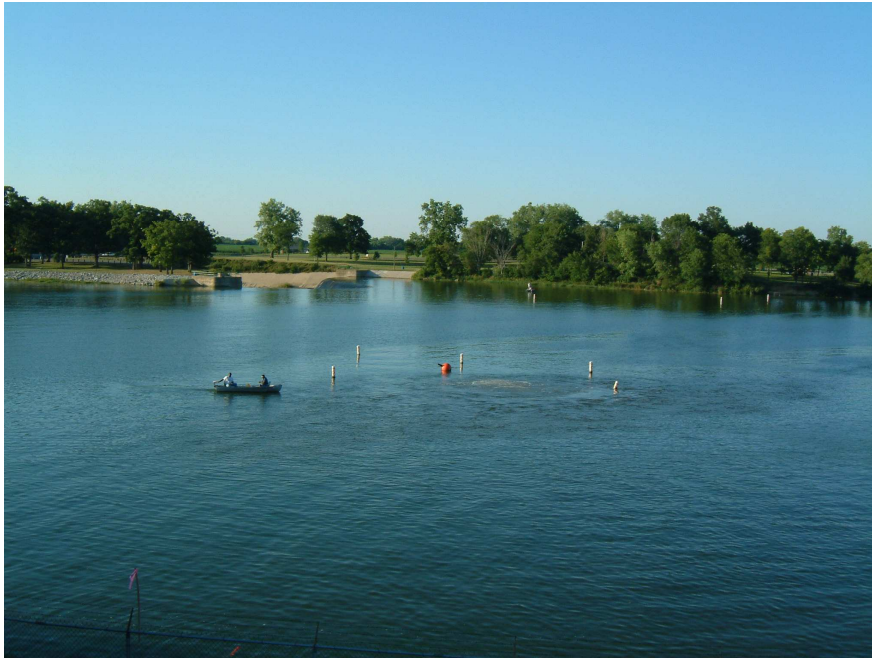
7
8
9 On June 20, 1996, destratifier units were placed on the bottom of Lakes
10 Bloomington and Evergreen. The units are designed to maintain adequate dissolved
11 oxygen levels in the lakes. The City of Bloomington installed the units as part of its
12 overall lake management program. The Illinois State Water Survey Office of Water
13 Quality Management recommended the system.
