Charleston Side-Channel Reservoir
Sedimentation Basin
Project Final Report

For
Illinois Environmental Protection Agency
Financial Assistance Agreement
Number 3190321

July 10, 2007

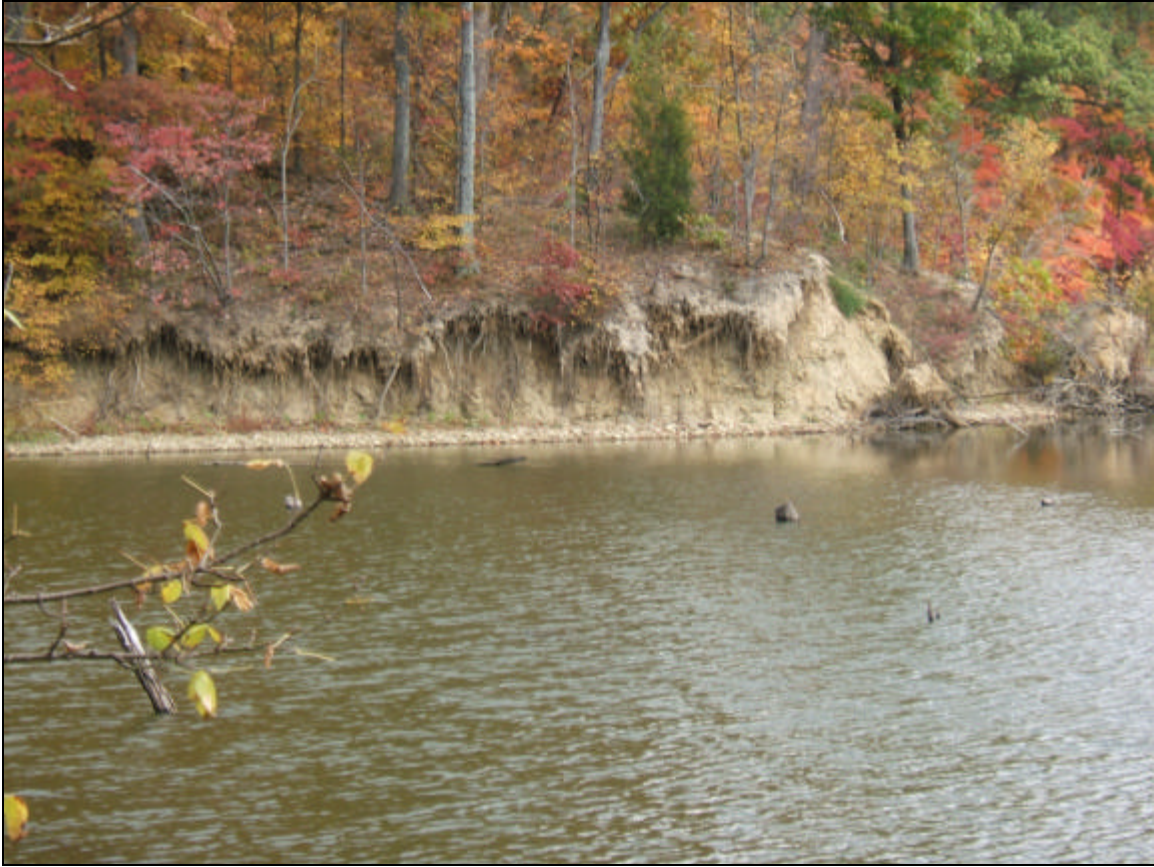
Figure 3. Pre-construction photo east shore of cove

The 2003 proposal called for the construction of a sedimentation basin at the CSCR. The basin would serve to trap nonpoint source pollution before it enters the CSCR. The original design called for the construction of a road to gain access to the proposed dam location. The construction method was modified to employ barge transport thus eliminating the need for a roadway. Because the shoreline and adjacent hillside were severely eroded on either side of the proposed dam, riprap areas were included in the project.

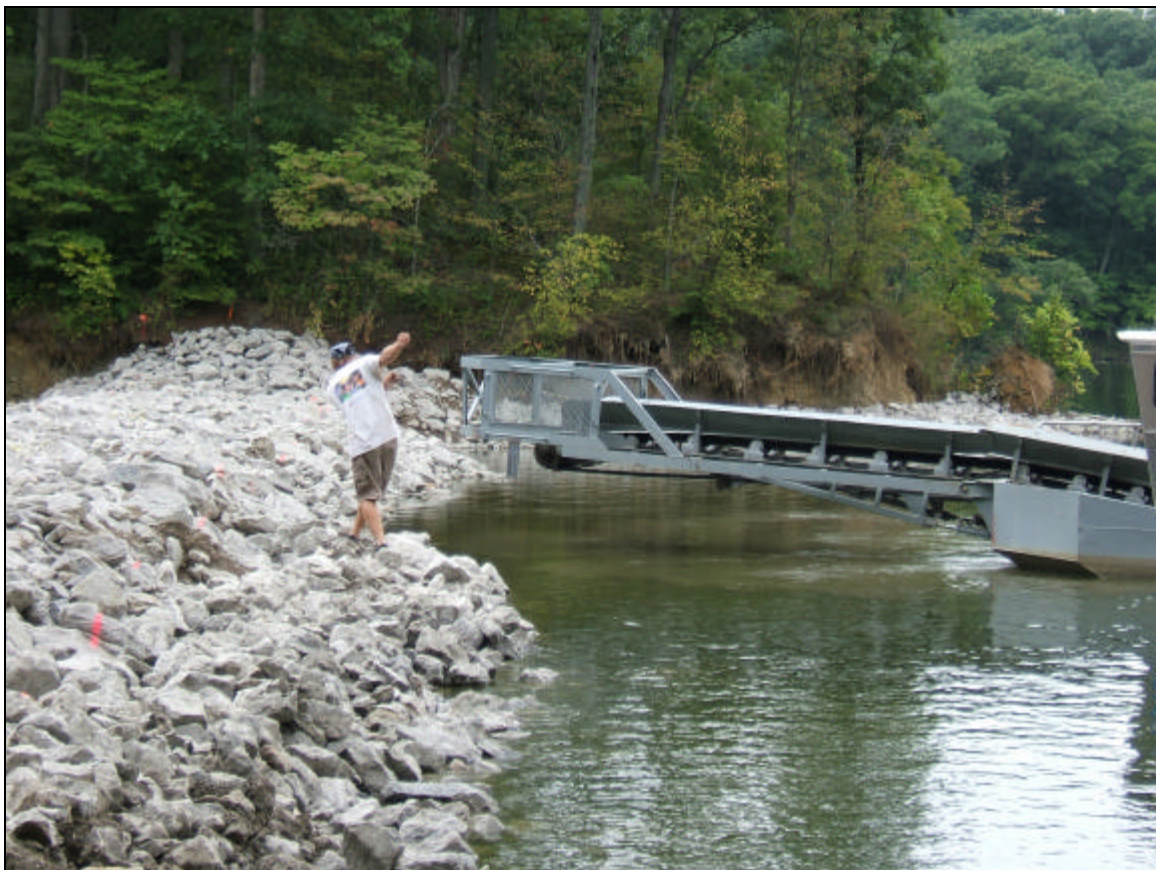
Figure 7. Barge building dam, shoreline work in background

During construction it was discovered that less RR3 rock was needed to construct the dam than had been estimated. This may have been due to two factors. One factor was that the length of the dam was shorter than had been determined during the planning stage of the project. In addition it appears that settling was less of a component than the original Natural Resource Conservation Services estimates had indicated. Since the contract for construction was based on tons placed and the RR3 was the same rock being used in the shoreline stabilization we elected to extend the shoreline work. The extended portion of the project is located east of the dam and along the north shore. While working in this area the contractor ran into an unusual problem for this reservoir. The slope of the near shore area was apparently too shallow for the contractor to reach the base of the eroded scarp. Instead of direct shoreline stabilization the contractor used the rock to build a breakwater. This distance from the middle of the top of the breakwater to the shore

ranged from 10 to 25 feet. This left a narrow channel of water between the shoreline and the backside of the breakwater. When supplementary funding was made available the breakwater was lengthened eastward.

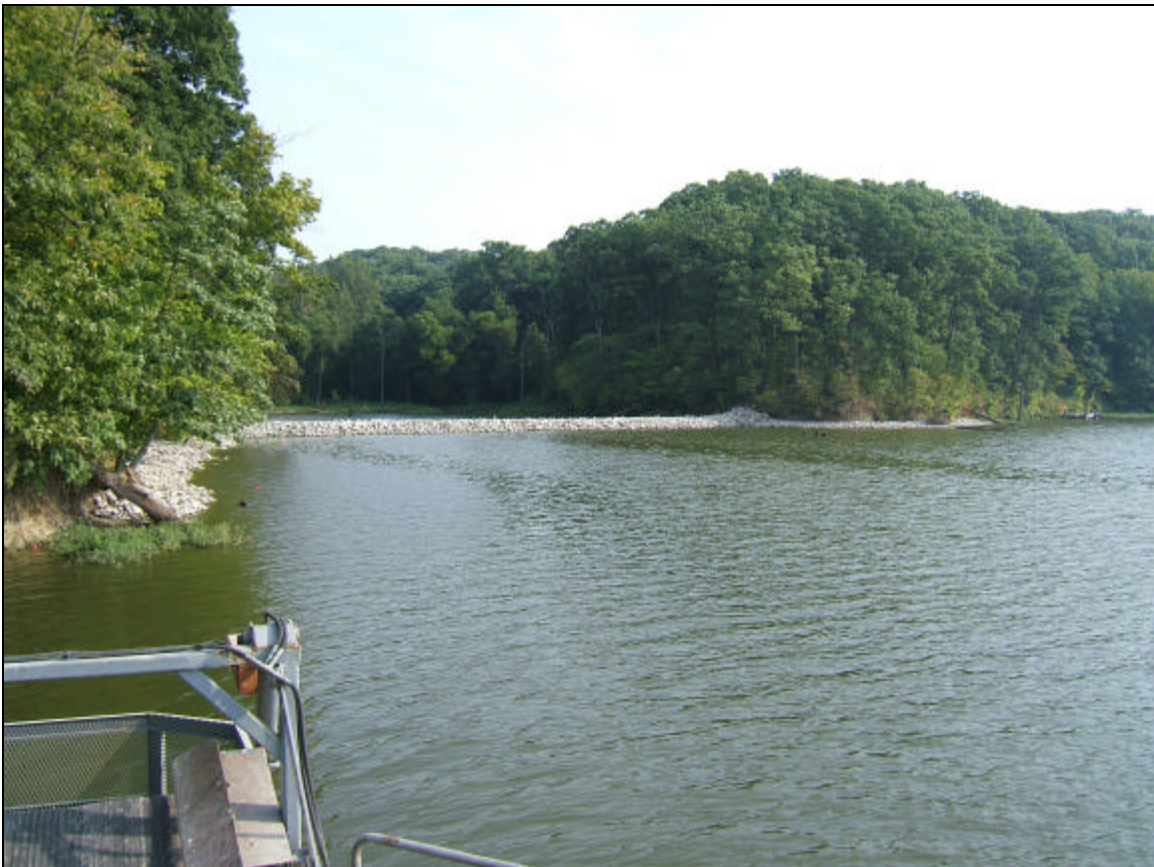
Figure 8. The Dam and Shoreline RipRap.

Photo shows the completed dam and some riprap. Note riprap was not yet finished on left side of photo.

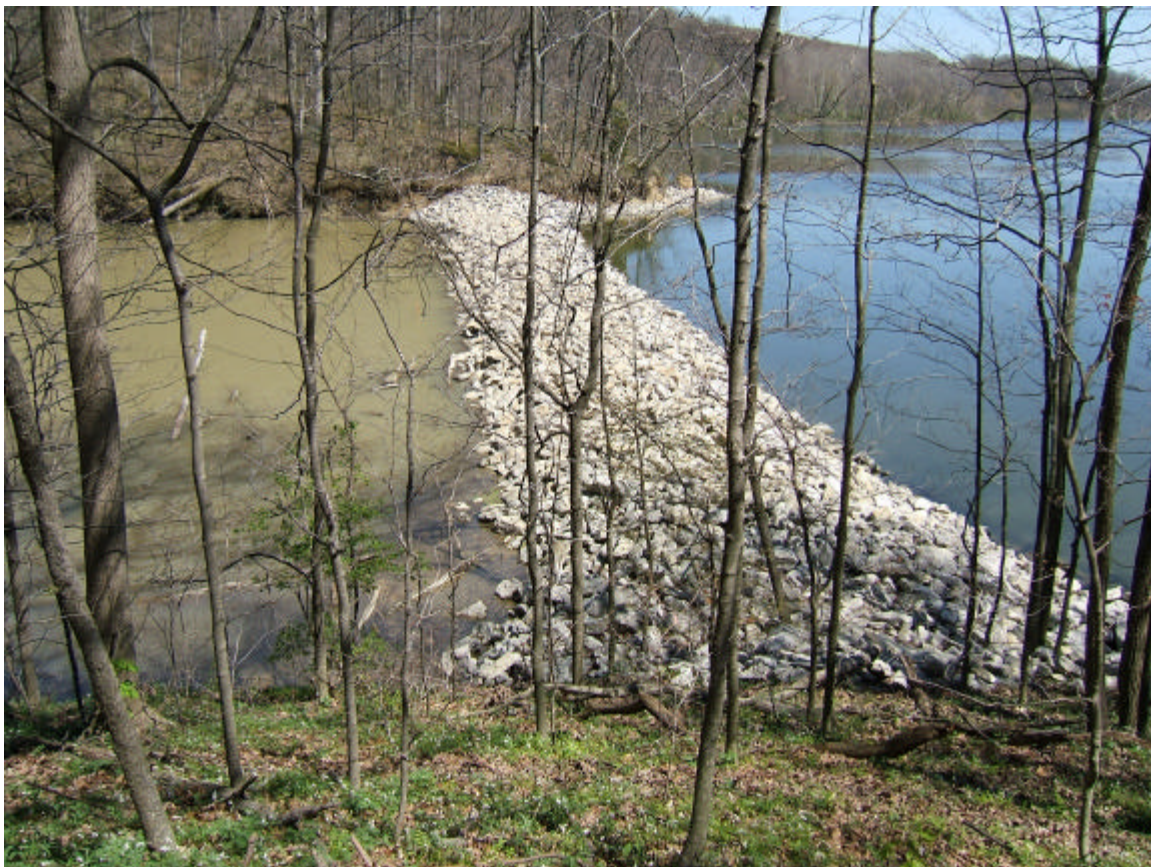
Figure 9. Basin and CSCR after April 2007 storm event

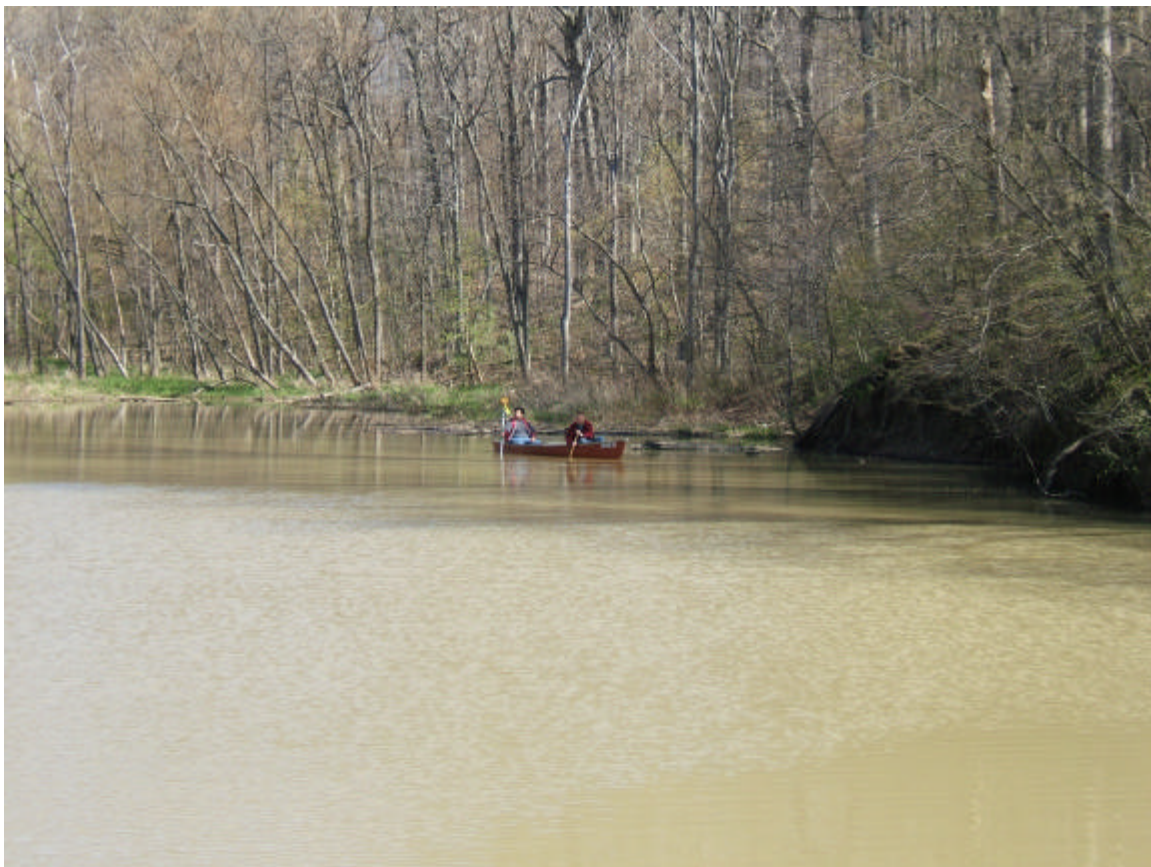
Figure 10. Survey crew working in the basin

Three permanent benchmarks have been established around the Charleston Side Channel Reservoir to aid with future surveying. The benchmarks were set in March of 2007. The surveying work was performed on April 16, 2007. The finished maps were delivered June 5, 2007. The results of this mapping work can be seen in Figure 11 and Appendix C.

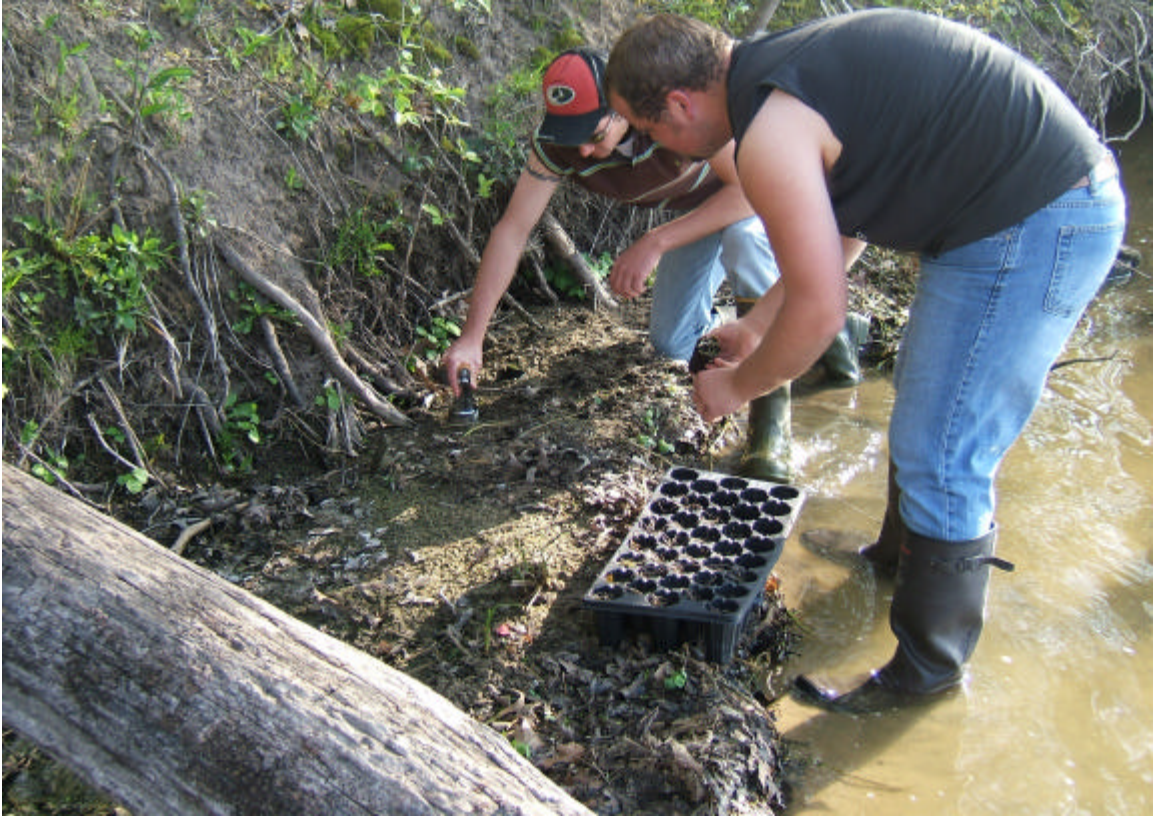
Figure 12. Planting aquatic vegetation behind breakwater

Plant material was purchased from JFNew of Walkerton, Indiana. Contact was first made with this company in 2005. The plant installation needs to be done during a time favorable to growing and after basin and riprap construction. The spring of 2007 became our target for planting. The order for the plants was made on February 21, 2007. The plant plugs and bulbs were received on April 9, 2007. A grow area was setup to maintain the viability of the material until we could plant it. This aquatic vegetation was planted on April 23 and 24. It was originally intended that \$1000.00 of aquatic vegetation would be planted. This was scaled back due to the limited amount of suitable planting space. Some areas would have had a very low probability of sustaining plant growth. Table 2, provides a list of plant material and cost. The labor for the planting involved 3 people over 2 eight-hour days. The operation involved the use of one pontoon boat, one canoe and one truck.

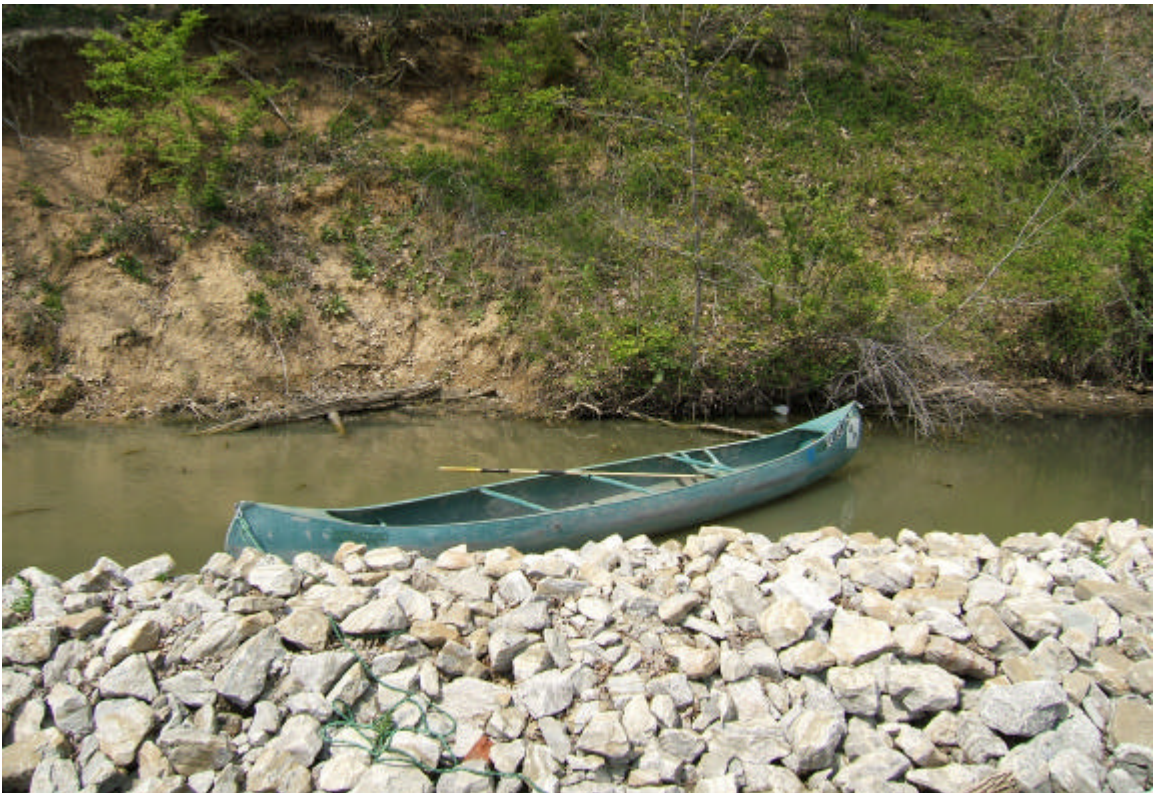
Figure 13. A portion of planting area behind breakwater
