CLEAN LAKES PROGRAM

Phase 1 Diagnostic Feasibility Study

GLENN SHOALS LAKE

CITY OF HILLSBORO, MONTGOMERY COUNTY, ILLINOIS

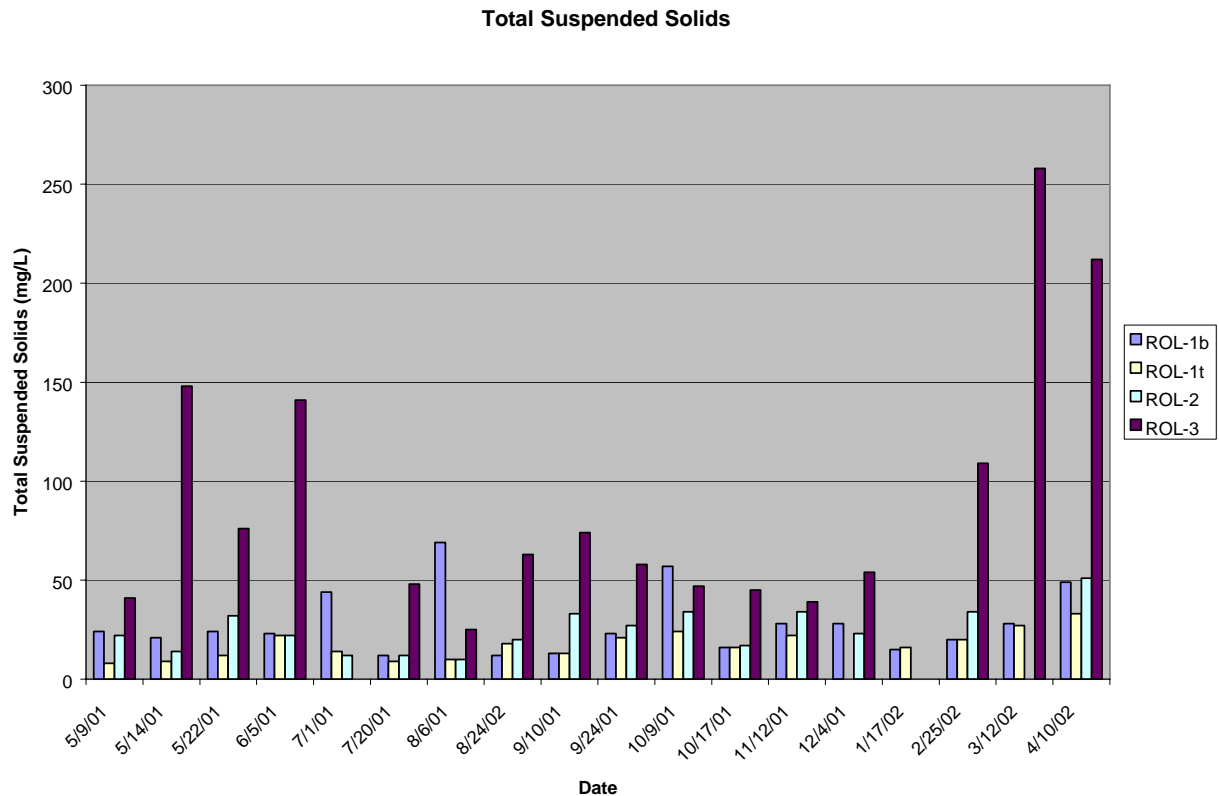
Figure 15 – Total Suspended Solids

include materials such as algae, decaying plant materials, minerals, and soil particles. Total suspended solids peaked 3/12/2002 at 258 mg/L at ROL-3 on the north end of the lake (Figure 15).

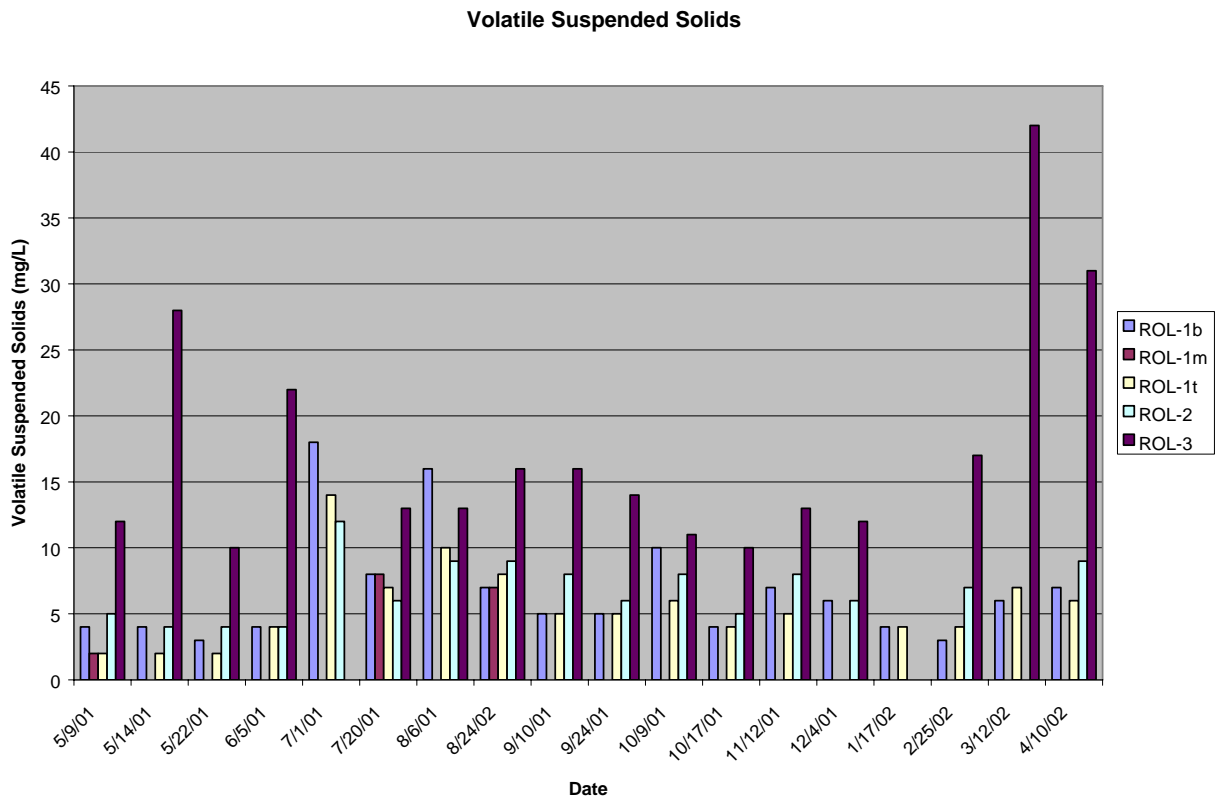
Figure 16 – Volatile Suspended Solids

Volatile suspended solids (VSS) is a measurement of only the organic material suspended in the water. This material would include algae, decaying plant material and all other organic material suspended in the water (Figure 16). VSS peaked on the same dates as TSS and NVSS and corresponded with, low Secchi depths and high chlorophyll *a* data (Figures 15, 16, 17, 18).

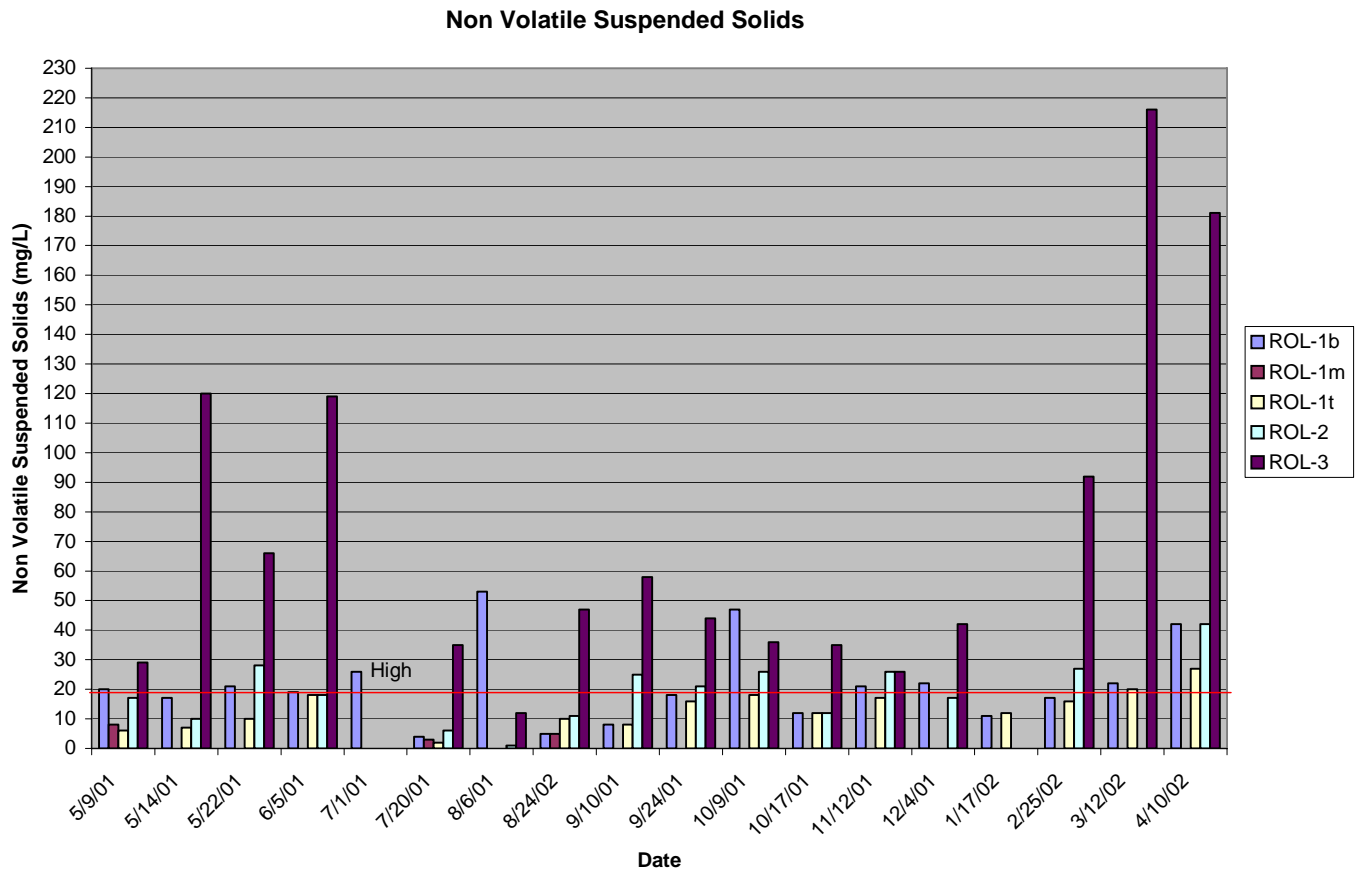
Figure 17 – Non Volatile Suspended Solids

Non-Volatile Suspended Solids (NVSS) is obtained by subtracting the VSS from the TSS. NVSS is the non-organic portion of TSS. NVSS is used by the IEPA as a parameter in their Aquatic Life Use Impairment Index (ALI). Lake site ROL-3 had higher concentrations of NVSS on most dates than the other sites (Figure 17).

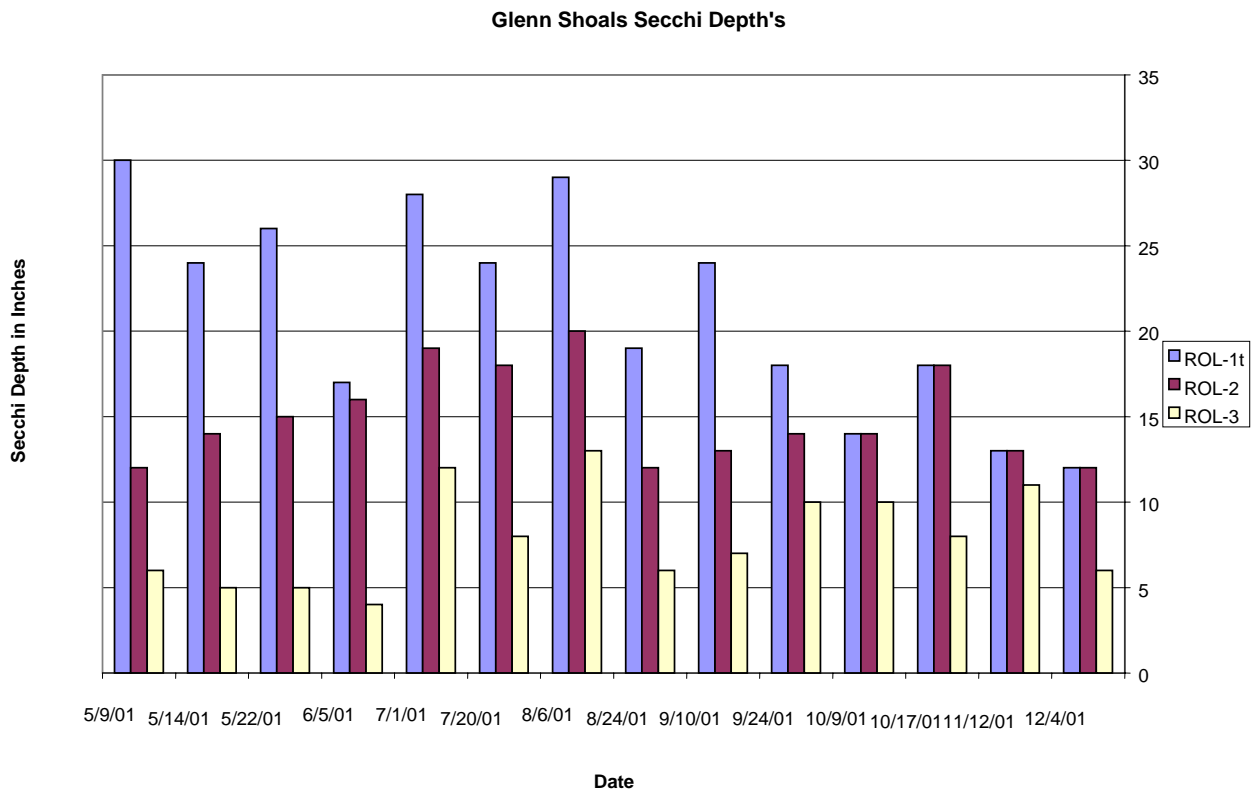
Figure 18 – Secchi Depth's

The Secchi disk is one of the most widely used tools to measure water clarity. Secchi transparency and color are used to determine criteria for lake water quality. The Secchi disk is a simple circular disk divided into alternate black and white quadrants. The disk is lowered into the water and the depth at which it can no longer be seen is the Secchi depth. It is one of the criteria in Carlson's Trophic State Index, which is used to determine the trophic status (Carlson 1977). Photosynthesis can generally occur at 2-3 times the Secchi depth (Kirschner 1995).

The turbidity as expressed by the Secchi depth readings (more turbid = shallower readings) is an indication of the combination of organic particles (mostly algae) and inorganic particles (mostly soil-clay) in the water column. Turbidity is an indication of a lake's health. High turbidity (shallow secchi readings) indicates poor health. This is a major problem with the lake (Figure 18).

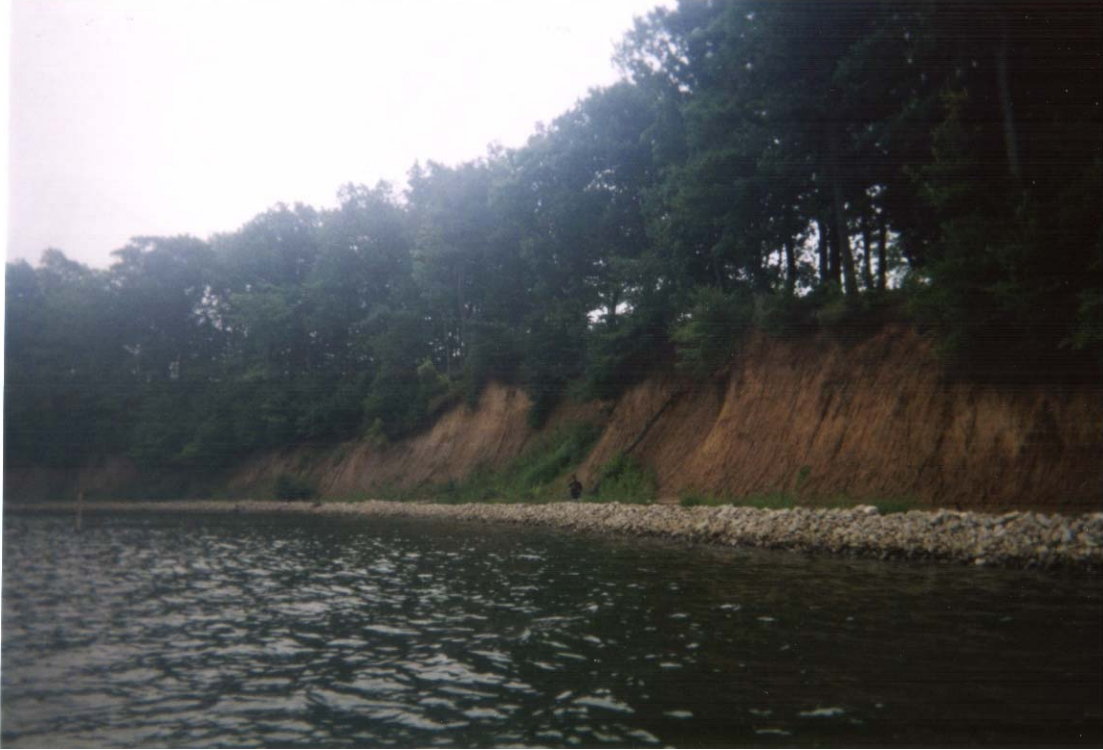
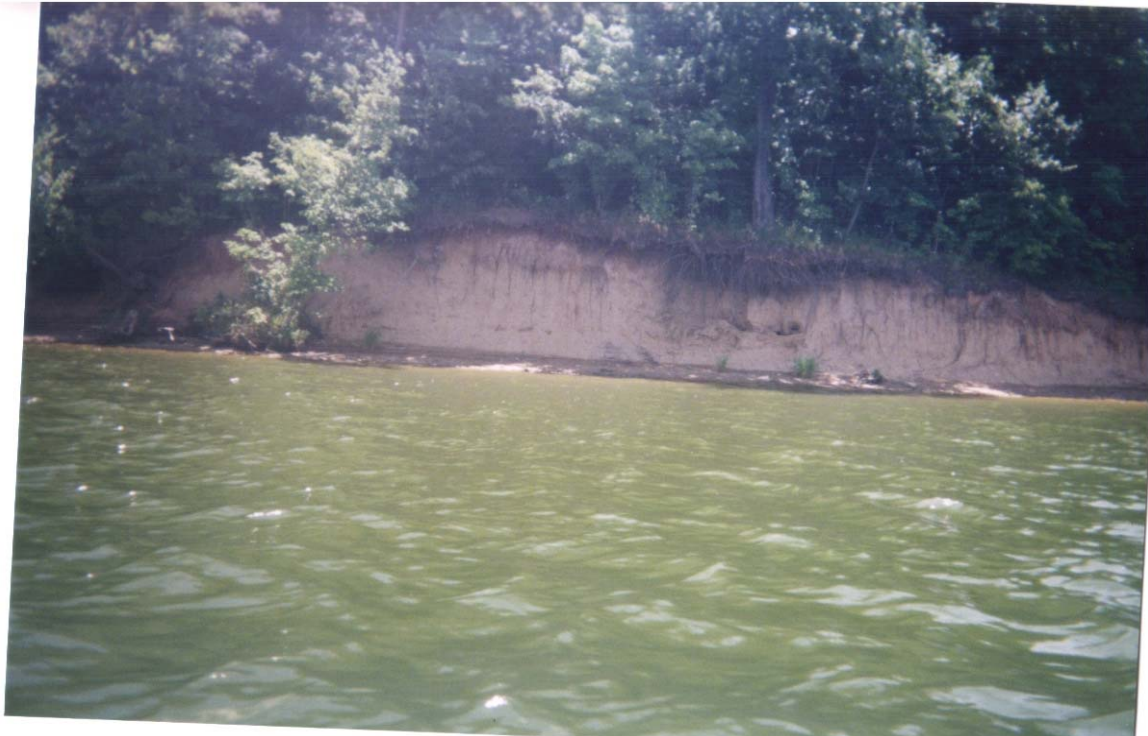
Figure 36 – Shoreline Erosion
Top – Riprap
Bottom – Without riprap

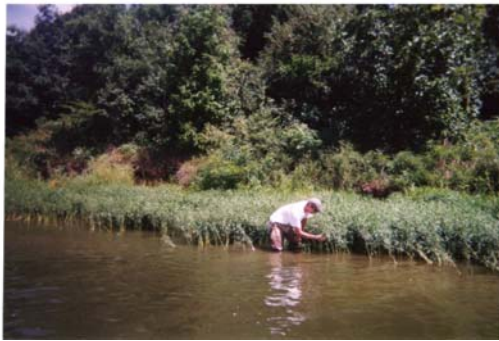
Figure 41 Macrophyte sampling sites

ZIES staff did an extensive macrophyte survey during July and August 2001. This survey consisted of collecting and mapping macrophytes throughout the lake. The lake was divided into sixteen areas where macrophytes were identified. These areas were labeled A-P. (Figure 41) Plants in these areas were identified by their scientific name (Steyermark 1999). The density of each type of plant was identified as sparse, moderate or

dense. This information was used to generate a map and table (Figure 41 and Table 30).

There were three major areas within the lake that contain a large amount of aquatic vegetation. These areas are designated B, M, and N on Figure 41. All of the three areas have several things in common the first being that they are all coves where major tributaries feed into the lake. Second is that the depth in these areas is mainly shallower

Area N is the location of the Northern most tributary on the lake. The creek channel is still prevalent through the center of this cove being the only area free of vegetation. The remainder of the cove is covered with a dense mat of *Jussiaea repens* and *Lemna minor*. The east shoreline of this area is vegetated with *Acer rubrum*, *Cephalanthus occidentalis*, and *Salix interior*. This shoreline is rather narrow before rising into upland habitat. The west side is a large flat, barely above the water level at normal pool, vegetated mainly by *Leersia oryzoides* but also supporting many other wetland species.

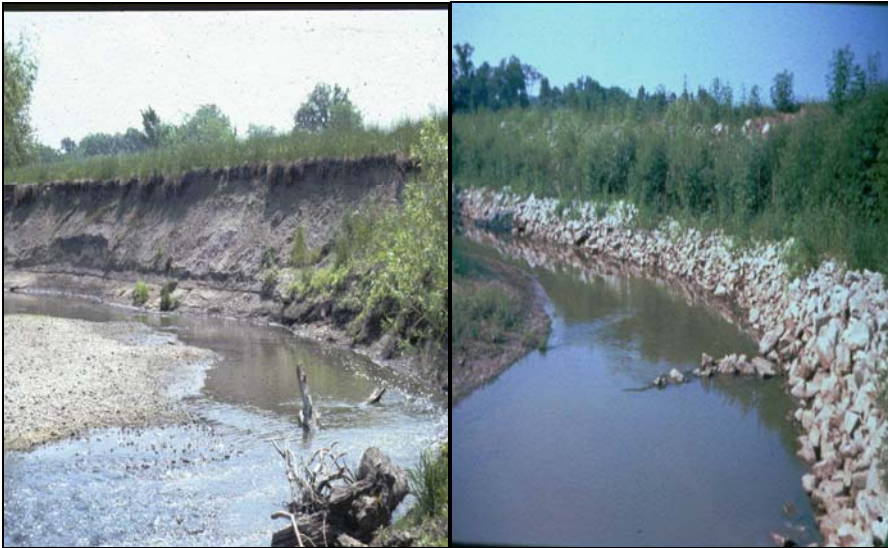
Figure 44 - Rip-Rap Stabilization

Stream banks can be a major contributor of sediments to the lake. The IEPA 303(d) report lists stream bank erosion as a major cause of impairment. The NRCS has identified stream bank erosion as a major contributor of sedimentation in watersheds with similar characteristics as those found in the Glenn Shoals watershed. The stabilization of 2,000 feet of stream banks using rock riffles, rip-rap, bend-way weirs, peak stone etc. throughout the watershed will have a significant impact on sediment reduction (Figure 44, 45). Estimated cost for this alternative is \$150,000.

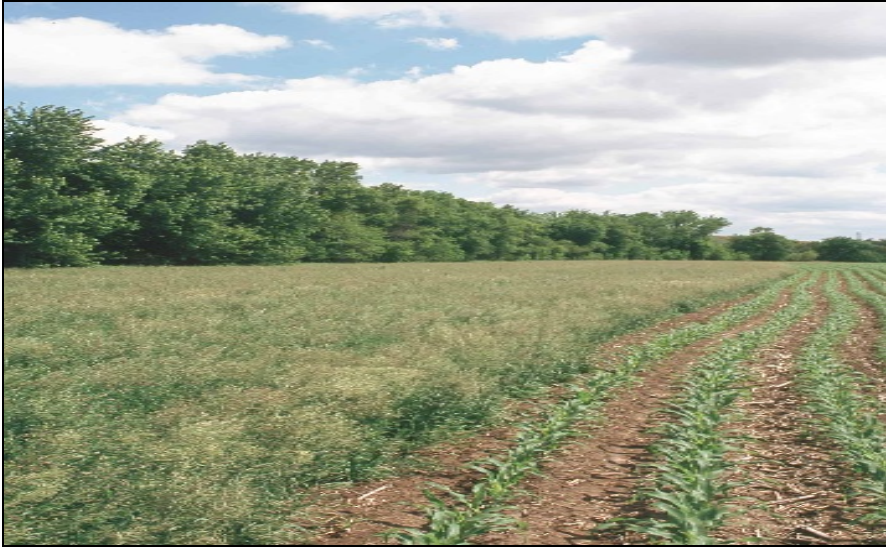
Figure 46 – Field Borders

Soil testing should result in more appropriate use of fertilizers and a reduced nutrient load for the lake. The theory is that when farmers realize through required soil tests that they are applying excessive expensive nutrients they will opt to reduce the amount of fertilizer applied. Since the main concern is for the quantity of phosphorus that is being used, perhaps a government program could be established that would pay for the soil testing for at least the phosphorus. This program would be administered through the NRCS office. With a majority of the area farmers participating, the nutrient load to the lake should be reduced by 10%. This will be accomplished through programs conducted by NRCS or the University of Illinois Extension Office at no cost to the city. (Figure 46)

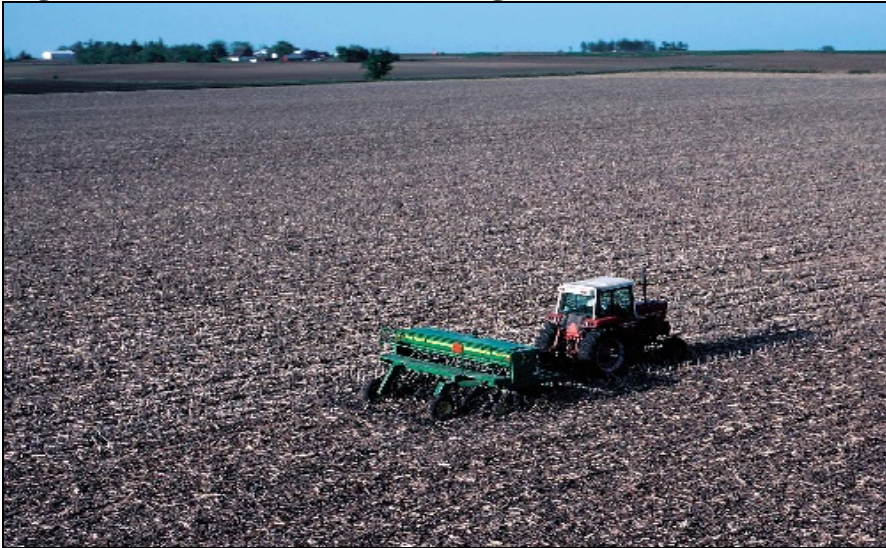
Figure 47 – Conservation Tillage

Conservation tillage—Conservation practices can significantly reduce the amount of sediments entering the lake. No-till planting, by utilizing crop residue, will significantly reduce erosion and maintain or improve soil organic matter. (Figure 47)

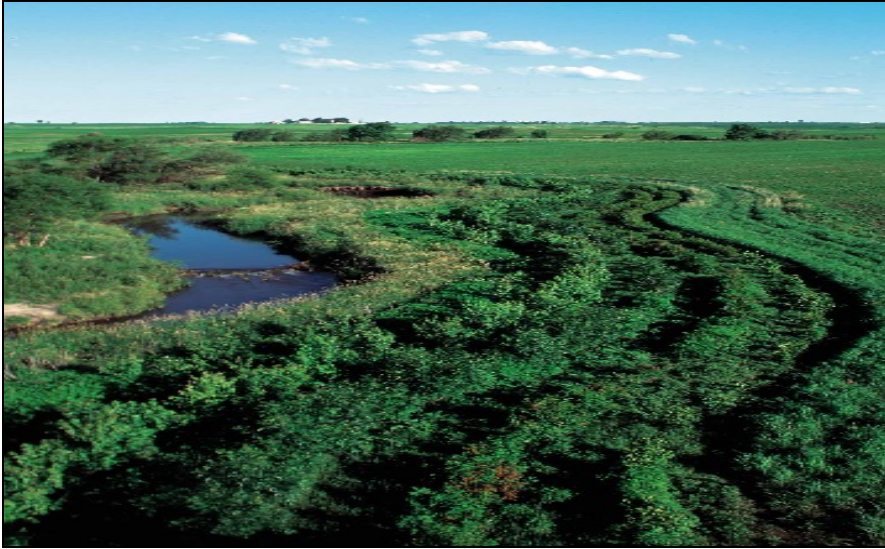
Figure 48 – Riparian Buffers

subsidies which will pay farmers to implement them. (Figure 48) Funding would be through existing Federal programs administered through the NRCS office.

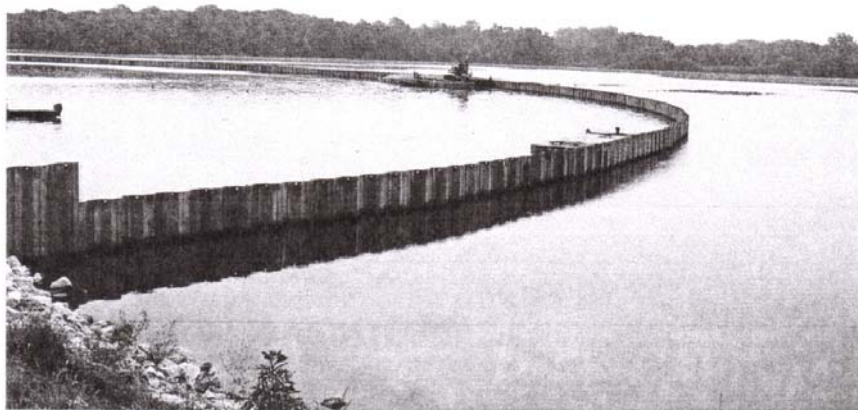
Figure 52 - In-Lake Control Structure at Meisenheimer Road

It would be possible to control the sedimentation of the lower portion of the lake by building this in lake control structure (Figure 52) at Meisenheimer Road. It would have two major benefits. The first benefit would be that the structure would reduce the amount of sediment in the south end of the lake and act as a sediment control structure. With an estimated trap efficiency of 50%, 21,000 metric tons of sediment would have been eliminated from the lake south of Meissenhimer Road during the year of the Clean Lakes study period.

Because of the size and location the in lake control structure would be highly efficient however only the two larger streams would be impacted. There would be no affect on ROL04 and ROL05. A negative affect will be that the structure would effectively divide the lake into two smaller lakes or eventually a lake and a wetland. Thus, in time the upper portion of the lake would become a wetland. The estimated cost for this 690 foot long structure would be \$572,000 for the structure and \$60,000 for engineering and permitting.

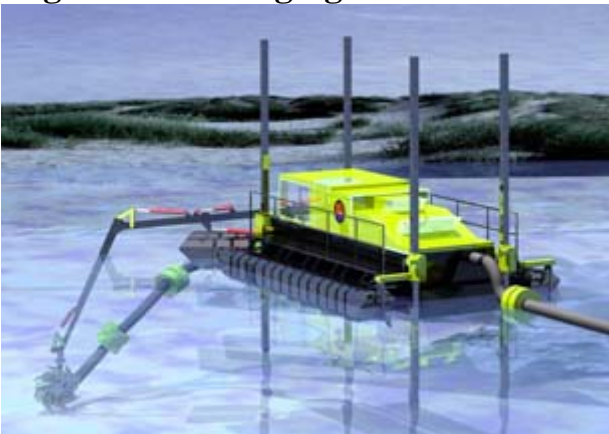
Figure 54 - Dredging

Dredging 61 acres at the north end of the lake, north of the fawn creek cove, an additional 5 feet of depth would increase the volume of the lake (Figure 54). It would also add more recreational area to the lake. Care should be taken not to destroy existing wetland and wildlife habitat. Estimated costs are \$4,871,460 for the dredging of 492,067 cubic yards. Considerations for finding an appropriate location site for the dredged materials along with transportation the material to site must be further evaluated.
