Rayse Creek Watershed Management Plan

RAYSE CREEK WATERSHED MANAGEMENT PLAN

Prepared for
Illinois Environmental Protection Agency

Department of Forestry
Southern Illinois University Carbondale
Research Publication No. NS-019

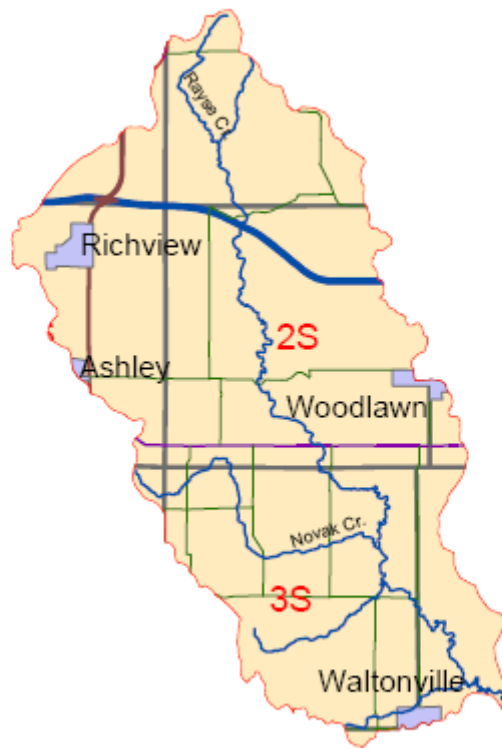
Figure 1. Rayse Creek watershed boundary
