IEPA/BOW/07-027

SOUTH FORK SANGAMON RIVER/LAKE TAYLORVILLE WATERSHED TMDL REPORT

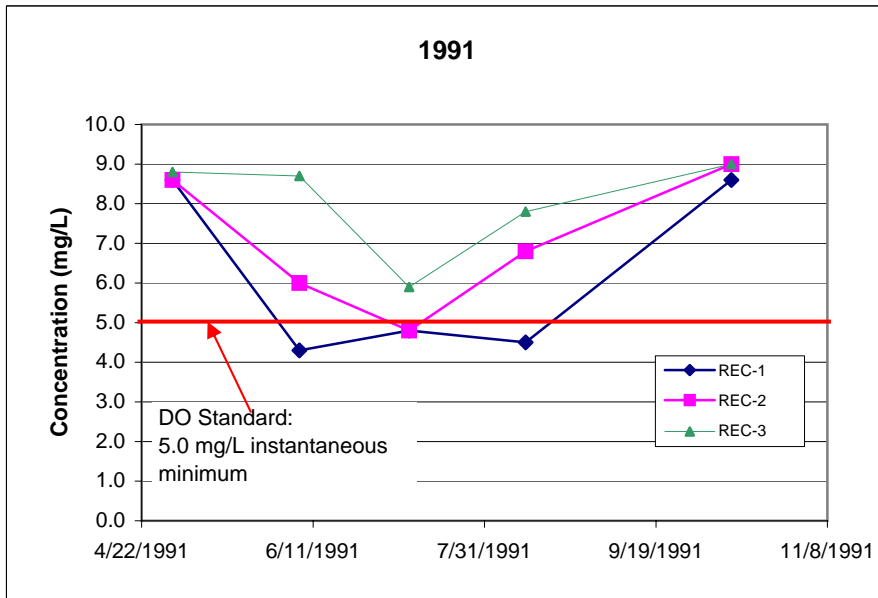
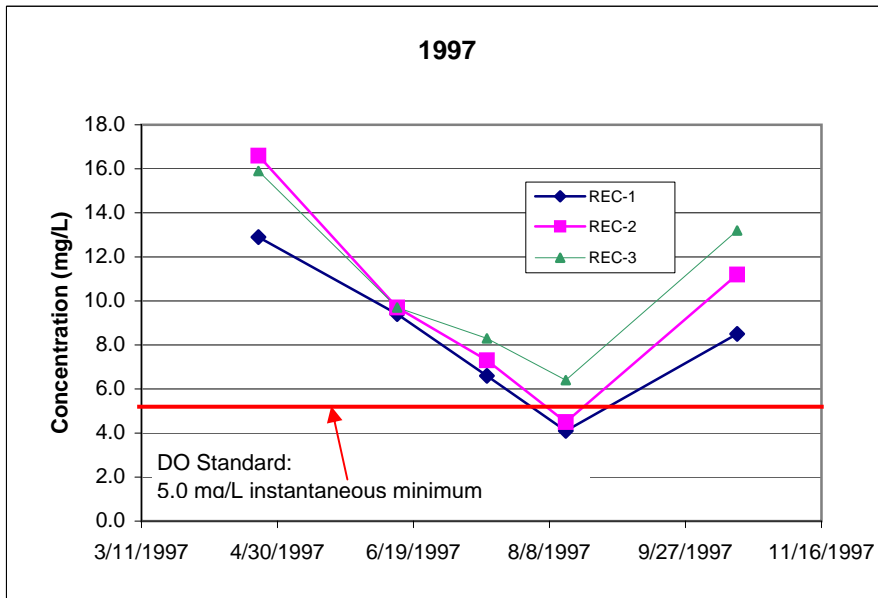
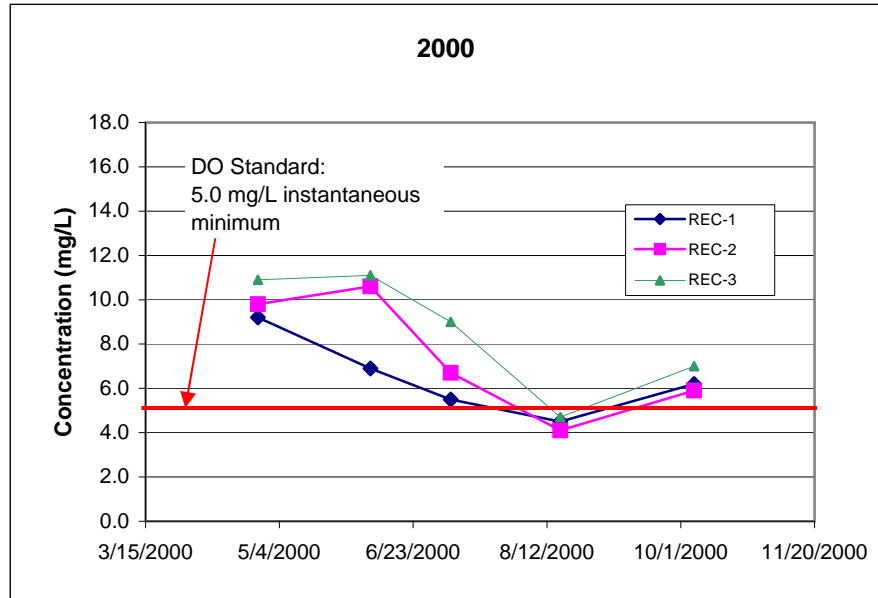
**Figure 5-3:
Lake Taylorville
DO Concentrations**

The annual averages for DO at all three sites as well as the lake average are not in violation of the DO standard at one-foot depth during any sampling year. Figure 5-3 shows DO sampling results at one-foot depth over time. In 1997 and 2000, DO violations occurred during the month of August.

Year	REC-1		REC-2		REC-3		Lake Taylorville	
	Data Count; Number of Violations	Average	Data Count; Number of Violations	Average	Data Count; Number of Violations	Average	Data Count; Number of Violations	Average
1991	5; 3	6.2	5; 1	7.0	5; 0	8.0	15; 4	7.1
1994	5; 1	7.1	5; 0	7.2	5; 0	6.4	15; 1	6.9
1997	5; 1	8.3	5; 1	9.9	5; 0	10.7	15; 2	9.6
2000	5; 1	6.5	5; 1	7.4	5; 1	8.5	15; 3	7.5

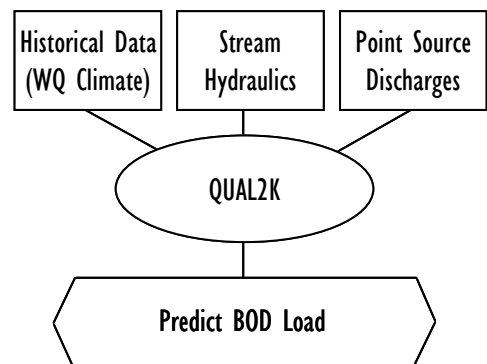
Schematic 1

The QUAL2K model was used to develop the DO TMDL for segment EO13 of South Fork Sangamon River. QUAL2K is a stream water quality model that is one-dimensional and applicable to well-mixed streams. The model assumes steady state hydraulics and allows for point source inputs, diffuse loading and tributary flows. Historic water quality data, observed hydraulic information, and point source discharge data were coupled with model defaults to predict the external oxygen-demanding load to the system.

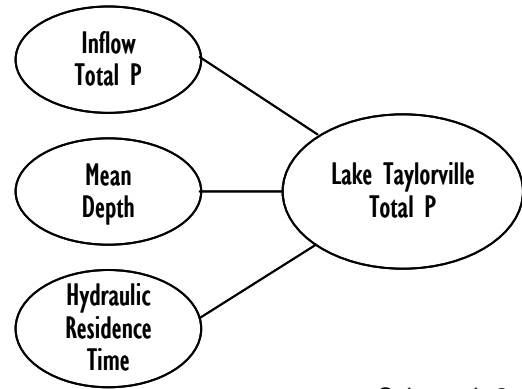
Schematic 2
BATHTUB Model Schematic

To develop the total phosphorus TMDL for Lake Taylorville, a model called BATHTUB was utilized. Model selection was discussed in the Stage One report.

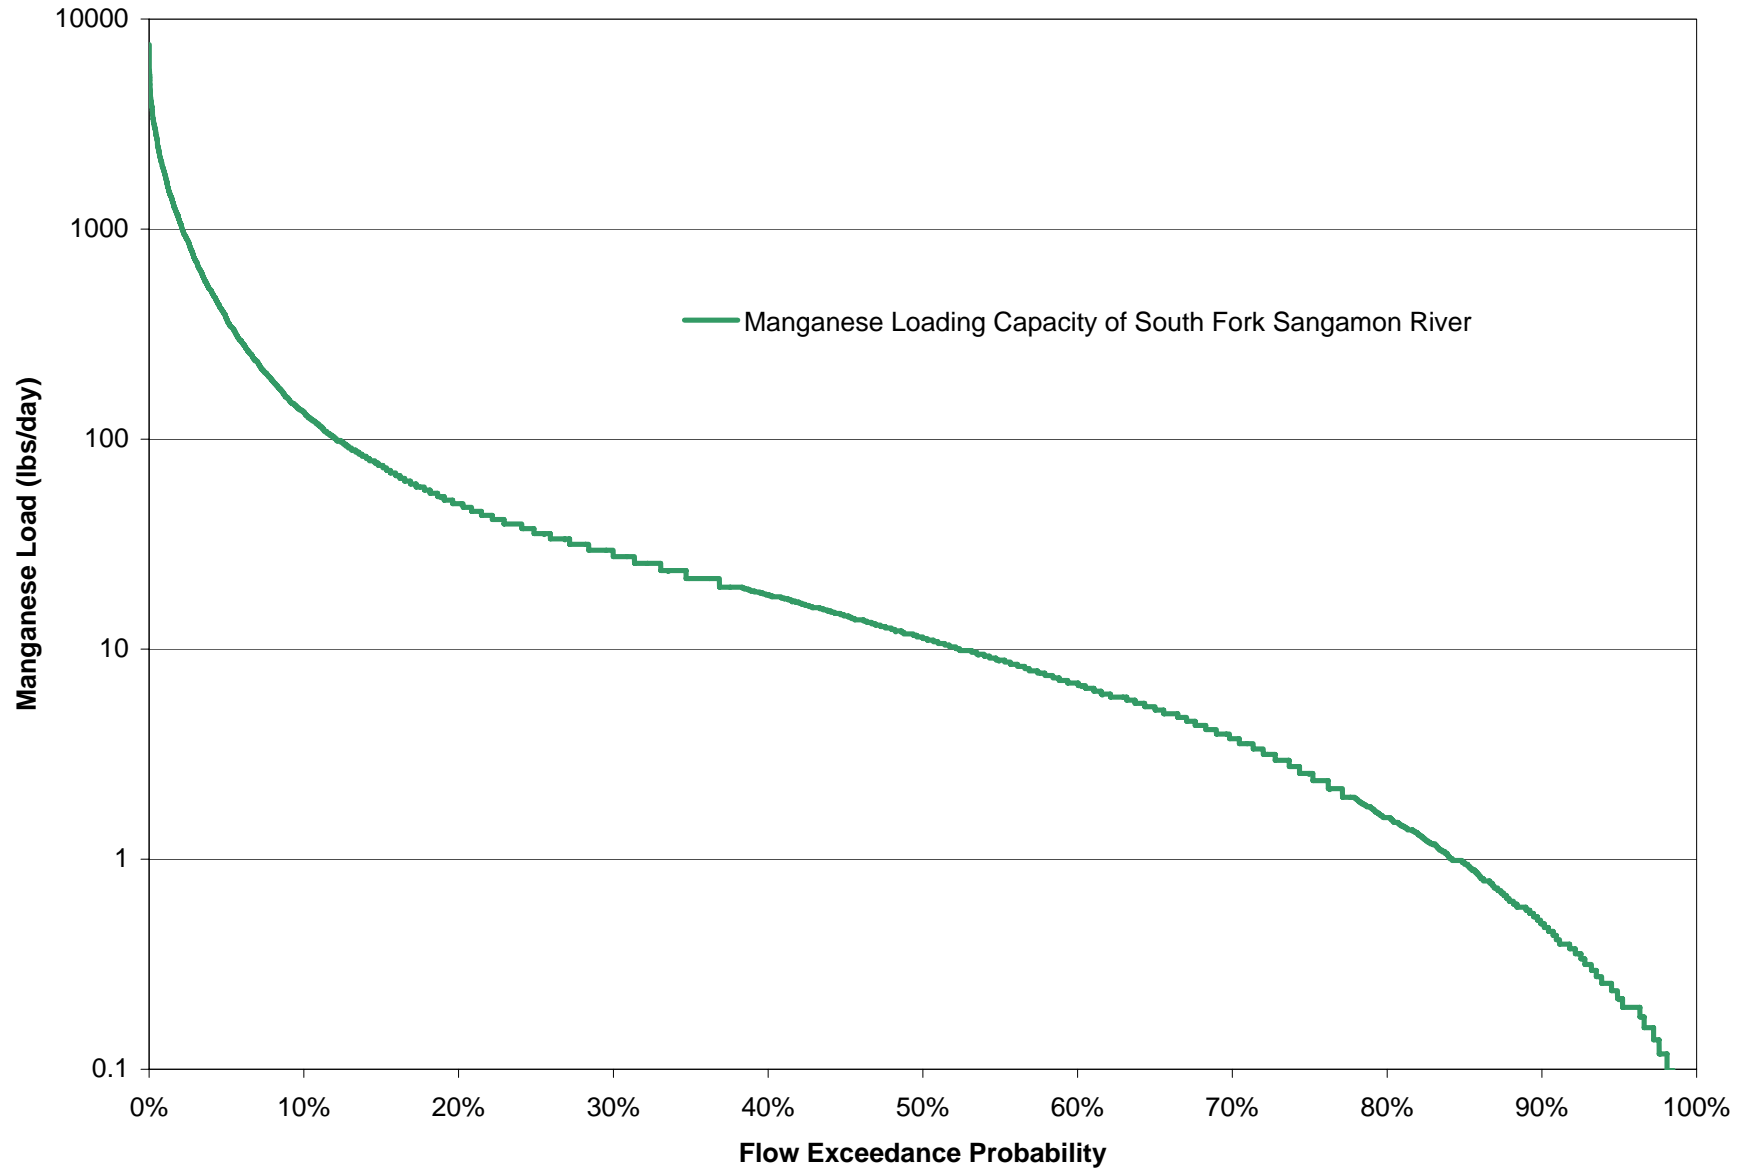
APPENDIX H:
MANGANESE ANALYSIS
SOUTH FORK SANGAMON RIVER
