Buffalo Creek Watershed-Based Plan December 2015

Buffalo Creek Watershed Plan

**Buffalo Creek Clean Water Partnership
and
Lake County Stormwater Management Commission**
500 W. Winchester Road
Libertyville, IL 60048

Cardno

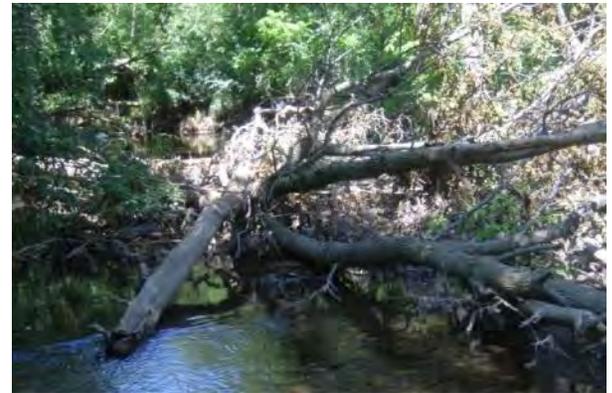
Photo of a stream reach that fails the debris load test in the Buffalo Creek Watershed, courtesy of SMC.

In addition to sediment, most streams transport some amount of debris (organic material typically originating outside the stream itself, such as tree limbs, brush and leaves). Because debris transport is a naturally-occurring stream process, some debris can provide habitat and contribute to a diverse in-stream environment. However, too much debris can be problematic and may result in large debris jams, causing backwater flooding and sediment deposition. Debris jams can also cause erosion of the streambanks which can lead to damage of riparian lands and property. It is not uncommon for streams that have a high degree of streambank erosion to also have high debris loads as trees along the stream banks are undercut by erosion and fall into the stream channel.

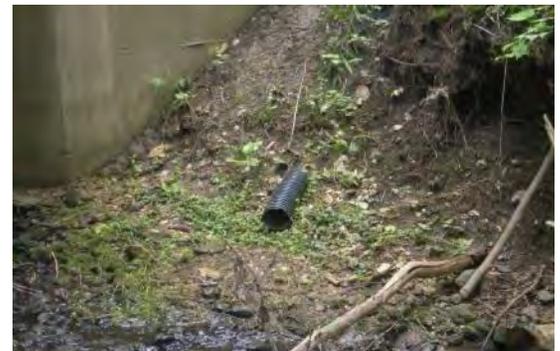
Photo of a drainage tile in the Buffalo Creek Watershed, courtesy of SMC.

Problem discharge points in the Buffalo Creek Watershed contribute to streambank erosion and the transport of excess sediment and associated nutrients to the stream channel. The location of these points is shown in
