Bureau of Land – Field Operations Section  
**Inspection Report**

<b>BOL ID:</b>	0390055036	<b>Region:</b>	Champaign
<b>USEPA ID:</b>	Not Applicable	<b>County:</b>	DeWitt
<b>Site Name:</b>	Clinton Landfill 3	<b>Phone:</b>	217-935-8028
<b>Address:</b>	9550 Heritage Rd	<b>Latitude:</b>	Not Available
<b>City/State/Zip:</b>	Clinton, IL 61727-2819	<b>Longitude:</b>	Not Available
<b>Permit No(s):</b>	2005-070-LF, 2018-007		
<b>Regulated As:</b>	811 Landfill		
<b>Operational Status:</b>	Operating

<b>Inspection Type</b>	Part 811 Landfill Inspection
<b>Inspection Date</b>	1/9/2018
<b>Inspector(s)</b>	Burger, Dustin
<b>Person(s) Interviewed</b>	David Bryant
<b>Previous Inspection Date</b>	10/26/2017

A combination compliance and pre-operational inspection was conducted at this permitted landfill on January 9, 2018. The pre-operational inspection was pursuant to Permit Log 2018-007 for a new 7.9-acre cell designated as 7A. No violations were found and the new cell is ready to receive waste.

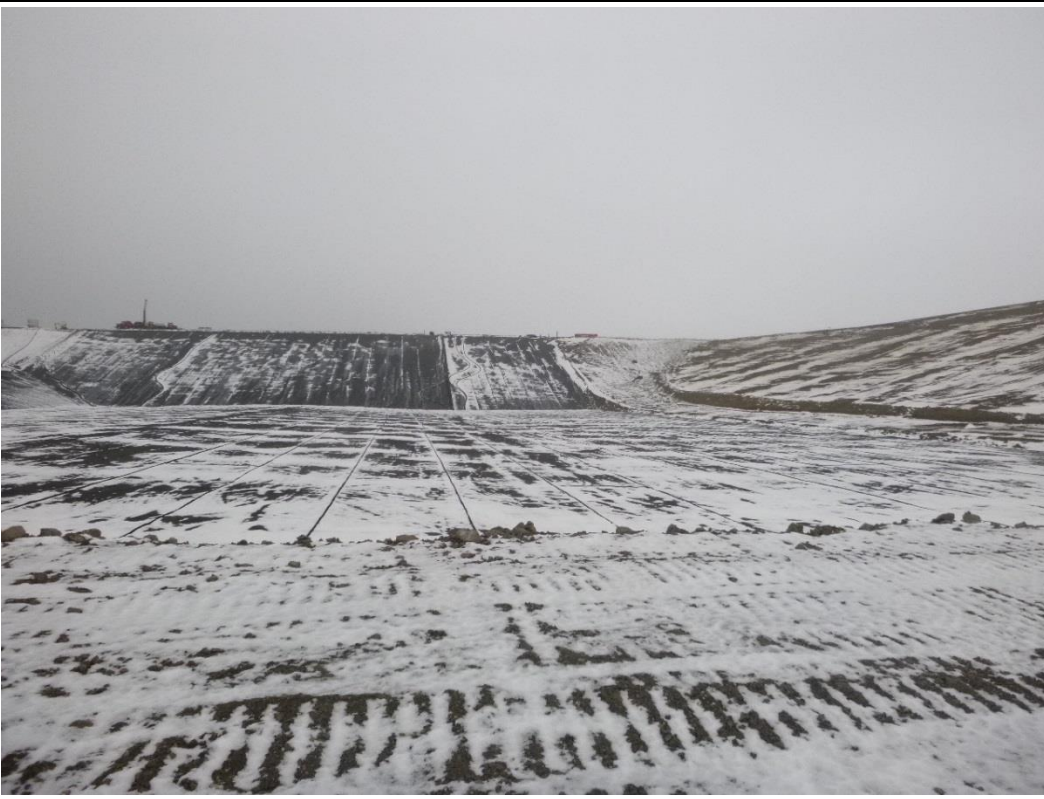
Photo ID: 1  
Photo Date: 1/9/2018  
Photo Time: 11:50:18  
Direction: West  
Taken By: Dustin Burger

We started the inspection at Cell 7A. The new cell is approximately 7.9 acres of newly constructed landfill disposal area. The cell is the last cell to be constructed on the west side of the landfill and connects the MSW cells 1, 3, and 5 to the chemical waste unit on the southwestern corner of the landfill. The construction for Cell 7 has been completed. The clay liner was finished and liner crews were busy installing the HDPE plastic liner during my last inspection. The leachate collection pipes and leachate drainage system were now installed (photos 1-2, 5). One of the distinguishing features of the new cell is the large berm between the new cell and the chemical waste unit to the south.

Cell 7A

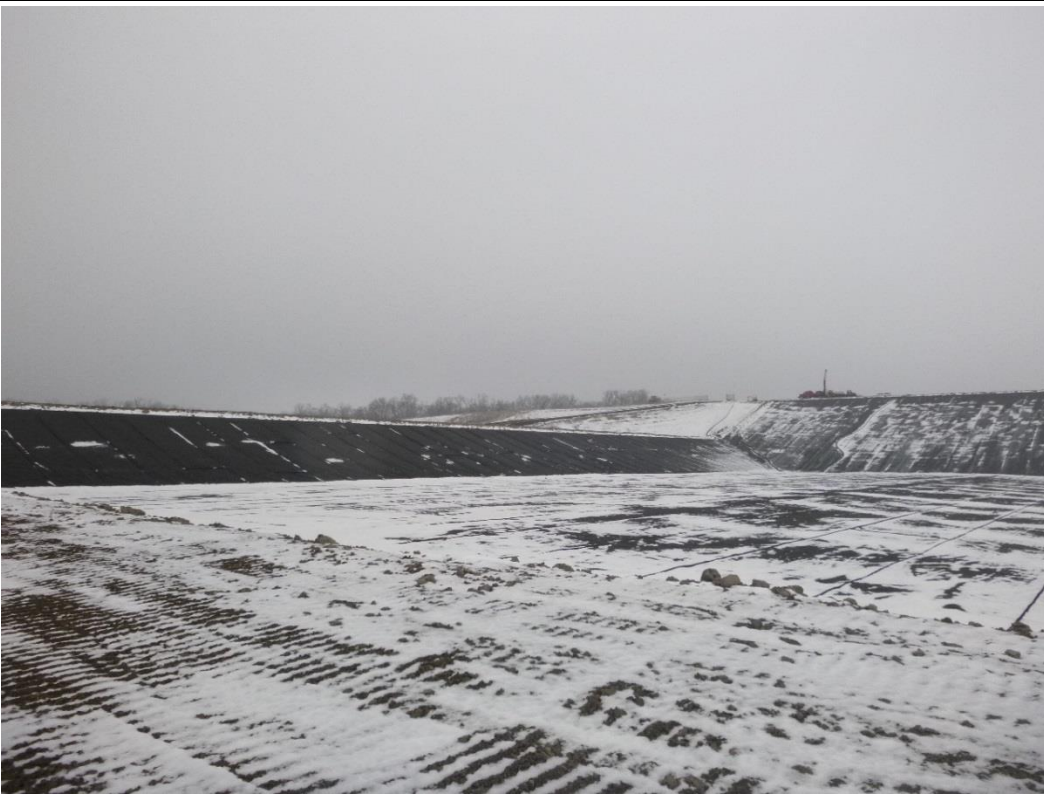
Photo ID: 2  
Photo Date: 1/9/2018  
Photo Time: 11:50:24  
Direction: West  
Taken By: Dustin Burger

Cell 7 A

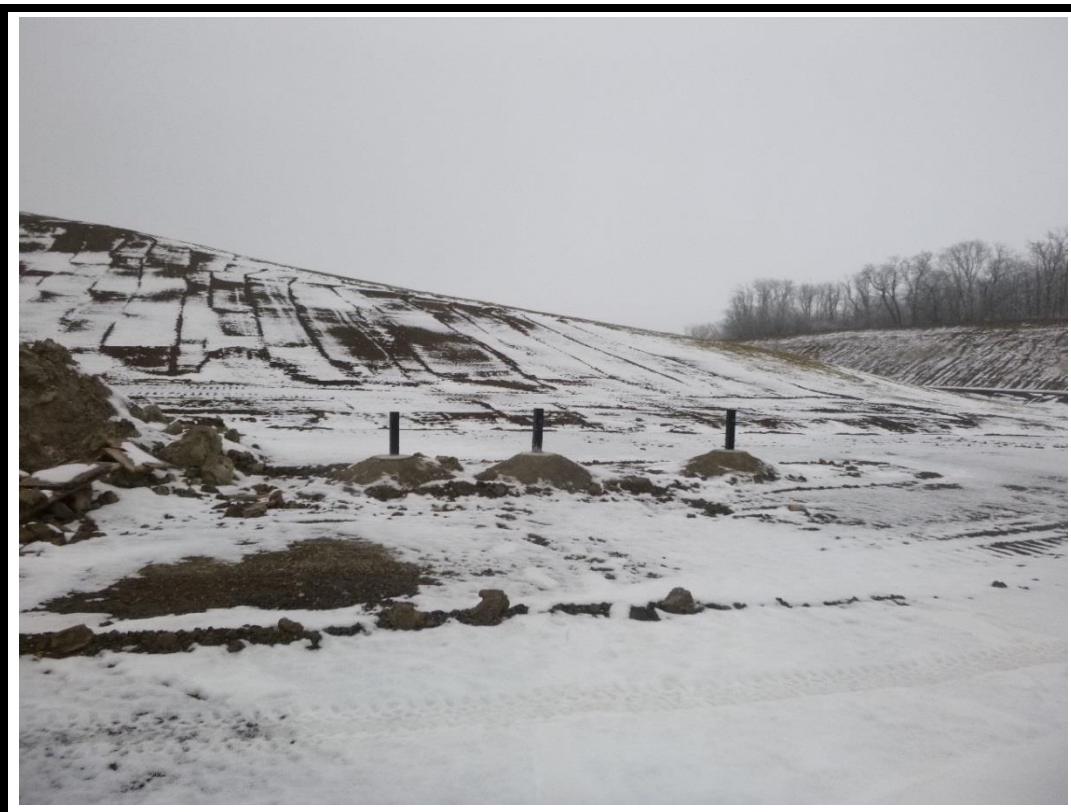
Photo ID: 3  
Photo Date: 1/9/2018  
Photo Time: 11:51:35  
Direction: North  
Taken By: Dustin Burger

The groundwater wells between the new Cell 7 and Cell 5 were replaced after the older wells were damaged by a giant roll of fiberglass textile that rolled down the landfill slope and hit the wells (photo 3).

New groundwater wells.  
Replaced after a roll of textile  
destroyed the previous wells.

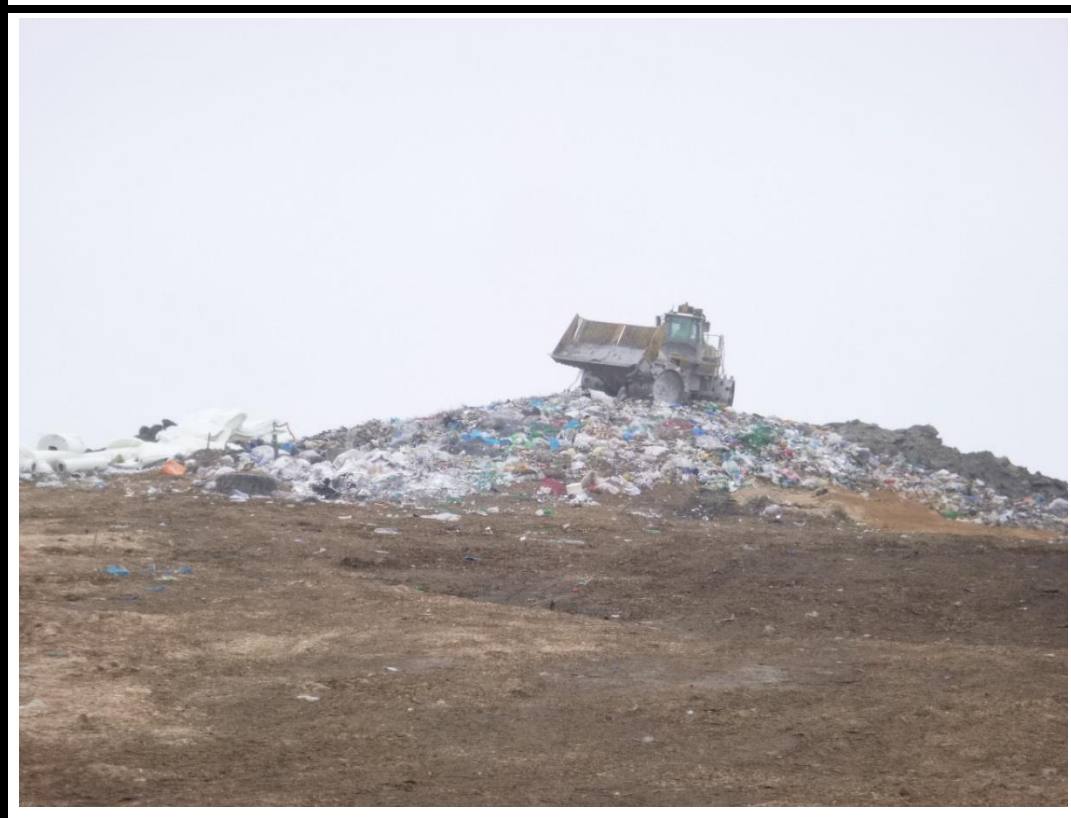
Photo ID: 4  
Photo Date: 1/9/2018  
Photo Time: 11:56:04  
Direction: North  
Taken By: Dustin Burger

The active area was in Cell 5 as part of a new lift of waste across the top of the landfill. The area was accepting general municipal waste. I watched a few trucks arrive and dump, looking for any banned materials, but found none (photo 4).

Active Area

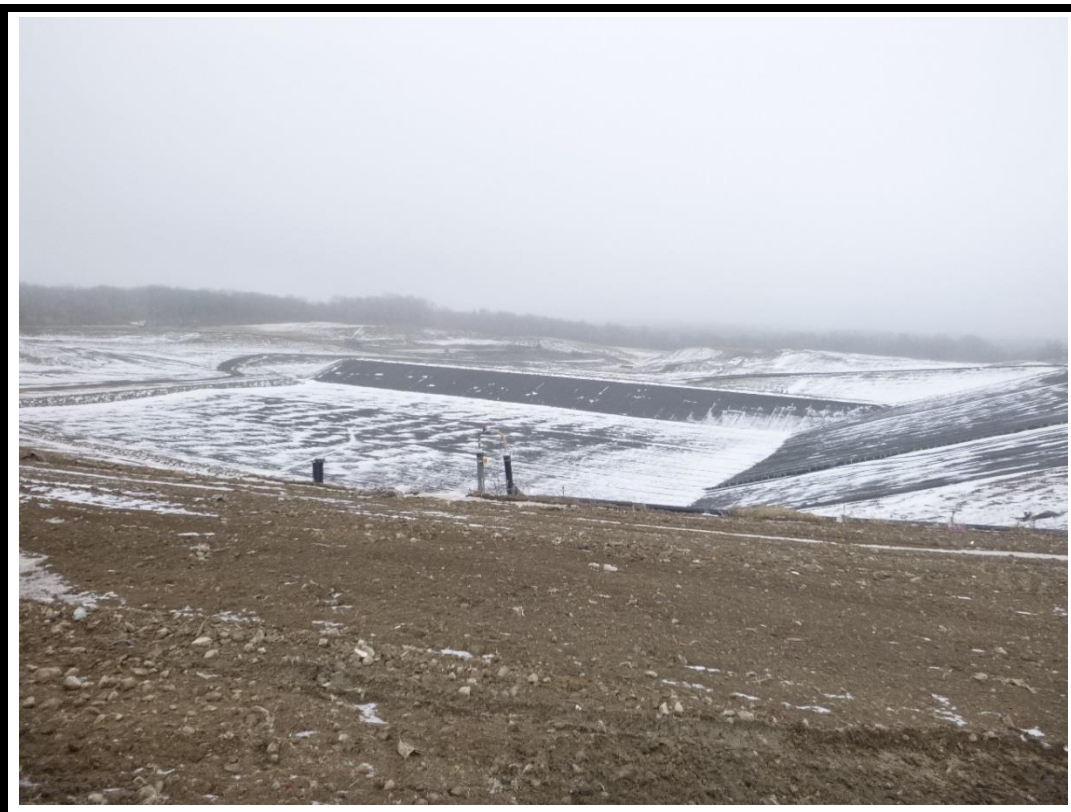
Photo ID: 5  
Photo Date: 1/9/2018  
Photo Time: 11:57:54  
Direction: South  
Taken By: Dustin Burger

Cell 7A

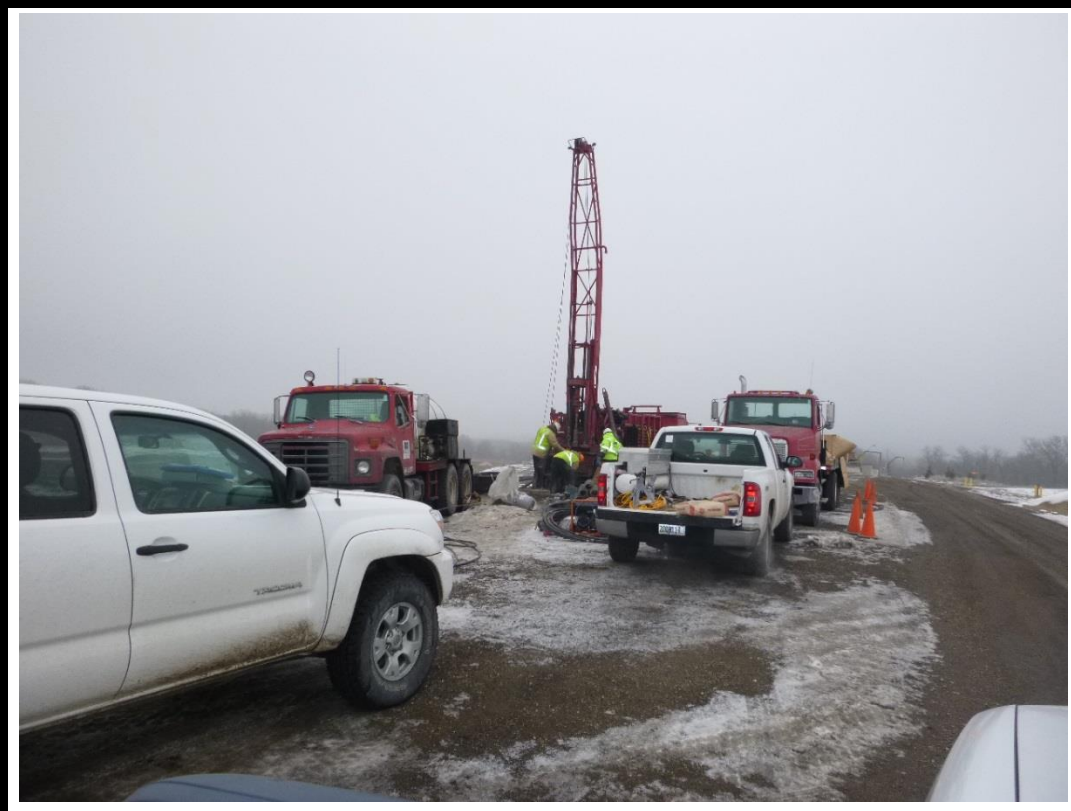
Photo ID: 6  
Photo Date: 1/9/2018  
Photo Time: 11:59:11  
Direction: South  
Taken By: Dustin Burger

Drill rig installing wells

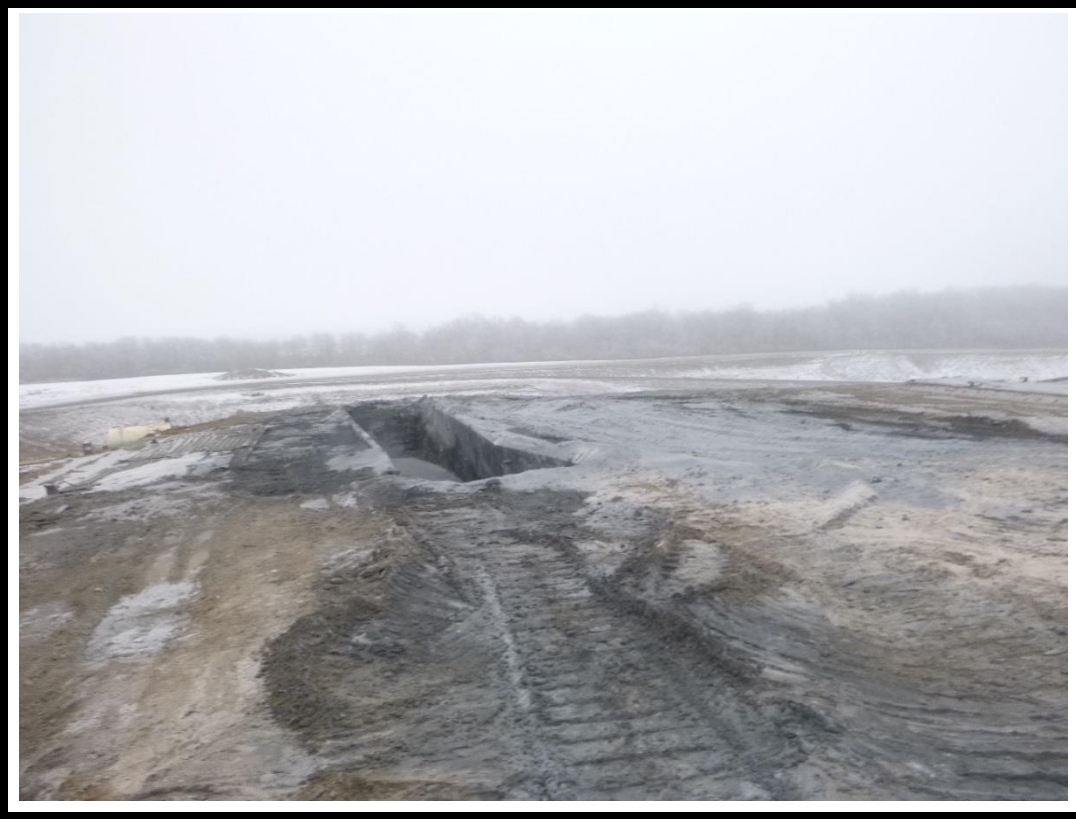
Photo ID: 7  
Photo Date: 1/9/2018  
Photo Time: 12:04:53  
Direction: East  
Taken By: Dustin Burger

The waste solidification area was open, but was not operating at the time of the inspection. Mr. Bryant said the amount of waste arriving for solidification had declined. The area is still used, but not as often as before.

Solidification Unit
