RE: Proposed Compliance Commitment Agreement from
Koppers Inc
Violation Notice A-2021-00217
I.D. 031300AAJ

**Re: Violation Notice A-2021-00217
ID: 031300AAJ**

Unit: U-03
Equipment: V-101 & V-201
Description: TAR FRACTIONATOR
Serial Number: 74-413B National Board: N/A

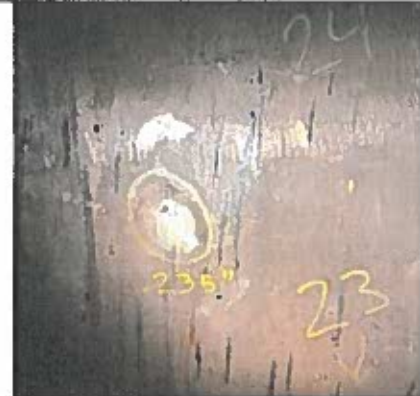
Reference ID: 26

Description: Shell defect areas above tray 23 @ xxx degrees

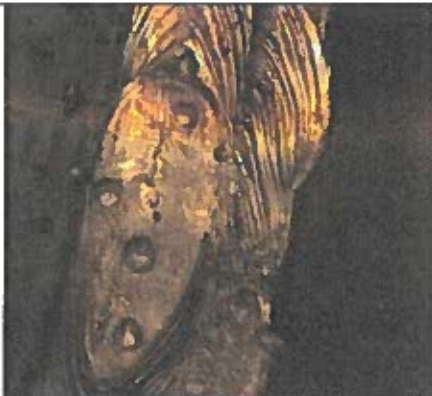
Reference ID: 35

Description: Dehyd Vapor nozzle N4 fillet weld crater crack
