AERIAL ASSESSMENT OF DUTCHMAN CREEK JOHNSON COUNTY, IL December, 2004

Prepared by Wayne Kinney for Illinois Department of Agriculture

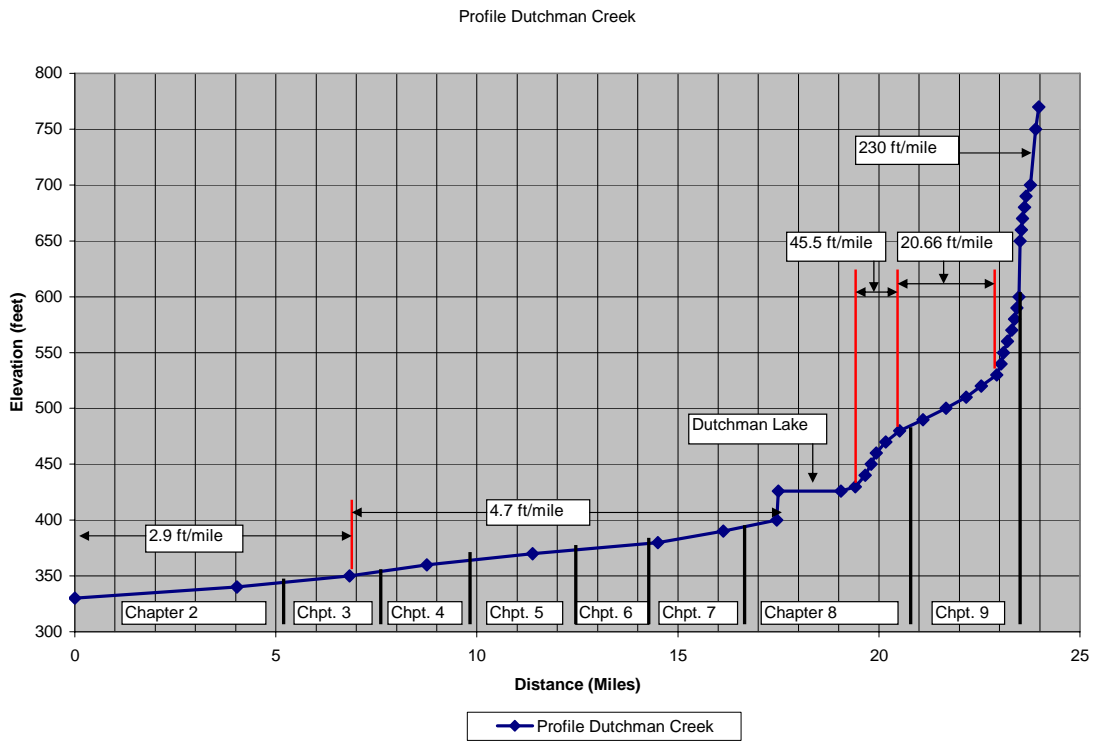
Figure 2. DVD Chapter Divisions along Valley Profile

Figure 2 on the next page shows the location of the DVD Chapter Divisions along the valley profile. Each Chapter consists of five minutes of video.
