**AERIAL ASSESSMENT OF THE LITTLE WABASH RIVER
COLES, SHELBY, EFFINGHAM AND CLAY COUNTIES**

June, 2005

Prepared by Wayne Kinney for IL. Dept. of Agriculture

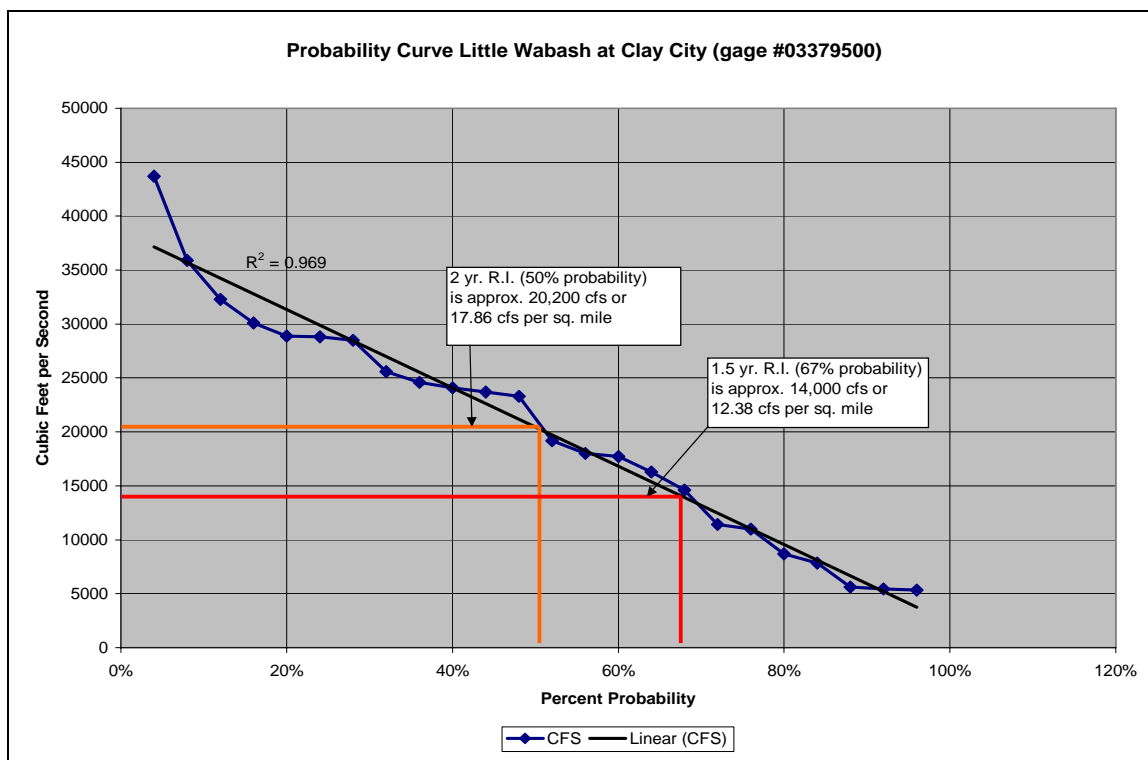
Fig. 12 Probability Curve: Annual Maximum Peak Discharge, USGS Gage #03379500

3. Below x-sec 7 the velocity drops from 4.2 ft/sec. to around 2.0 ft/sec.
4. Cross section 1 (chapter 13) carries 55% of predicted Q₂ discharge at top low bank elevation. A Probability Curve plotted for Gage #03378635 (Fig. 11.--1981 to 2004 data) shows the 1.5 yr. return interval storm to be about 78% of the 2 yr. maximum peak discharge. The 55% figure at X-sec 1 then equates to an approx. return interval of less than 1.05 R.I. and by definition makes top bank the “geomorphic bankfull”.

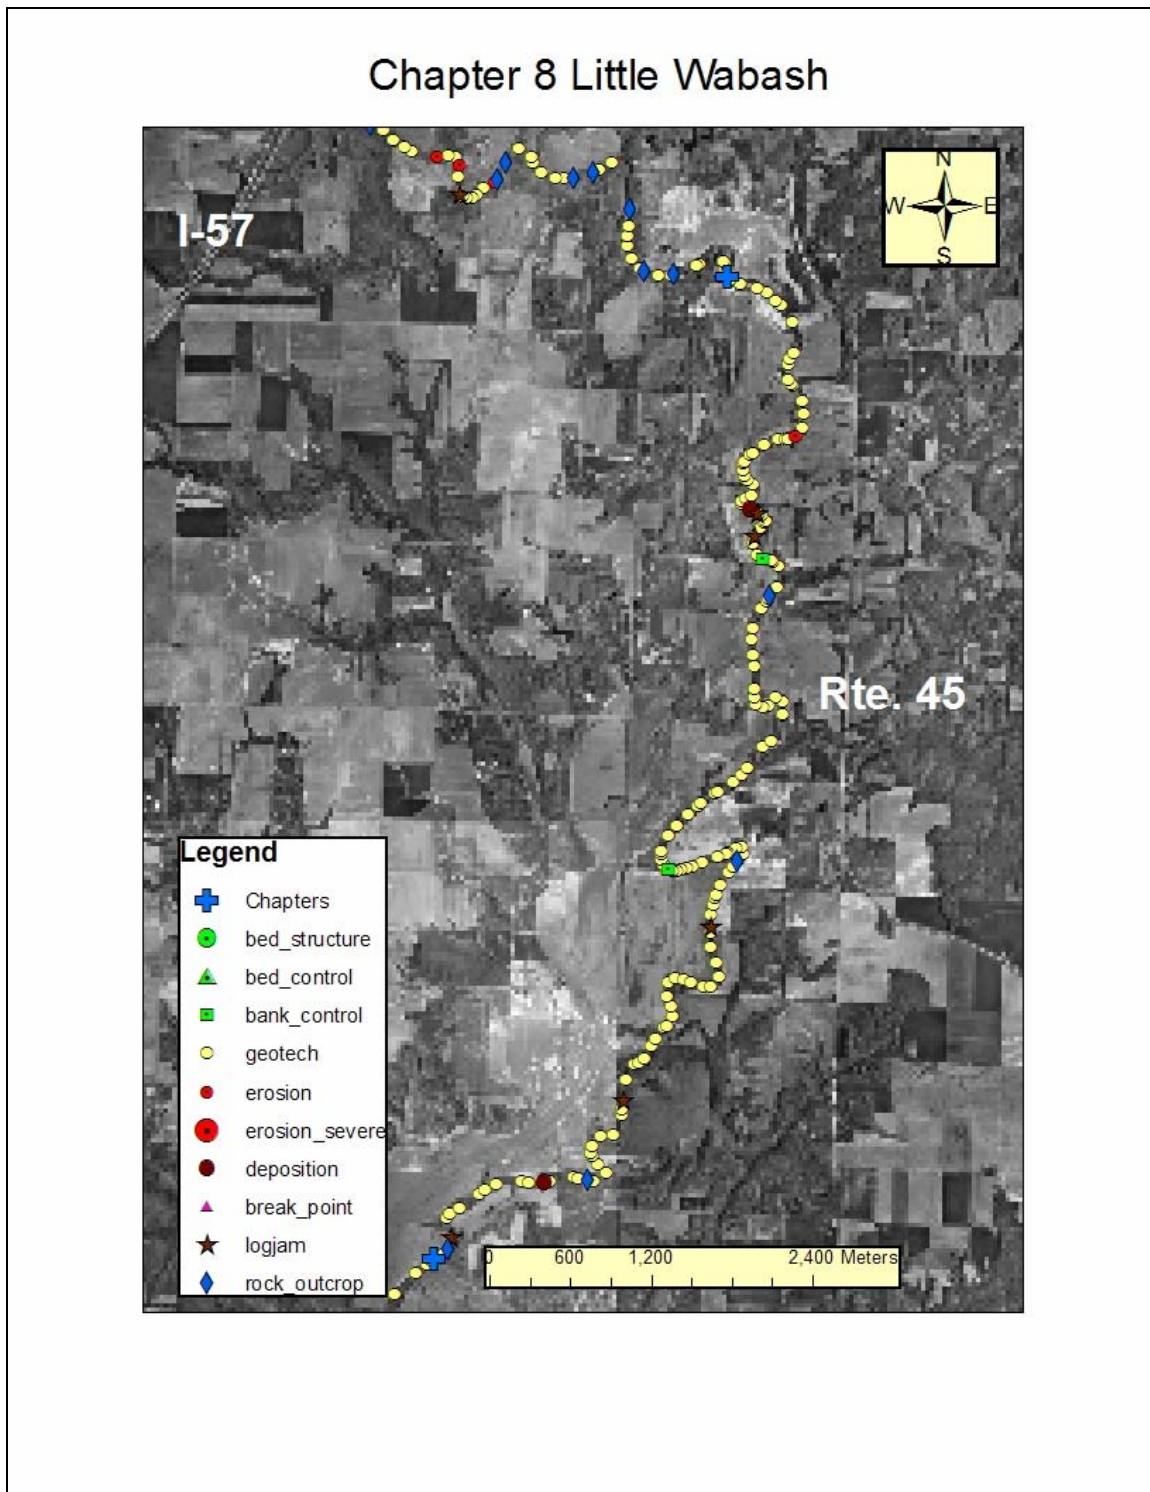
Fig. 25 Chapter 8 Little Wabash River

13. In general the erosion failure mode in the Little Wabash in Chapters 8-12 occurs due to a combination of highly permeable soils with low shear strength often overlaying low permeability subsoils. Where the low permeability soils are above the channel bed, seeps occur and geotechnical failures are dominant. Where the highly permeable soils comprise the entire bank height, bank erosion occurs as bank caving or mass failures and has not been classified as “geotechnical” although primarily soils related due to low shear strength.

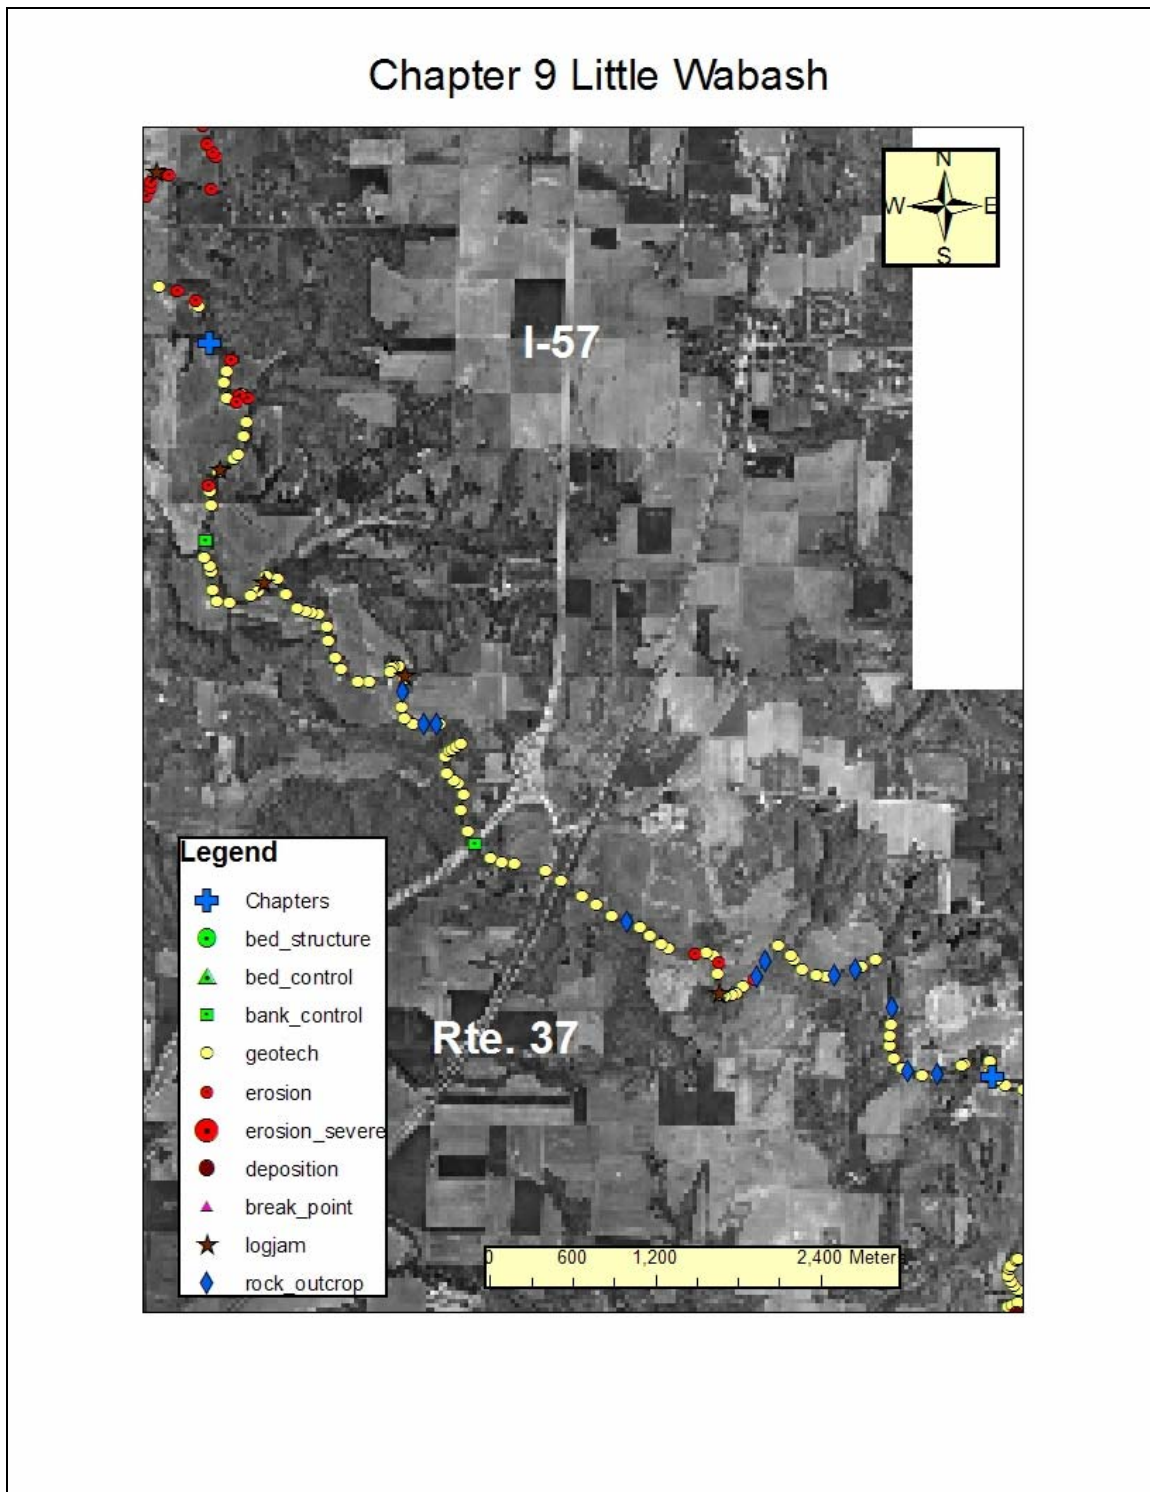
Fig. 26 Chapter 9 Little Wabash River

7. Soils adjacent to the stream in chapters 9 thru 12 (x-sec 2-7) are Horton silt loam and Wirt loam. Both are formed in loamy and sandy alluvium and have very low shear strength and play a significant role in the bank erosion found in this reach. Permeability is 0.6 to 2.0 in/hr and can be as high as 20 in/hr on Wirt soil type.

8. Chapters 9 thru 12 show very significant movement of bedload in the form of “sand waves” during low flow. Under high flow events the channel dimension may change significantly depending on the amount of “bedload” that becomes “wash load” (Fig.17).
