PROJECT EVALUATION AND FINAL REPORT

**KINKAID LAKE TMDL BEST MANAGEMENT PRACTICES
IMPLEMENTATION**

FINANCIAL ASSISTANCE AGREEMENT NO. 3190521

Report Submitted by:
Kinkaid-Reed's Creek Conservancy District
1763 Water Plant Road
Murphysboro, Illinois 62966

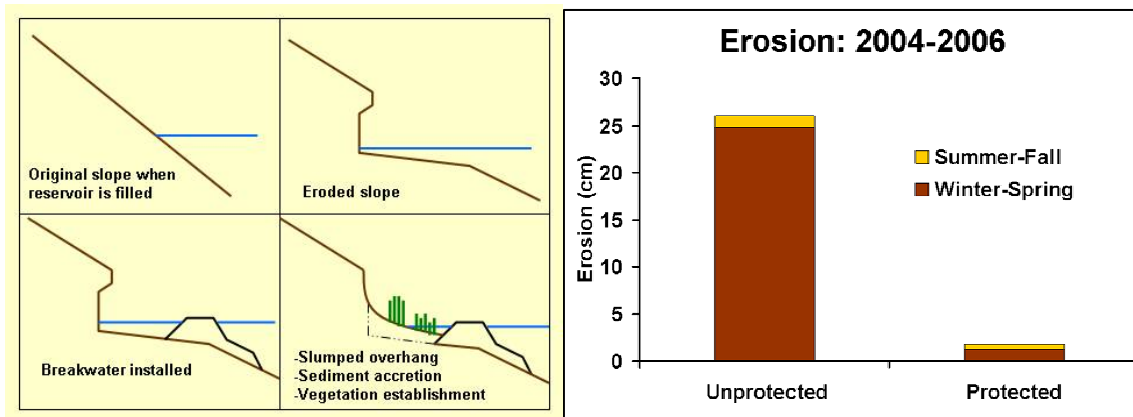
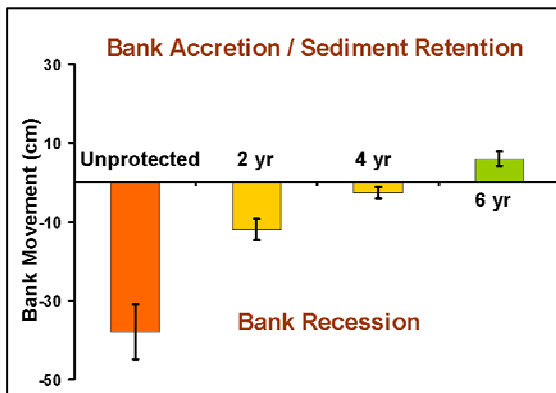
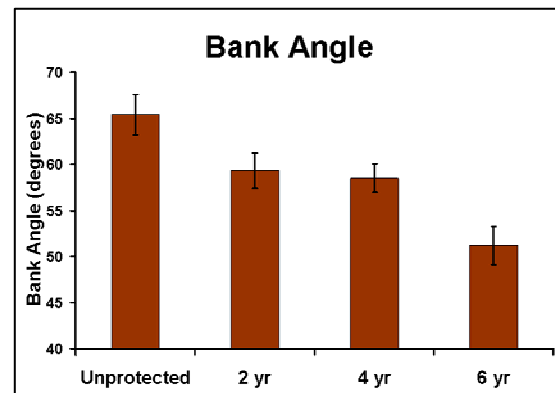
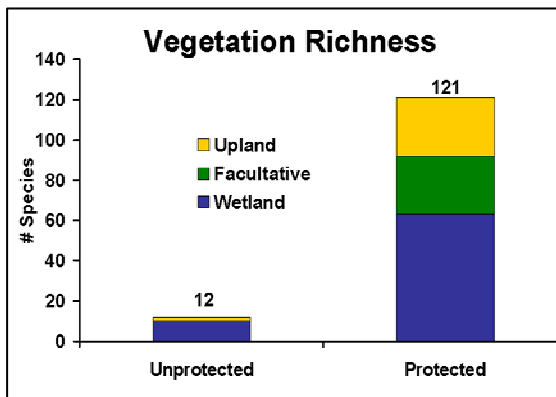
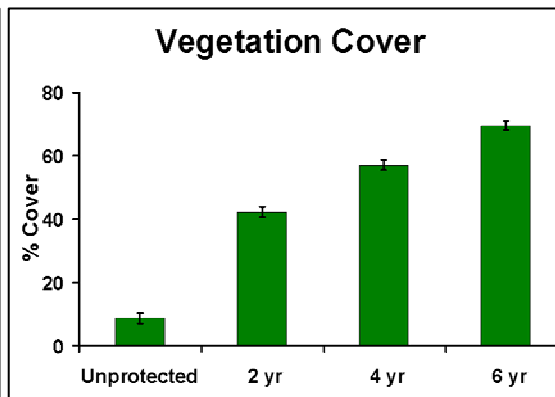
Protected Shoreline Succession

Breakwaters were monitored from 2004-2006. Breakwaters reduced wave energy within the protected areas leading to bank/littoral stabilization and natural vegetation establishment. This contributed to water quality, aesthetics, and habitat. Increased vegetative cover (6x) and richness (10x) were observed at protected sites (121 spp.) compared to unprotected sites (12 spp.). Numerous wildlife species were observed in the newly established habitat including mammals, birds, fish, reptiles, amphibians, and various invertebrates.
