Re: LPC#0390055036—DeWitt County
Clinton/Clinton Landfill #3
Compliance File

LPC#0390055036—DeWitt County
Clinton/Clinton Landfill #3
FOS File
February 18, 2014 Inspection
Inspector: Dustin Burger
GIS Information from BOL Inventory: N40.11507 W-88.9589

Narrative Inspection Report

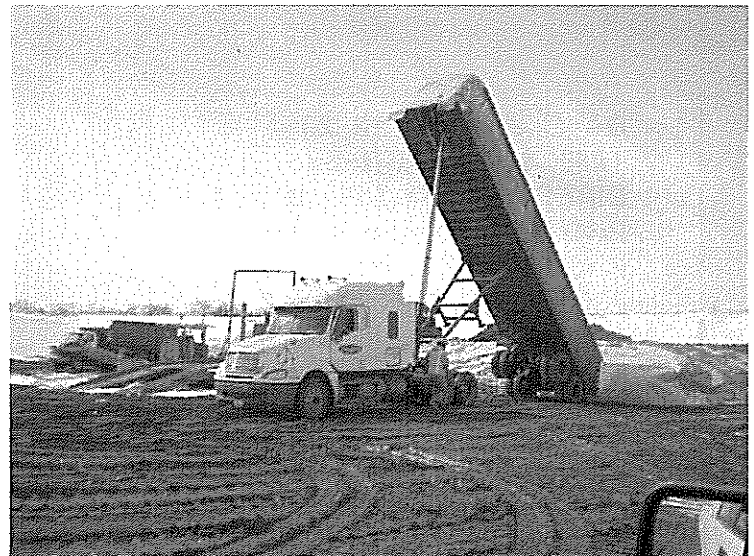
The active area was located on the floor of cell 5A1. We watched several trucks unload. One carried bottom ash from ADM (photo 1). Another was a transfer semi-truck that used the truck tipper to dump a load of municipal waste. The landfill trains the truck drivers to operate the tipper, so the landfill is not required to have an employee stop their work to operate the equipment. The tipper is not used often, and this was actually one of the few times I have seen it operate at this landfill. As a contrast, the landfill at Pontiac where Mr. Bryant worked previously operates 3-6 tippers at a time. At one time that facility had over 10 operating at once. The difference between the two facilities is the Pontiac site's main customers were transfer stations in the Chicago area, whereas most of the waste received at Clinton comes in on rear loading packer trucks (what most people would call a typical garbage truck) and roll-off boxes, which are large removable dumpsters that can be carried by a truck.

DATE: February 18, 2014
TIME: 11:10A.M.-Noon.
DIRECTION: West
PHOTO by: Dustin Burger
PHOTO FILE NAME:
0390055036~02182014-001.jpg
COMMENTS: Load of bottom ash
being dumped

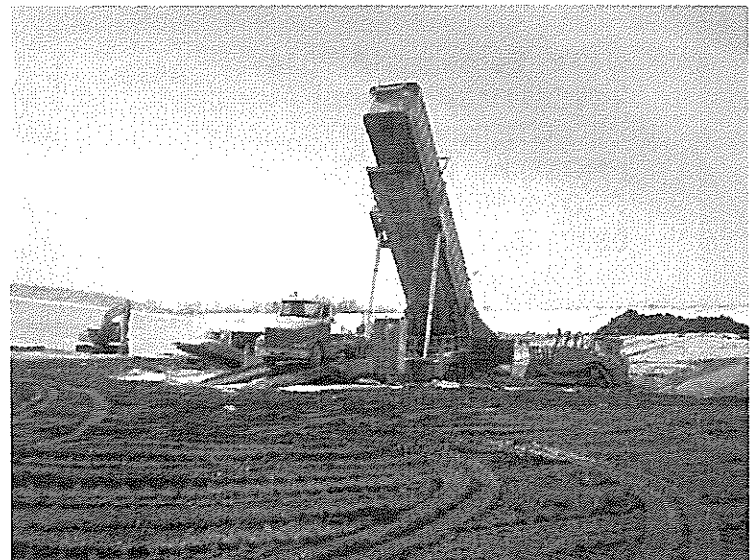
DATE: February 18, 2014
TIME: 11:10A.M.-Noon.
DIRECTION: West
PHOTO by: Dustin Burger
PHOTO FILE NAME:
0390055036~02182014-002.jpg
COMMENTS: Load of municipal
waste on truck tipper

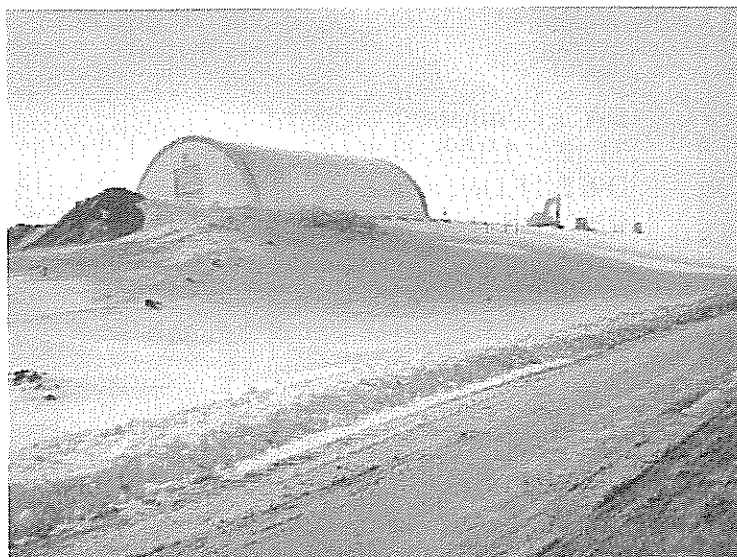
The waste solidification area on top of Cell 1C was not being used during the inspection (photo 3). I did note that the snow around the solidification area was discolored by blowing ash. While the winds lately have been strong, I was surprised at this observation. The solidification process involves adding liquid waste, such as leachate from the landfill, to a buried metal container. Coal bottom ash which is stored in a tent-like shelter is then added to the container. A trackhoe mixes the ash and liquid waste until the liquid is absorbed. The process is exothermic, as the lime in the ash reacts with the liquid the mixture bubbles and froths. The resultant mixture is piled next to the tank and is then hauled to the active face for disposal. Mr. Bryant said he could tell the blowing material was wetted ash by the color. Considering the weather, I thought the wetted ash would freeze solid and not blow. It is possible that the ash was blown away while the ash was being added to the liquid or during the mixing process. Bryant said he would scoop up the snow and ash and place it into the active area. He added that the company was considering adding a facility to handle dusty waste. The process would involve a rotary mixer to wet and stabilize the wastes. He was unsure if the approximate \$3 Million for the equipment would be worth the investment.

No violations were noted during the inspection. The blowing dust from the solidification area is not a violation of the Act, Permit, or Regulations since it did not leave the permitted area. It is, however, an area of concern and should be addressed by the facility.

DATE: February 18, 2014
TIME: 11:10A.M.-Noon.
DIRECTION: Southwest
PHOTO by: Dustin Burger
PHOTO FILE NAME:
0390055036~02182014-003.jpg
COMMENTS: Solidification area
Note: discolored snow from blowing ash.

No violations were noted at the time of this inspection. The Agency did, however, note an issue with dust blowing from the facility's solidification unit onto the surrounding area. By April 15, 2014, please submit a letter describing actions to be taken to mitigate the release of dust from the solidification process. For your information, a copy of the inspection report is enclosed.

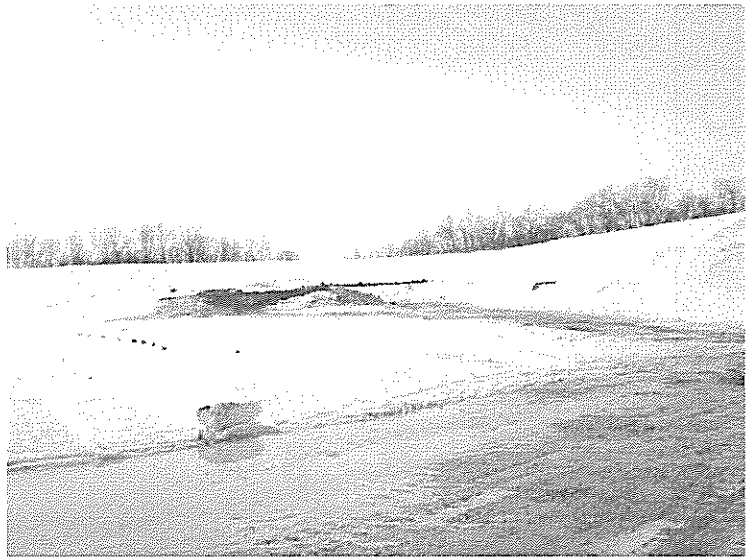
The waste in the CWU cell was adequately covered by cover soils. I took one photo of the area (photo 5). The eastern half of the cell was still unused and had the protective

plastic cover in place over the cell to prevent rainwater or snowmelt from entering the leachate collection system.

DATE: February 18, 2014
TIME: 11:10A.M.-Noon.
DIRECTION: South
PHOTO by: Dustin Burger
PHOTO FILE NAME:
0390055036~02182014-005.jpg
COMMENTS: Chem Waste Unit

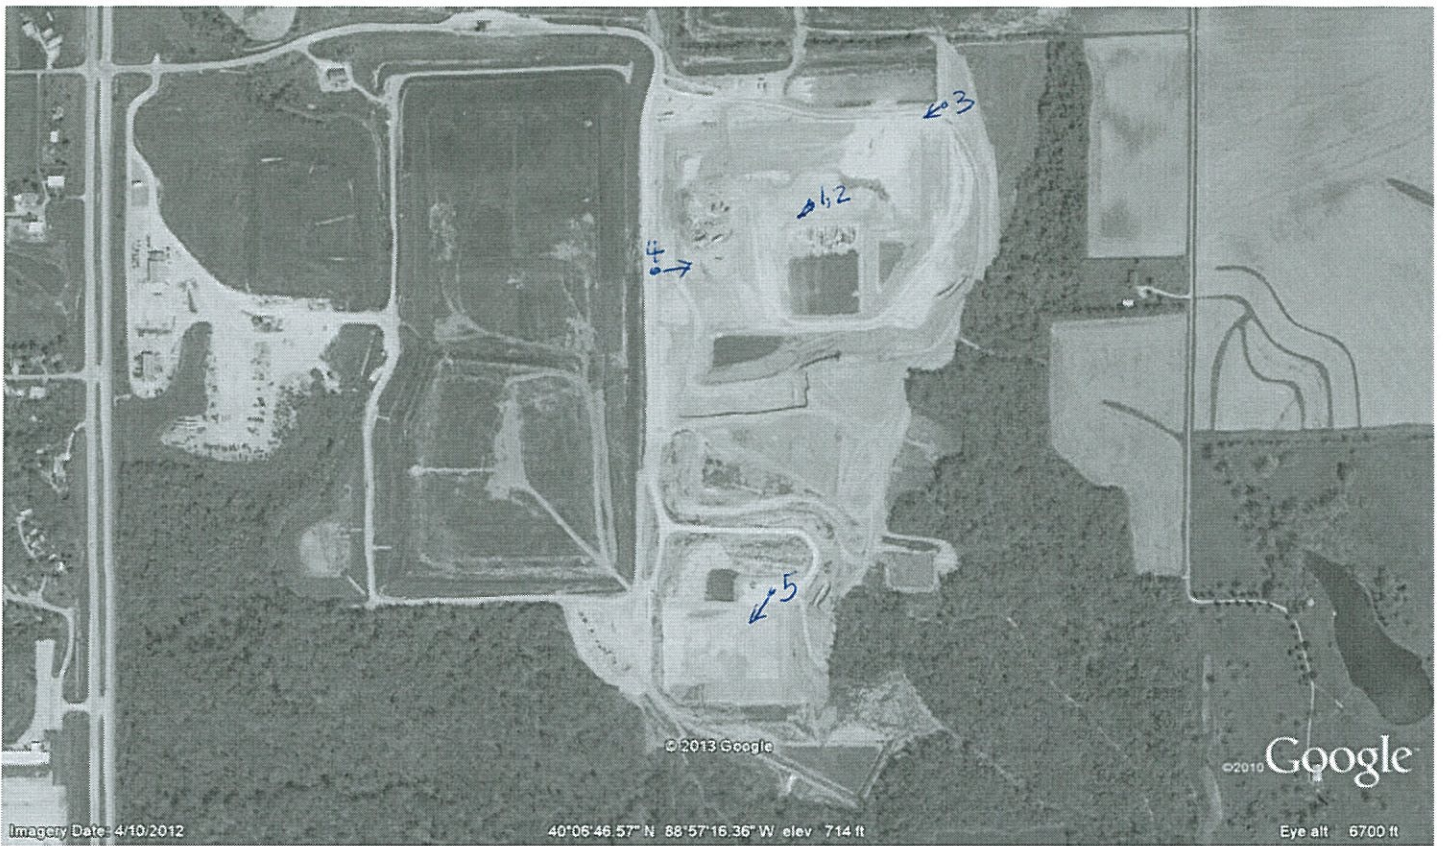
Site Map.

* denotes photo location/direction.
