**AERIAL ASSESSMENT REPORT FOR
BEAUCOUP CREEK**

**JACKSON, PERRY AND WASHINGTON COUNTIES
SEPTEMBER 2005**

PREPARED BY WAYNE KINNEY, FOR IL. DEPARTMENT OF AGRICULTURE

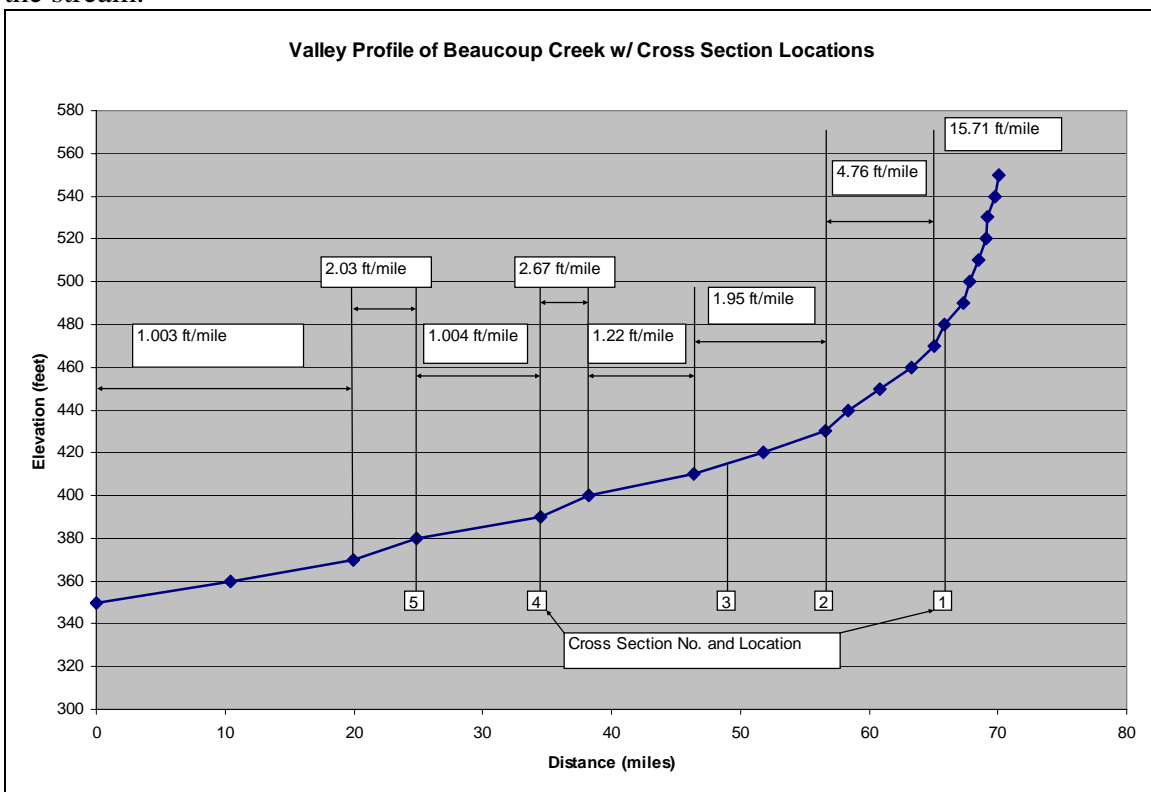
Figure 2 Channel Profile of Beaucoup Creek

Detailed elevation data is not available; therefore the channel slope is calculated from USGS topo maps by measuring the channel length between contour lines. The report refers to this as “valley profile” although a true valley profile would use a straight line distance down the floodplain rather than channel length. However, this method is used because it incorporates sinuosity into the calculation and allows the channel slope to be assume equal to “valley slope” in order to estimate channel capacity, velocity, etc., although there are short segments where the channel slope may differ significantly near roads, logjams, knickpoints, etc.

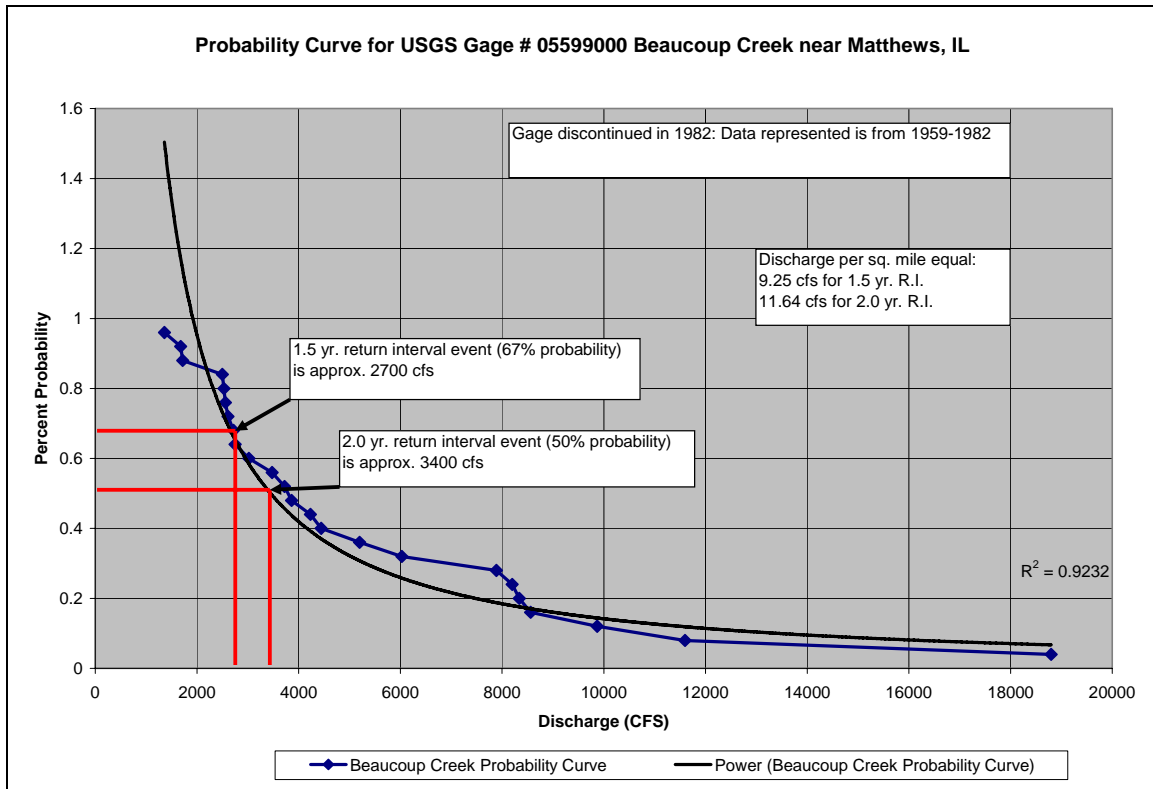
Fig. 6 Probability Curve –USGS Gage 05599000 for period 1959-1982

A plot of the discharge probability curve from USGS Gage # 05599000 over the last 24 yrs. of continuous record (1959-1982) in Fig. 6 indicates the 2 yr. discharge (50% probability) at approx. 3400 cfs and the 1.5 yr. discharge (67% probability) at approx. 2700 cfs. The drainage area at Gage # 05599000 near Matthews, IL is 292 sq. miles; therefore the discharge per sq. mile is 11.64 and 9.25 cfs per sq. mile respectively for the 2 yr. and the 1.5 yr. R.I. discharge. The field determined "bankfull" discharge in the study area ranges from 7.75 to 31.8 cfs/sq. mile. Referring to Fig. 5 the data indicates the bankfull discharge at cross section 5 is 7.75 cfs per square mile. Cross section 5 has a drainage area of 278 sq. mi., therefore if the data is extrapolated to the former gage site the discharge would be 2263 cfs (7.75 x 292) and represents a Return Interval (R.I.) of approx. 1.2 yrs at cross section 5 near the gage site. It is expected that the cfs/sq. mile discharge would increase as the drainage area decreases and the valley slope increases. This is the case with Beaucoup Creek. It should be noted however that the field determined bankfull elevations at cross sections 2, 4 and 5 are actually at the top bank elevation and therefore indicate that Beaucoup Creek is well connected to its floodplain at these locations.

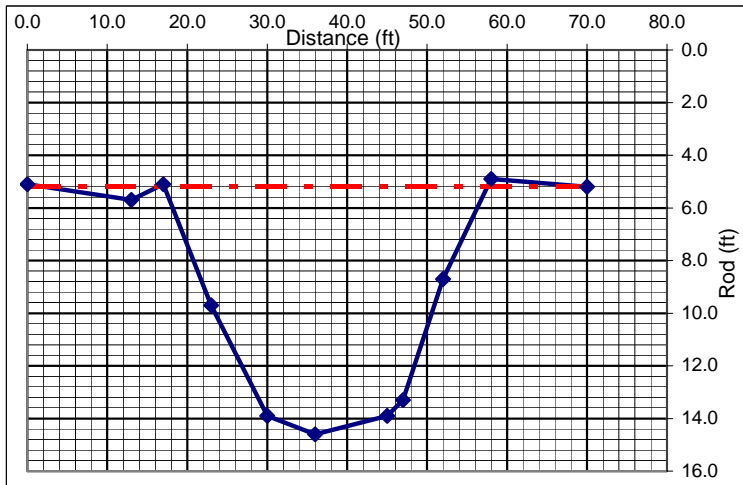
True Cross Section

Project: x-sec 2
 Assisted by: Wayne Kinney
 Date: 9/8/2005
 Channel Slope (S): 0.000902 ft/ft
 Manning's n: 0.040
 Flow Depth: 9.4 ft

Rod (ft)	Distance (ft)
5.2	70.0
4.9	58.0
8.7	52.0
13.3	47.0
13.9	45.0
14.6	36.0
13.9	30.0
9.7	23.0
5.1	17.0
5.70	13
5.10	0

Trial Depth 2	Trial Depth 3
Selected Flow Depth:	9.4 ft	
Channel Flow (Q):	740.3 cfs	
Channel Velocity:	2.9 ft/sec	
Cross-Sectional Area (A):	254.2 sq.ft.	
Hydraulic Radius (R):	4.2 ft

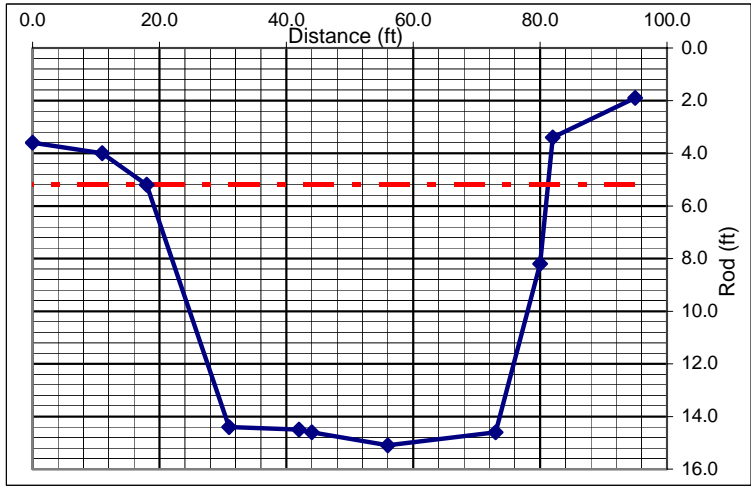
Project: x-sec 3
 Assisted by: Wayne Kinney
 Date: 9/8/2005
 Channel Slope (S): 0.000369 ft/ft
 Manning's n: 0.040
 Flow Depth: 9.9 ft

Rod (ft)	Distance (ft)
1.9	95.0
3.4	82.0
8.2	80.0
14.6	73.0
15.1	56.0
14.6	44.0
14.5	42.0
14.4	31.0
5.2	18.0
4.00	11
3.60	0

Trial Depth 2	Trial Depth 3
Selected Flow Depth:	9.9 ft	11.5
Channel Flow (Q):	1,338.5 cfs	1,579.9
Channel Velocity:	2.6 ft/sec	2.6
Cross-Sectional Area (A):	505.4 sq.ft.	616.3
Hydraulic Radius (R):	7.2 ft	6.8

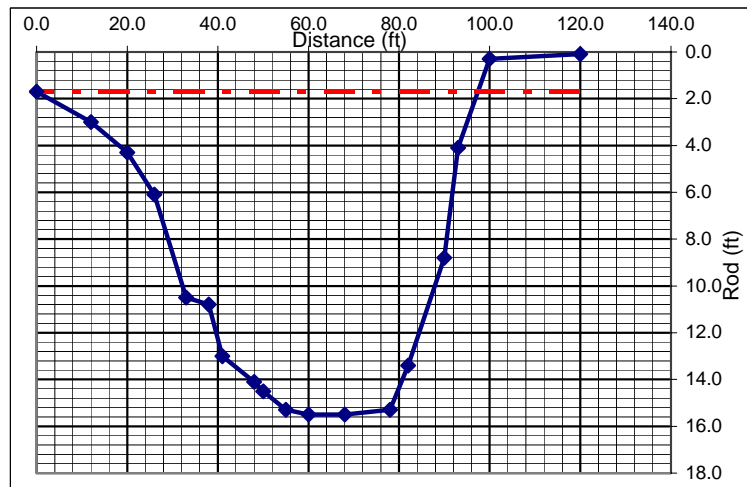
Project: x-sec 4
 Assisted by: Wayne Kinney
 Date: 9/8/2005
 Channel Slope (S): 0.000267 ft/ft
 Manning's n: 0.040
 Flow Depth: 13.8 ft

Rod (ft)	Distance (ft)
0.1	120.0
0.3	100.0
4.1	93.0
8.8	90.0
13.4	82.0
15.3	78.0
15.5	68.0
15.5	60.0
15.3	55.0
14.50	50
14.10	48
13.00	41
10.80	38
10.50	33
6.10	26
4.3	20
3.0	12
1.7	0

Trial Depth 2	Trial Depth 3
Selected Flow Depth:	13.8 ft	13.8
Channel Flow (Q):	1,886.9 cfs	1,886.9
Channel Velocity:	2.4 ft/sec	2.4
Cross-Sectional Area (A):	801.4 sq.ft.	801.4
Hydraulic Radius (R):	7.6 ft	7.6

2. Cross section 1 is incised with top bank being more than twice the maximum bankfull depth.
3. Cross section 4 (near Pinckneyville) appears to be downcutting with a cemented layer having high manganese concentrations being eroded in channel bed at riffle locations. Although the bankfull discharge is at top bank, this could be an area of degrading channel bed.

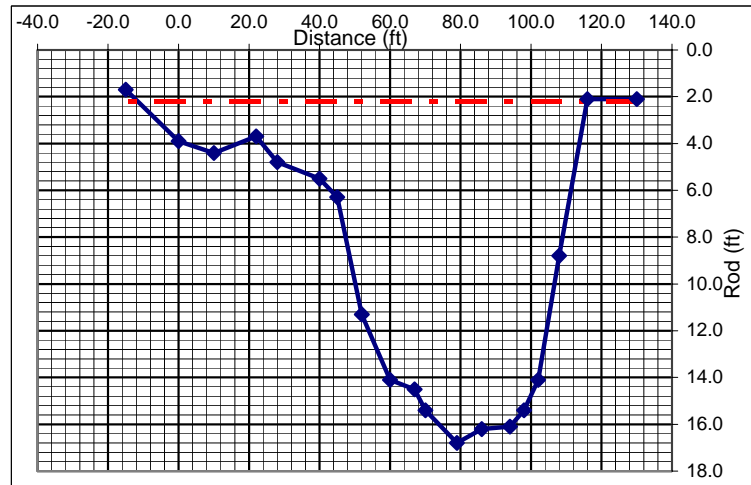
Project: x-sec 5
 Assisted by: Wayne Kinney
 Date: 9/8/2005
 Channel Slope (S): 0.000267 ft/ft
 Manning's n: 0.040
 Flow Depth: 14.6 ft

Rod (ft)	Distance (ft)
2.1	130.0
2.1	116.0
8.8	108.0
14.1	102.0
15.4	98.0
16.1	94.0
16.2	86.0
16.8	79.0
15.4	70.0
14.50	67
14.10	60
11.30	52
6.30	45
5.50	40
4.80	28
3.7	22
4.4	10
3.9	0
1.7	-15

Trial Depth 2	Trial Depth 3
Selected Flow Depth:	14.6 ft	14.7
Channel Flow (Q):	1,913.9 cfs	1,827.9
Channel Velocity:	2.1 ft/sec	2.0
Cross-Sectional Area (A):	893.6 sq.ft.	906.4
Hydraulic Radius (R):	6.6 ft	6.1

This reach contains cross section 5, located downstream of IL. Rte. 152, which is well connected to the floodplain with an out-of-bank and a “geomorphic bankfull” return interval frequency of approx. 1.2 years. Therefore since neither DO nor manganese has been identified as an impairment in this reach and the width/depth is around eleven (11) the recommended treatment for the streambank erosion in this reach to use Stone Toe Protection at the rate of 1 ton per foot where bank erosion is to be controlled.
