**AERIAL ASSESSMENT OF KINKAID CREEK
AND LITTLE KINKAID CREEK
JACKSON COUNTY, IL
November, 2004**

Prepared by Wayne Kinney for Illinois Department of Agriculture

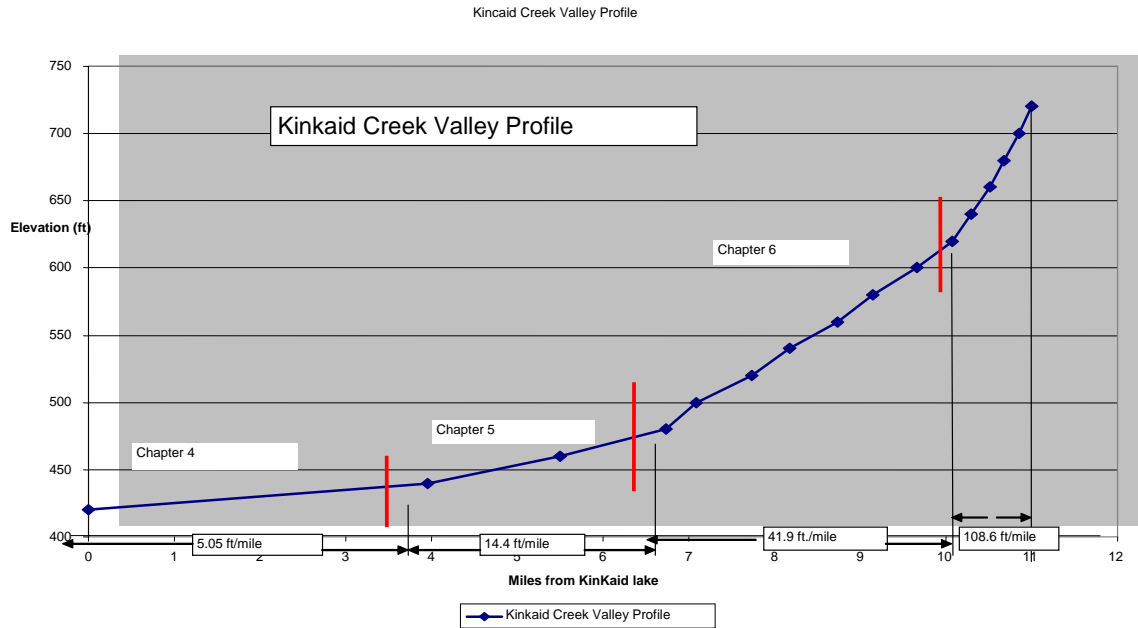
Figure 1

Both Kinkaid Creek and Little Kinkaid Creek have much steeper gradients in the upper 25 to 40% of the watershed. In Kinkaid Creek the change in valley slope increases 290% approximately 6.75 miles (60% of total length) above Kinkaid Lake. Little Kinkaid Creek has a corresponding increase of 270% approximately 5.2 miles (75% of total length) above Kinkaid Lake. (See Fig.1 and Fig. 2)

The slope data is calculated from USGS topo maps instead of actual survey data. Although they accurately represent a significant change, points are at best approximations as the contour intervals are 10 and 20 feet a part. Given the significant change in valley slope, it should be expected that velocities and the sediment carrying capacity of both Kinkaid and Little Kinkaid Creeks would be reduced significantly at these points.

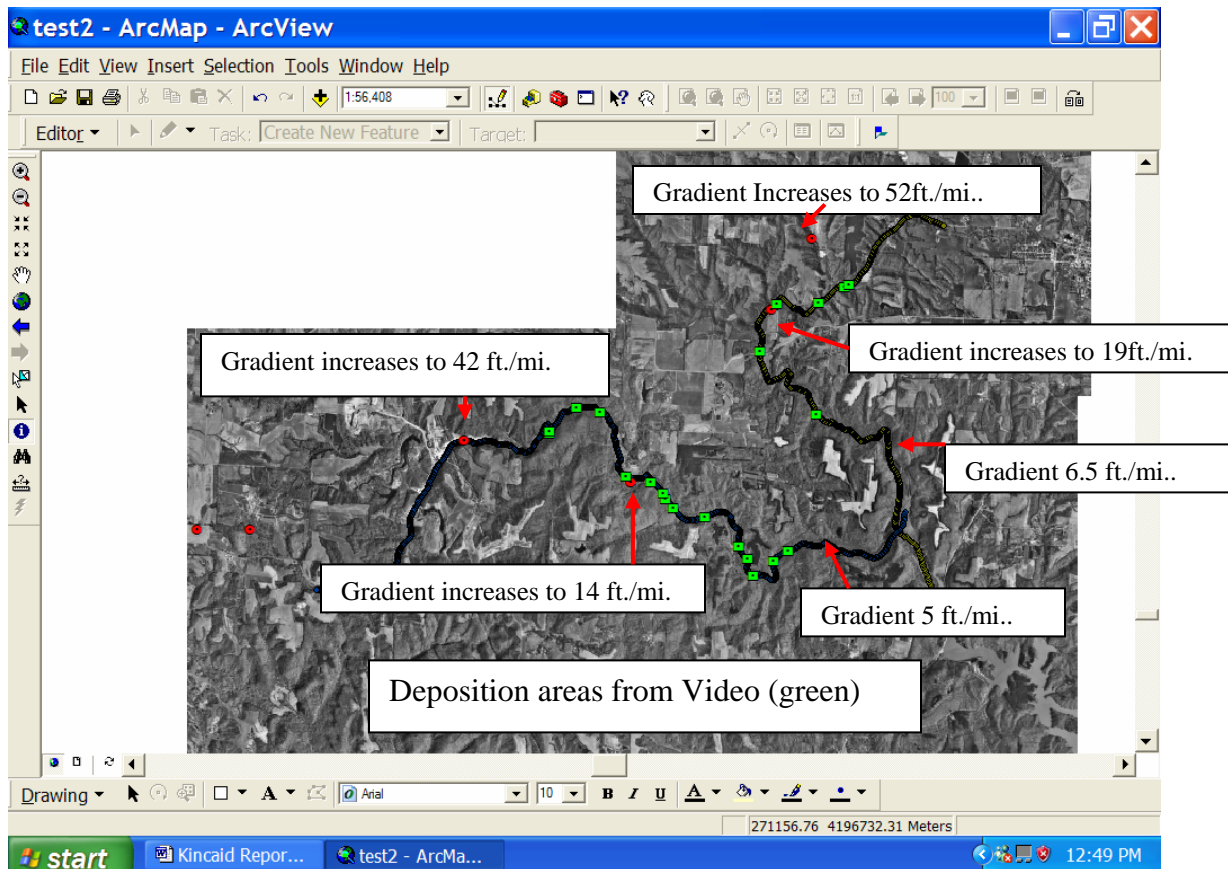
Figure 3

It could be expected there would be indications of increased deposition at these points as the stream loses sediment transport capacity. The occurrence of deposition identified from the aerial video corresponds very well with this assumption for both streams. There are no depositional areas identified in the reaches that have valley slopes near 42 and 52 ft./mi. respectively. (Fig. 3)

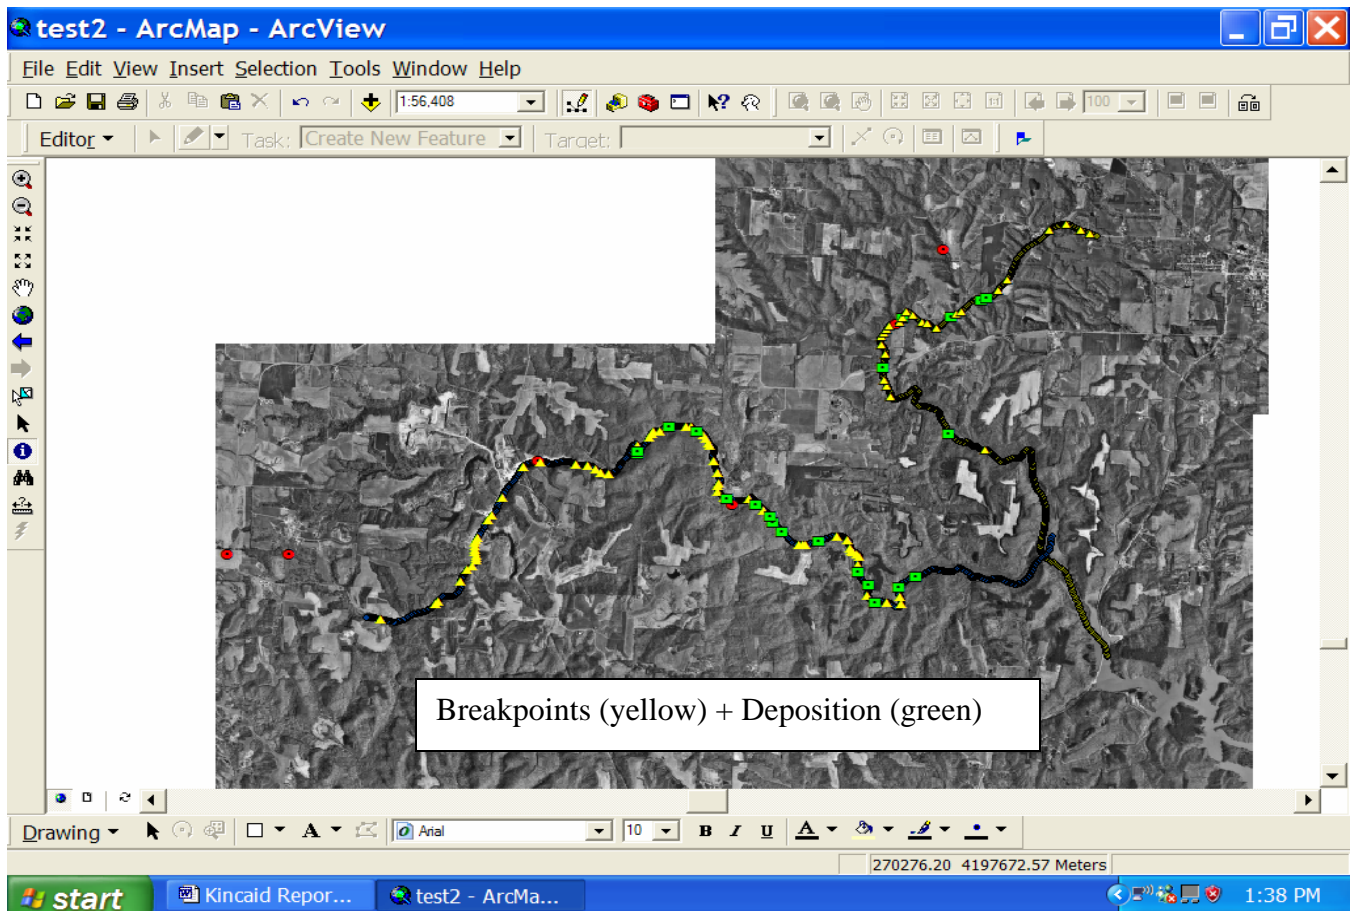
Figure 4

Comparison of features for the points identified from the DVD indicates that many breakpoints are found to be associated with the deposition areas, suggesting that these may be accumulations of heavy sediment rather than degradational features. (Fig. 4) Subsequent ground truthing has confirmed this assumption.

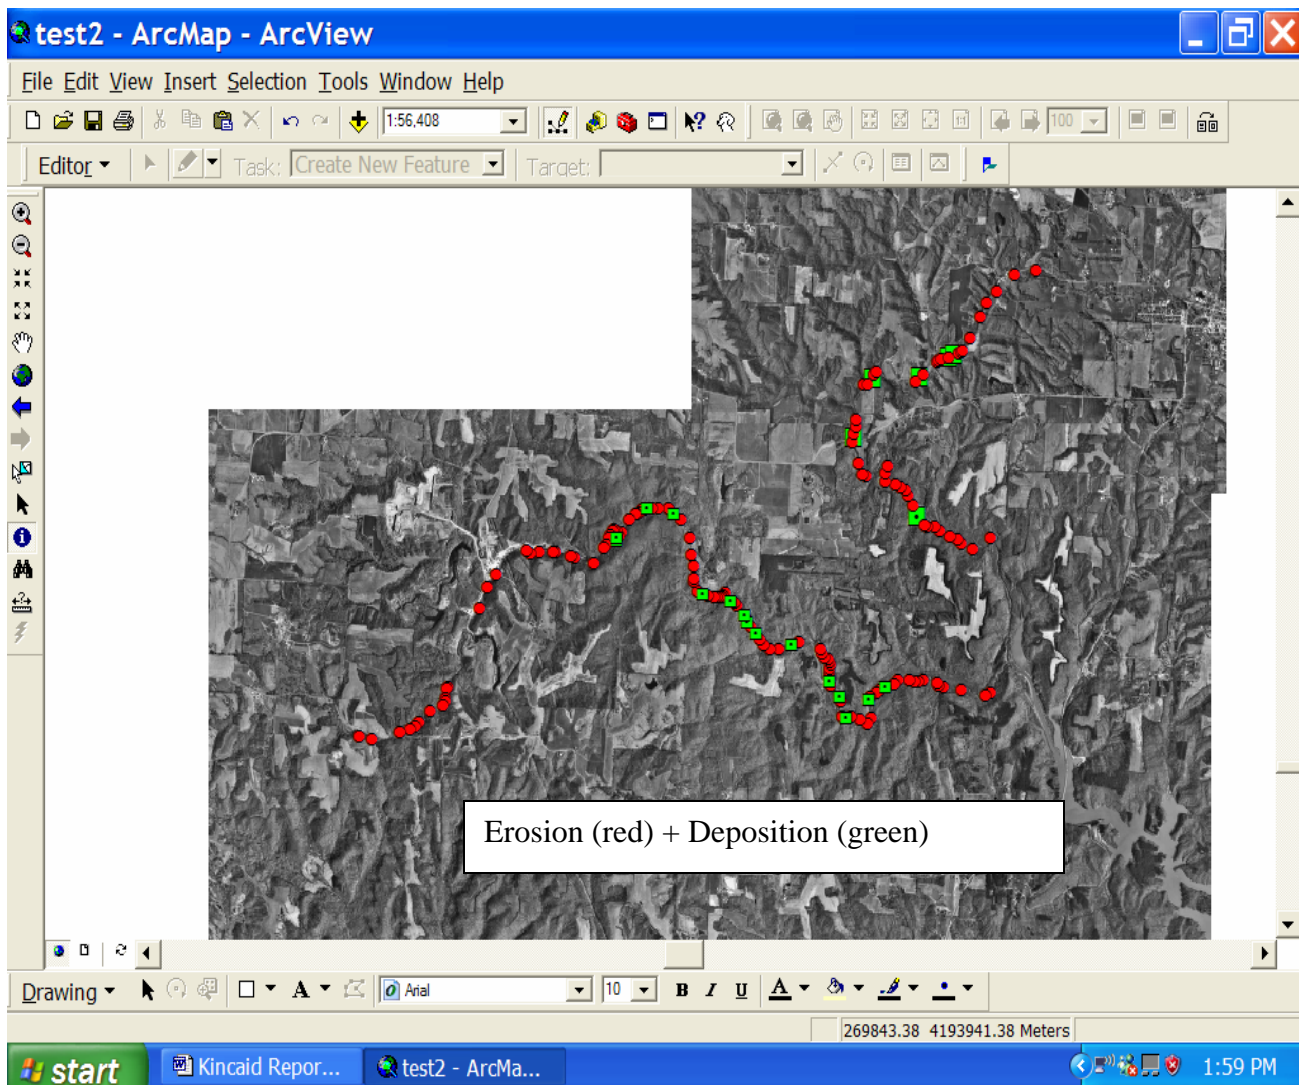
Figure 5 shows the erosion sites identified from the DVD are distributed along most of the length of Kinkaid and Little Kinkaid Creeks with little correlation to valley slope or where the deposition is occurring. In fact, the erosion points are more frequent in the depositional areas than in the areas upstream.

There clearly seems to be a different erosion process working in the upper reaches of these streams than in the lower gradient reaches nearer to Kinkaid Lake. Assessment of the DVD and the data collected during the ground investigation confirms that erosion in the upper reaches is driven by high velocities and generally confined flow resulting in very high transport capacity.

However, the lower reaches are driven by the bedload transported from the upper reaches being deposited within the channel in the lower gradient sections. By hydraulic sorting, the larger bedload materials are deposited first followed by progressively smaller size bedload, as the streams continue to lose gradient as they approach Kinkaid Lake. The finer materials (silts and clays) having the highest rate of affinity to carry phosphorus are presumed to be carried all the way to Kinkaid Lake.

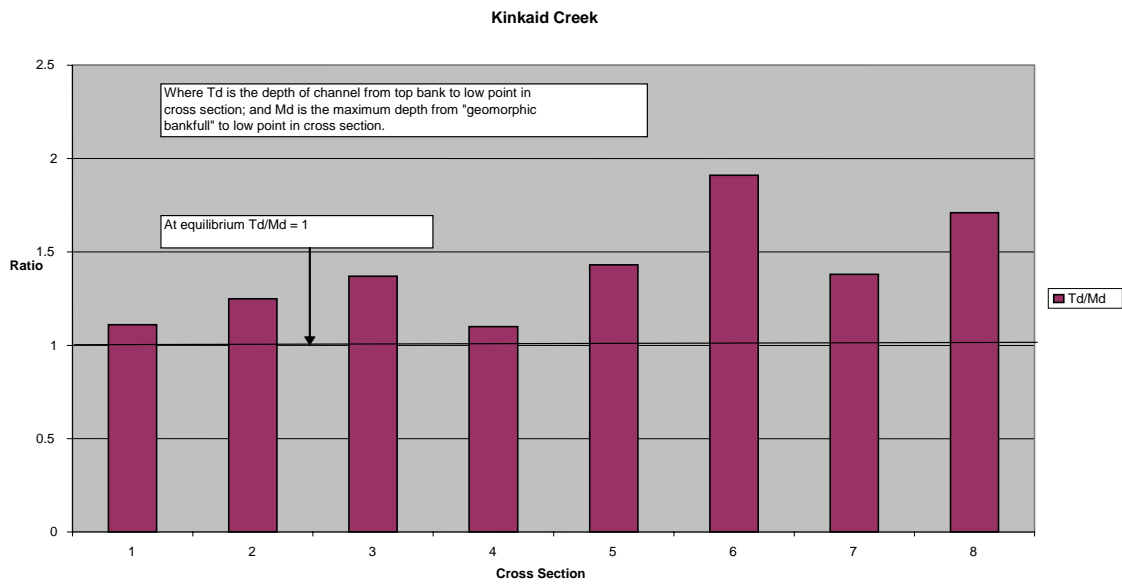
A stable stream will have a developed floodplain at the Maximum Bankfull depth and therefore would have a ratio of Td/Md of 1 or Td would be 100 percent of Md as another way of expressing the same value. Figure 6 and Figure 7 show the comparison of Td and Md for Kinkaid and Little Kinkaid Creeks.

3. Channel degradation will be limited in upper reaches by the many places where the channel bed is on solid bedrock.
4. Past channel incision has resulted in channel depths ranging from 10% to 93% deeper than “bankfull flow”. (Fig. 6 and Fig. 7)

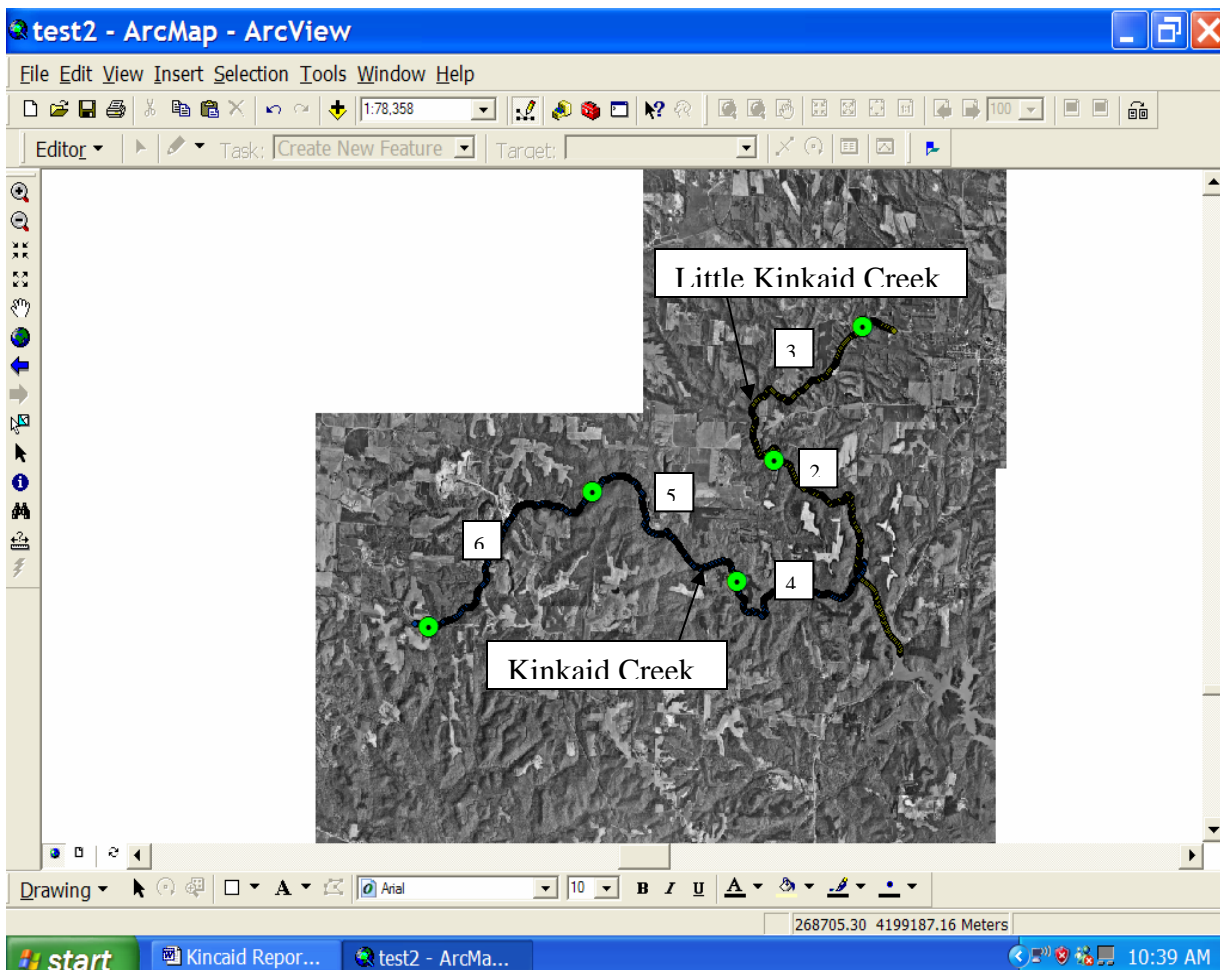
Figure 8: Chapter Divisions on DVD used for Recommendations

The DVD has been divided into “chapters” as shown in Figure 8. Each chapter consists of five minutes of video.

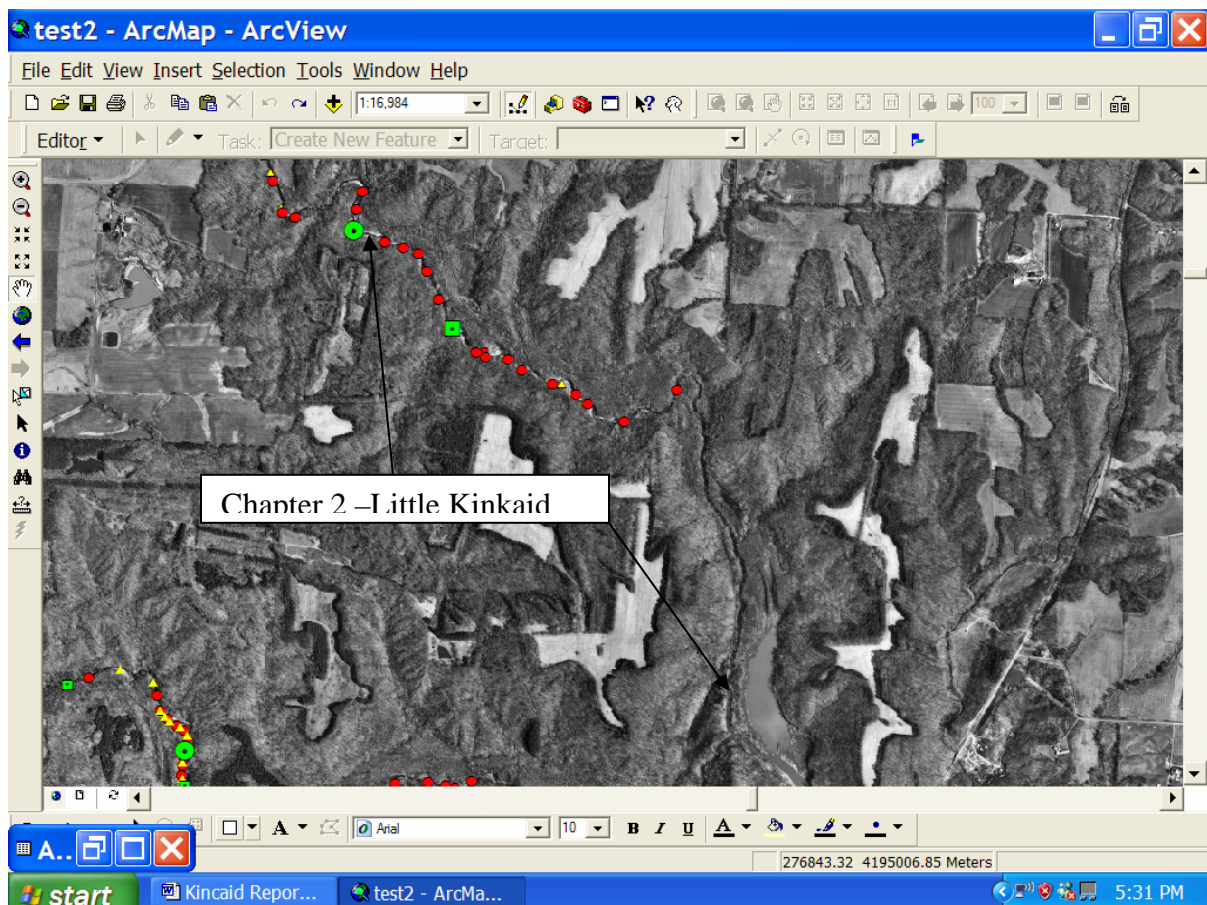
Figure 9: Location of Chapter 2 –Little Kinkaid Creek

This section of Little Kinkaid Creek is the outlet into Kinkaid Lake above Route 151. Sediments identified on the DVD from 5:00 to 8:00 minutes are fine sediments and are being transported by channel flows as bedload. From 7:41 minutes to the end of the chapter, there are 15 identified erosion sites and one deposition site. Bar development increases sharply around 8:00 minutes as does frequency of bank erosion sites. Cross section one is taken at 9:17 minutes and the velocity is estimated at 3.7 ft./sec., with approximately 1.3 feet of incision. The bedload deposition with a D90 of three inches in diameter is driving the channel laterally causing the increased bank erosion.

1. No infra-structure was identified as threatened by the lateral migration. Treatment options for lateral migration are not recommended in this reach. Any reduction in sediment load achieved by stabilizing streambanks would need to be weighed against increases in sediment transport through treated reaches.

2. Reconnecting Little Kinkaid Creek with its floodplain at this point is recommended, provided it is done in conjunction with reducing the bedload reaching this segment. The use of Rock Riffle Grade Controls is the recommended treatment, but the design must insure that a stable “bankfull channel” can be maintained without excessive maintenance costs. The goal would be to pass finer sediments through the system and onto the floodplain for deposition, as well as reducing the large diameter bedload by stabilizing the streambanks within the newly created pools.

3. At six bankfull widths between riffles, this section of 3500 feet would require 10 to 12 riffles approximately two feet high at an estimated 300 tons of stone per structure. At \$30 per ton installed, the cost per structure would be \$9,000. Treatment cost for Chapter 2 would be \$90,000 to \$108,000.

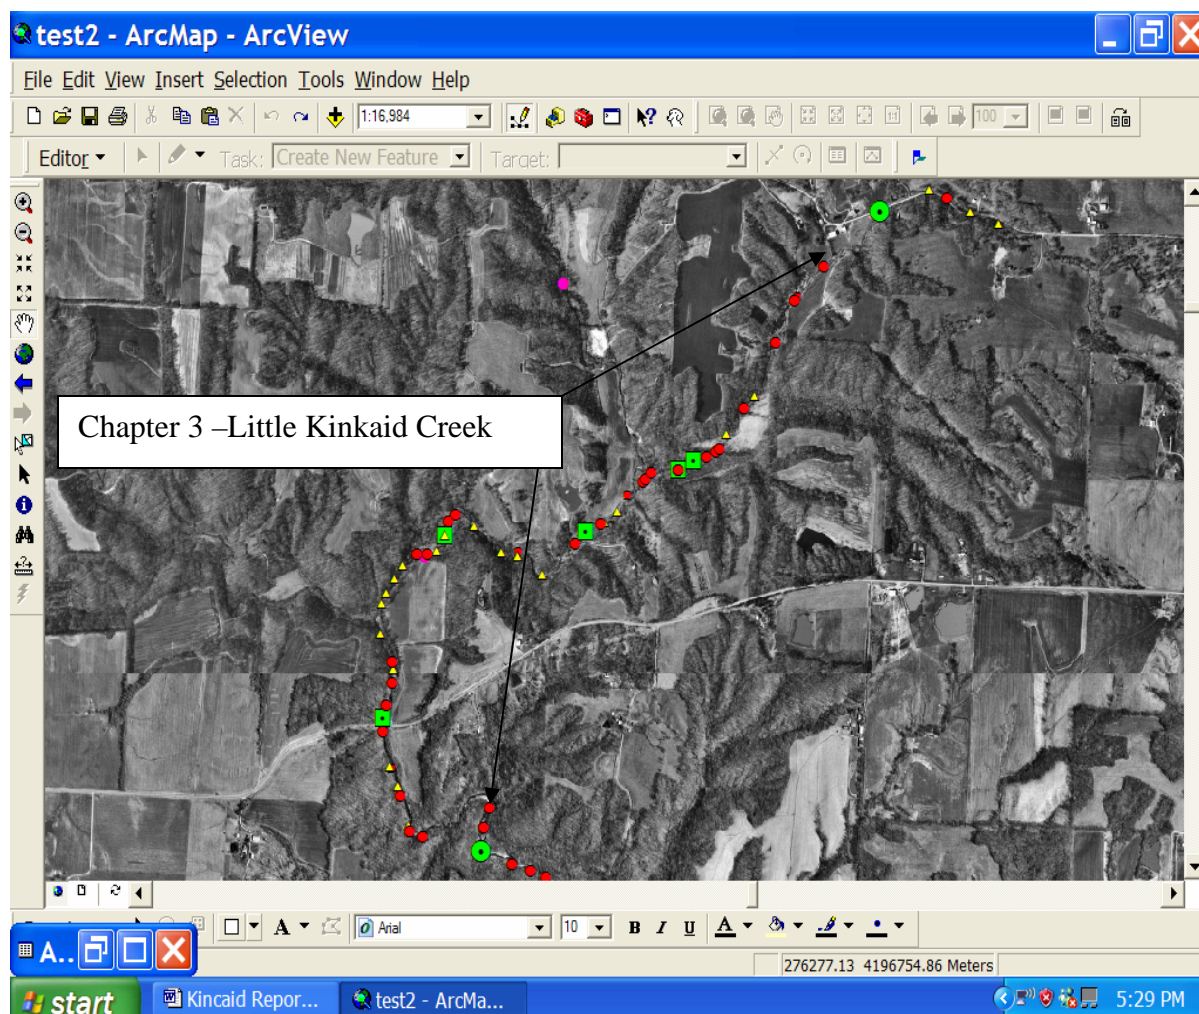
Figure 10: Location of Chapter 3–Little Kinkaid Creek

This segment is a continuation of Chapter 2 up to about 10:35 minutes on the DVD. At this point the channel enters a reach with bedrock bed control and some rock outcrop in the channel banks. The channel remains vertically stable through 14:18 minutes where the bedrock channel bed disappears through the remainder of the chapter. Valley slope in this section increases from 6.5 ft./mi. to 19 ft./mi. around 12:20 minutes.

The reach below 12:20 to 10:35 minutes appears to have been channelized and is a probable reason why bedload deposition does not appear as a problem until downstream of the channelized reach at 10:35 minutes. Cross sections two through six are in this chapter. There are velocity increases at each point upstream at 3.5 ft./sec., 4.0 ft./sec., 5.0 ft./sec. and 5.8 ft./sec. respectively at cross section two through five. This section appears to be transporting bedload effectively from cross section six downstream through cross section three before deposition becomes a significant problem.

The amount of past incision in this chapter steadily increases from the 1.3 feet found in Chapter 2 to 1.6 feet, 3.6 feet and 4.0 feet respectively at cross sections two through four. This incision probably means flows will be much deeper, with higher velocities and more tractive force within the channel before over bank flow occurs. Therefore, the stream is able to move the bedload through this chapter with minimal bar development and bank erosion is now more a function of velocity and tractive force than a result of bedload deposition (i.e., it is flow driven).

1. Continue with Rock Riffle installation through 10:35 minutes with an additional three to four riffles. With the estimated cost per riffle at \$9,000, the total cost amounts to \$27,000 to \$36,000. To be effective, the bedload now being deposited below 10:35 minutes needs to be addressed in the upper reaches to reduce volume and make Rock Riffle construction feasible.
2. In spite of past incision, the streambanks and channel bed are relatively stable above 10:35 minutes due to the abundance of natural stone. Some economic damage may occur as well if this section were reconnected to the floodplain as there are several crop fields and a county bridge in this chapter.

There are three sites where the lateral migration is threatening cropland. These sites at 11:12, 11:20, 11:49 minutes can be treated by use of Stone Toe Protection (STP) to protect adjacent improvements and stop the lateral migration. STP at these locations will have minimal effect on sediment transport, as very little deposition is occurring in this section, but will have an impact on the sediment contributions by controlling the lateral erosion. A total of 1000 feet of STP at 0.75 ton/ft. is needed. The estimated cost of installation is \$18,750 (750 ton @ \$25/ton).

3. Above 14:30 minutes there is some downcutting below a series of Rock Riffle Grade Control Structures installed under the IDOA Streambank Stabilization and Restoration Program in 1997. One additional structure and approximately 500 feet of STP are recommended to re-enforce this installation. The estimated stone requirements are 100 tons for the Rock Riffle and 300 tons for the STP. The cost is estimated at \$10,000 (400 ton @ \$25 ton).

4. The existing Rock Riffles in Chapter Three have been in place for seven years and have not filled with bedload. The performance of these riffles provide some evidence that Rock Riffles can be installed in the upper reaches to create a riffle-pool sequence and reduce sediment contributions downstream. The riffles seem to be maintaining depth and passing bedload very well from upstream sources. However, there has been some minor erosion between riffles and the addition of a small amount of STP would be a beneficial to maintain long-term stability.

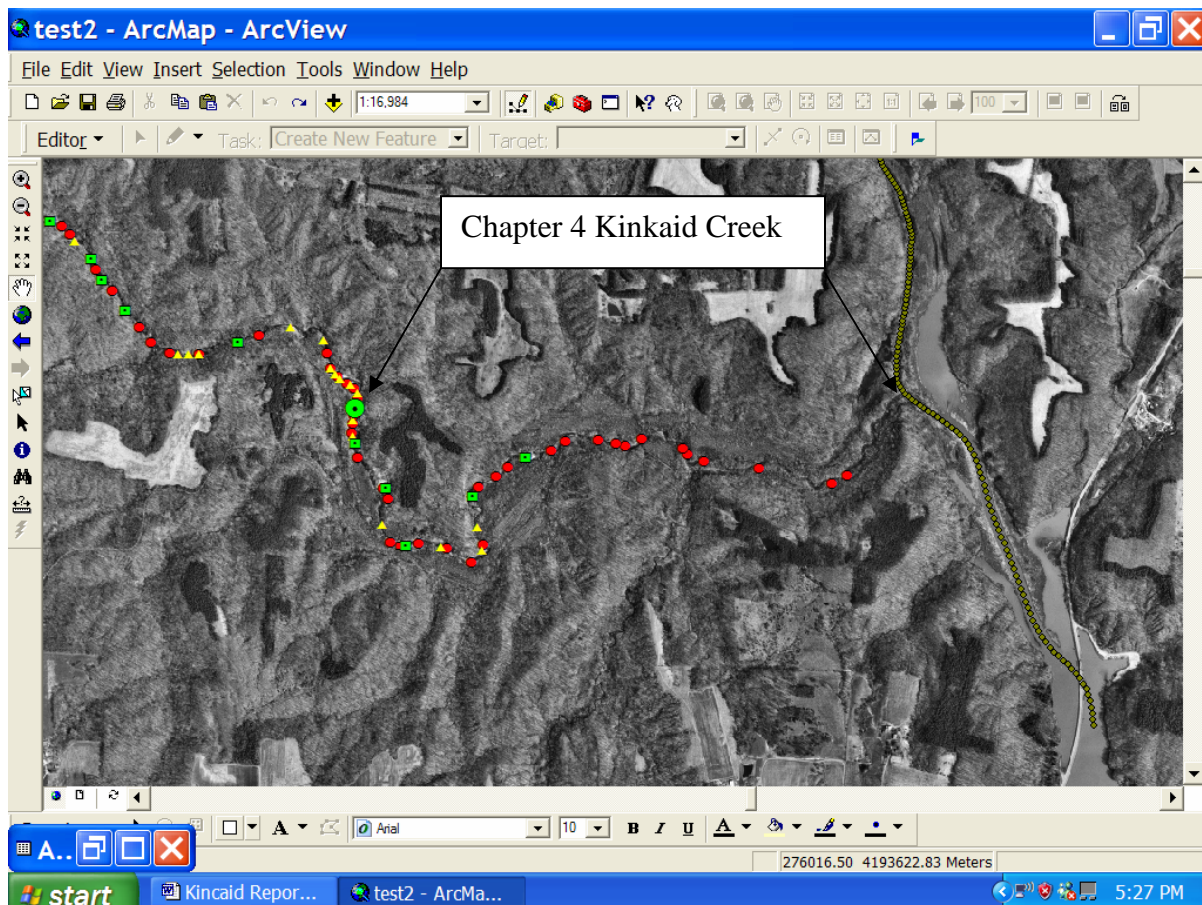
Figure 11: Location of Chapter 4 –Kinkaid Creek

This section of Kinkaid Creek is the outlet into Kinkaid Lake above Route 151. Sediments on the DVD from 15:50 to 17:17 minutes are fine sediments and are being transported by channel flows as bedload. From 16:18 minutes to the end of the chapter there are 30 identified erosion sites and five deposition sites. Bar development increases sharply around 17:17 minutes as does frequency of bank erosion sites. Cross section one is taken at 19:07 minutes and velocity is estimated at 3.6 ft./sec.. with approximately 0.9 feet of incision. The bedload deposition with a D90 of two inches in diameter is driving the channel laterally causing the increased bank erosion.

1. No infrastructure was identified as threatened by the lateral migration. The treatment options for lateral migration are not recommended in this reach. Any reduction in sediment load achieved by stabilizing streambanks would need to be weighed against increases in sediment transport through treated reaches.

2. Reconnecting Kinkaid Creek with its floodplain from 18:00 to 20:00 minutes is recommended, provided it is done in conjunction with reducing the bedload reaching this segment. The use of Rock Riffle Grade Control Structures is the recommended treatment, but the design must insure that a stable "bankfull channel" can be maintained without excessive maintenance costs. The goal would be to pass finer sediments through the system and onto the floodplain for deposition and reducing the large diameter bedload by stabilizing the streambanks within the newly created pools.

3. At six bankfull widths between riffles, this section of 4800 feet would require 10 to 12 riffles approximately two feet high at an estimated 350 tons of stone per structure. At \$30 per ton installed, the cost per structure would be \$10,500. Estimated treatment cost for Chapter 4 would be \$105,000 to \$126,000.

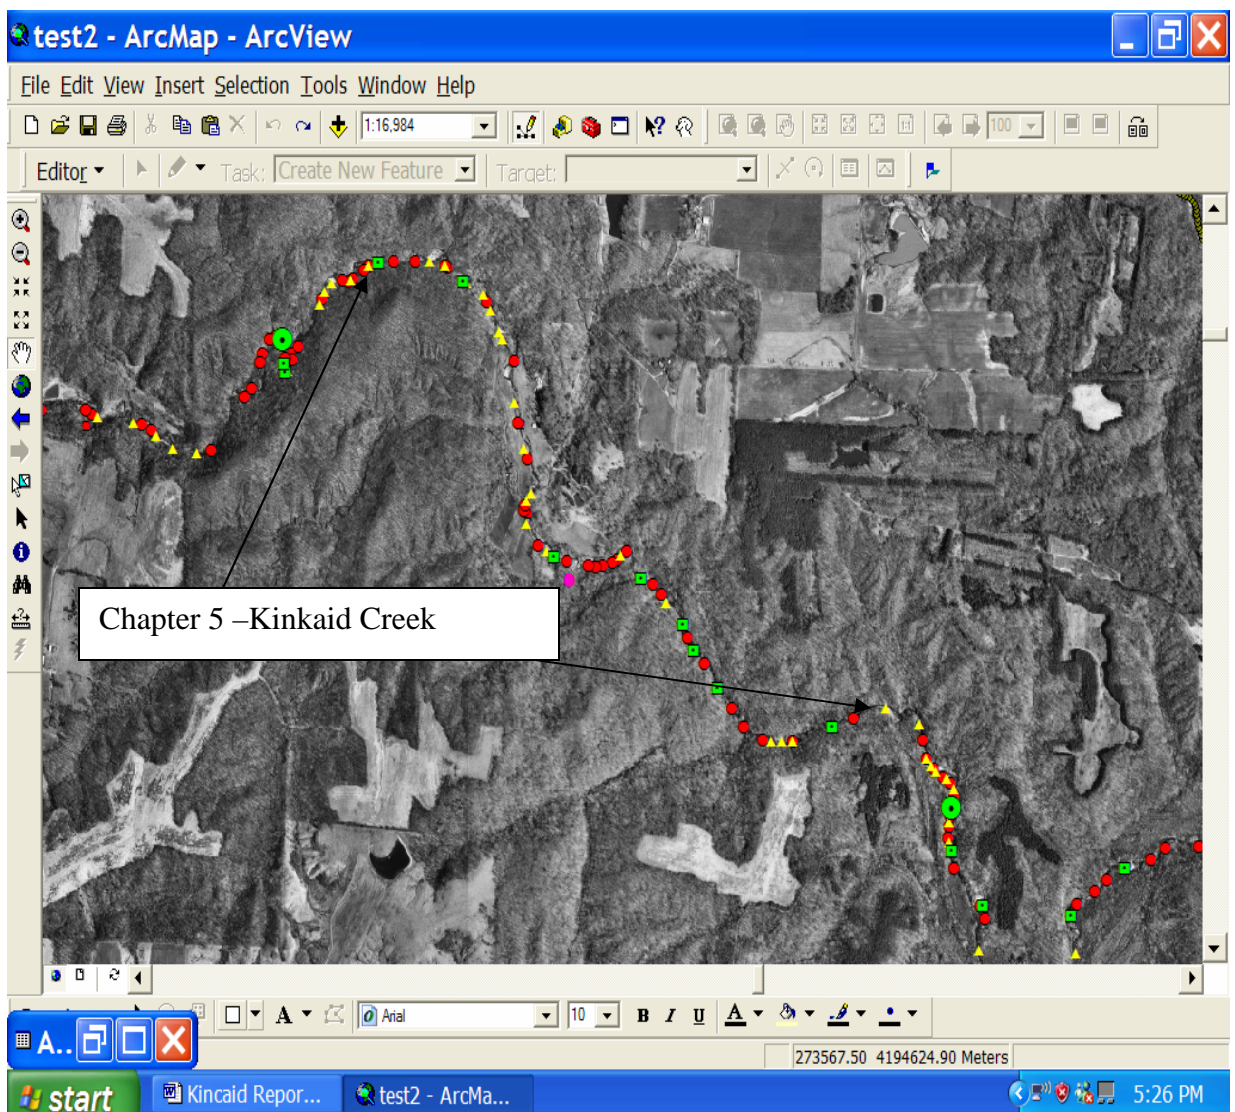
Figure 12: Location of Chapter 5 –Kinkaid Creek

This chapter is a continuation of chapter 4 until approximately 20:28 minutes where the deposition and erosion decrease significantly. Cross Section two is in this chapter at 20:21 minutes where incision has increased to 2.1 feet from 0.9 feet and velocity has remained at 3.6 ft./sec.. Cross section three, four and five are also in this chapter and have increased velocities of 5.2 ft./sec., 5.4 ft./sec. and 5.4 ft./sec. respectively. Cross sections three and five have incision of 2.4 and 2.6 feet, while cross section four is only incised by 0.6 feet. This low incision rate for cross section four is probably due to two factors.

First, there is a concrete low water crossing downstream about 800 feet that is preventing downcutting from migrating upstream to cross section four. Second, the channel has been straightened in this reach and excavation and fill may have altered the true bank height. Below this concrete crossing around 22:15 minutes the valley slope increases from 5.0 ft./mi. downstream to 14.4 ft./mi. upstream. This chapter has 45 erosion sites identified along with 10 deposition points and 37 break points all scattered uniformly throughout the chapter with few specific areas of concentration.

1. Install Rock Riffle Grade Control Structures through the entire reach of 12,500 feet. Fifty Rock Riffles will be required to reconnect the channel to the floodplain. Each structure will require 400 ton of stone. At \$30/ton, the cost of each Rock Riffle is estimated to cost \$12,000. The estimated treatment cost for this chapter is \$600,000 (50 x \$12,000).
2. There are two additional sites where lateral migration is affecting adjacent cropland. These sites can be treated with approximately 700 feet of STP in addition to the Rock Riffles. At \$25 per ton, the cost of this treatment will be \$17,500.

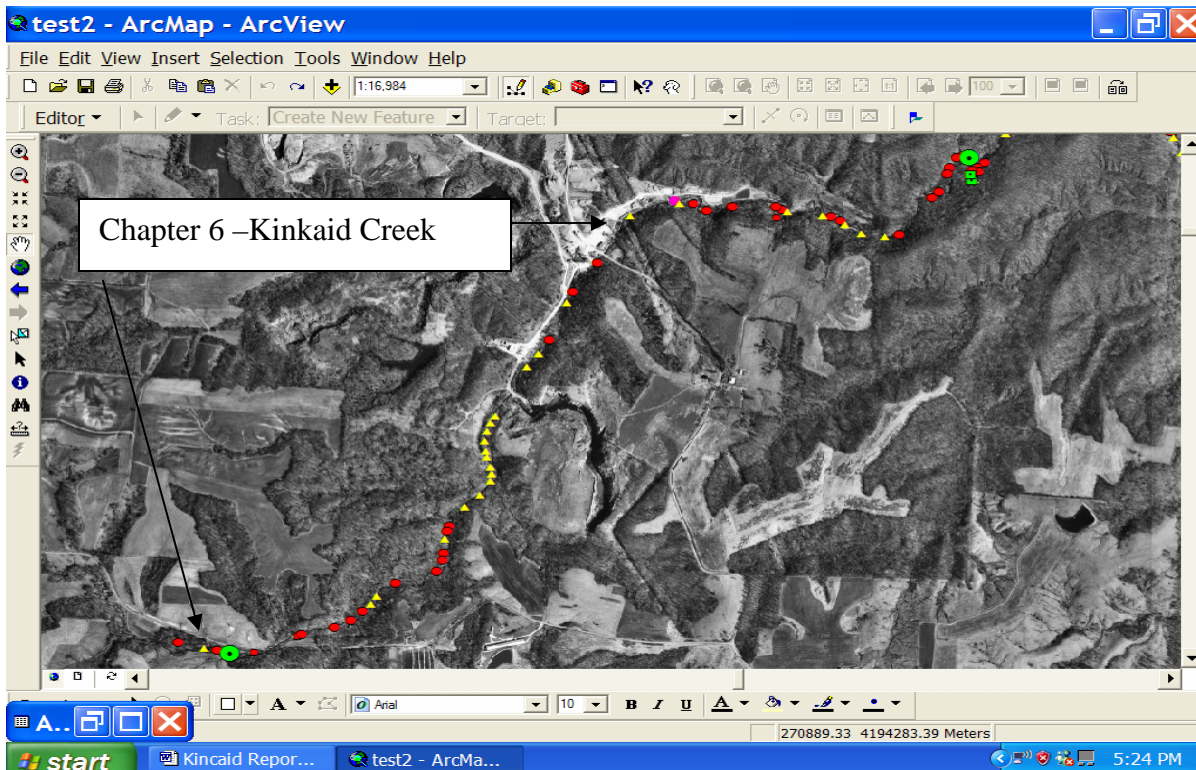
Figure 13: Location of Chapter 6 –Kinkaid Creek

The incision in this chapter is controlled by bedrock throughout the entire length of stream. There are locations where there is no bedrock visible, but grade is still controlled by rock outcrops at multiple locations. In most locations, the channel is still incised and separated from the floodplain, but it has generally reached its limit in depth. The Kincaid Stone Company operates a limestone quarry along about a third of this chapter's length and reconnection to the floodplain could cause damage to the quarry's operation. There are 28 identified erosion points in this chapter and 24 break points, which are bedrock in the channel bed. Only six of the 28 erosion sites are along the quarry operation.

The lower end of this chapter at 25:30 minutes is where the channel begins to open up in valley width while above this point to 26:00 minutes (near the lower end of the quarry operation) the channel is very confined in a deeply incised rock-lined valley. From the beginning of the chapter, up through the quarry operation at 28:00 minutes there is very little opportunity for deposition and none was identified on the DVD.

The valley slope increases near the lower end of the quarry operation to 42 ft./mi. and remains relatively uniform upstream through the end of Chapter 6. Velocities remain at 5.0 to 5.5 ft./sec. at cross sections six through eight. It is very likely that a very high portion of the bedload entering the upper end of Chapter six is transported all the way through to Chapter 5 where the problems with deposition occur.

1. Above 28:00 minutes a series of Rock Riffle Grade Controls can be constructed to raise the water surface profile closer to the floodplain with the intent of reducing the fine sediment load being transported downstream by encouraging more rapid development of a new floodplain of sufficient width to slow velocities. While the incision has reached 4.6 feet at cross section six, the newly developing floodplain being formed is nearly 60 feet wide at an elevation of only 1.5 feet above bankfull.

Therefore, riffles approximately two feet high may raise the water surface enough to reduce velocities and encourage deposition. The area from 28:00 to 29:45 minutes would be applicable to this technique.

This reach is approximately 5200 feet long and would require about 25 riffles for treatment. Since the channel continues to get narrower the cost per riffle is estimated to be \$4,500 (150 tons at \$30 per ton). The total cost of treatment for this reach is estimated to be \$112,500.
