**RE: Phase Contrast Microscopy (PCM) Air and Transmission Electron Microscopy (TEM)  
Sampling Summary Letter  
Fox Shore Apartments  
Common Area: Garage  
430 N. River Road, Aurora, IL 60506  
TRC Project: 000740748**

## PROJECT SUMMARY

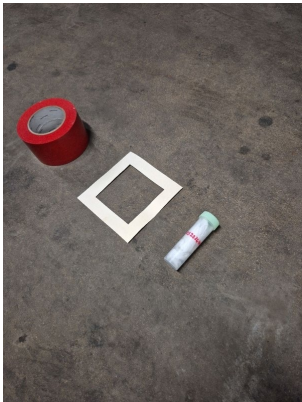
| Sample Date | Sample Type | Work Area Sample Location | Area Sampled (cm <sup>2</sup> ) | Asbestos Structures (str/cm <sup>2</sup> ) | Asbestos Present (Y/N) |
|---|---|---|---|---|---|
| 05/28/26 | Post Cleaning - Wipe | Garage Containment- South Floor | 100 | <2.99 | No |

| LOG NOTES SECTION | |
|---|---|
| <p><b>Caption:</b> 052826W1 - Garage Containment South Floor</p> | <p><b>Caption:</b> 052826W2 - Garage Containment North Floor</p> |

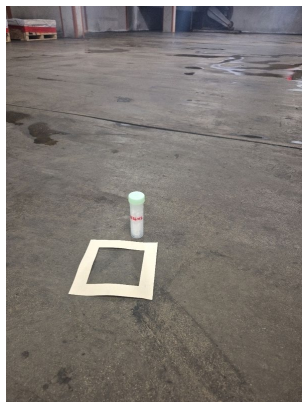
| Sample Date | Sample Type | Work Area Sample Location | Area Sampled (cm <sup>2</sup> ) | Asbestos Structures (str/cm <sup>2</sup> ) | Asbestos Present (Y/N) |
|---|---|---|---|---|---|
| 05/28/26 | Post Cleaning - Wipe | Garage Containment- North Floor | 100 | <2.99 | No |
