ILLINOIS ENVIRONMENTAL PROTECTION AGENCY

Re: LPC#0390055036—DeWitt County
Clinton/Clinton Landfill #3
Compliance File

LPC#0390055036—DeWitt County
Clinton/Clinton Landfill #3
FOS File
February 18, 2014 Inspection
Inspector: Dustin Burger
GIS Information from BOL Inventory: N40.11507 W-88.9589

Narrative Inspection Report

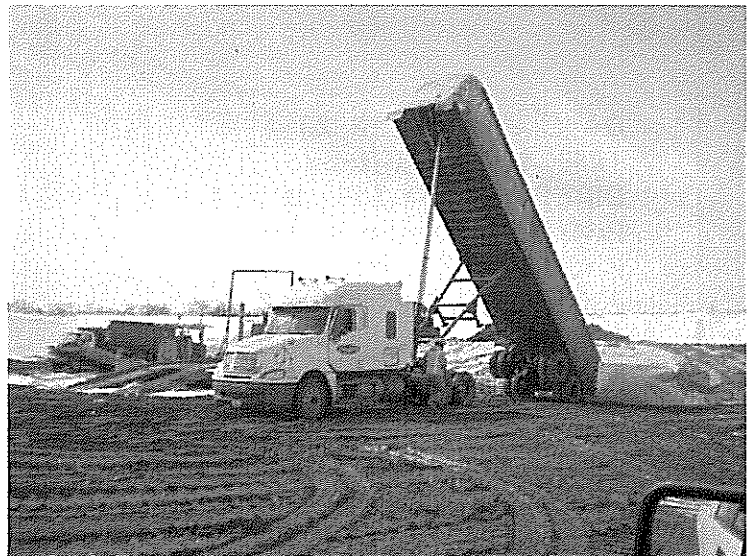
The active area was located on the floor of cell 5A1. We watched several trucks unload. One carried bottom ash from ADM (photo 1). Another was a transfer semi-truck that used the truck tipper to dump a load of municipal waste. The landfill trains the truck drivers to operate the tipper, so the landfill is not required to have an employee stop their work to operate the equipment. The tipper is not used often, and this was actually one of the few times I have seen it operate at this landfill. As a contrast, the landfill at Pontiac where Mr. Bryant worked previously operates 3-6 tippers at a time. At one time that facility had over 10 operating at once. The difference between the two facilities is the Pontiac site's main customers were transfer stations in the Chicago area, whereas most of the waste received at Clinton comes in on rear loading packer trucks (what most people would call a typical garbage truck) and roll-off boxes, which are large removable dumpsters that can be carried by a truck.

DATE: February 18, 2014
TIME: 11:10A.M.-Noon.
DIRECTION: West
PHOTO by: Dustin Burger
PHOTO FILE NAME:
0390055036~02182014-001.jpg
COMMENTS: Load of bottom ash
being dumped

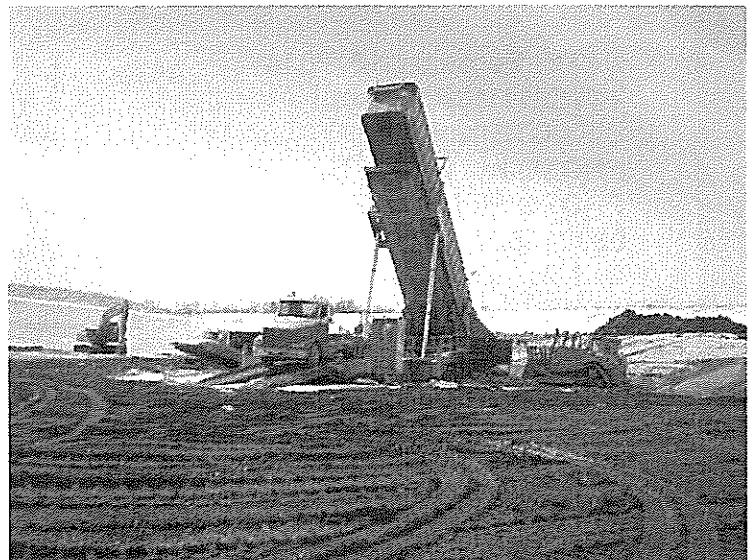
DATE: February 18, 2014
TIME: 11:10A.M.-Noon.
DIRECTION: West
PHOTO by: Dustin Burger
PHOTO FILE NAME:
0390055036~02182014-002.jpg
COMMENTS: Load of municipal
waste on truck tipper

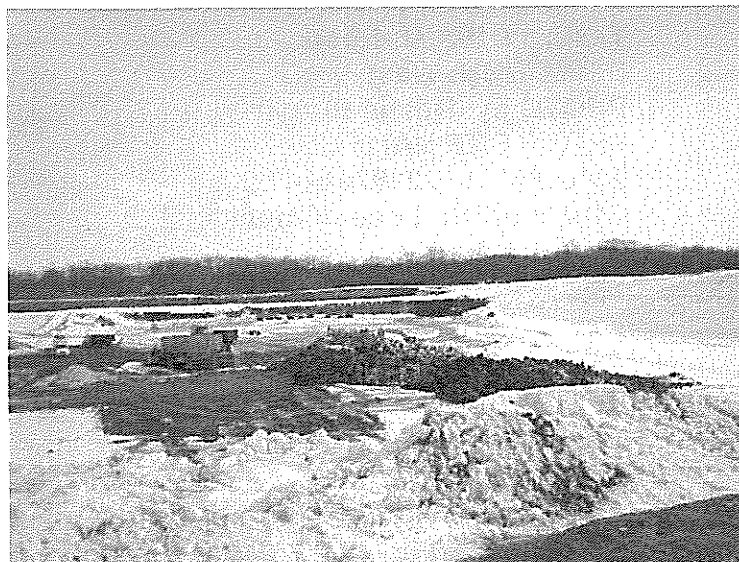
DATE: February 18, 2014
TIME: 11:10A.M.-Noon.
DIRECTION: East
PHOTO by: Dustin Burger
PHOTO FILE NAME:
0390055036~02182014-004.jpg
COMMENTS:
