RE: Proposed Compliance Commitment Agreement from
Koppers Inc
Violation Notice A-2021-00217
I.D. 031300AAJ

**Re: Violation Notice A-2021-00217
ID: 031300AAJ**

Unit: U-03
Equipment: V-101 & V-201
Description: TAR FRACTIONATOR
Serial Number: 74-413B National Board: N/A

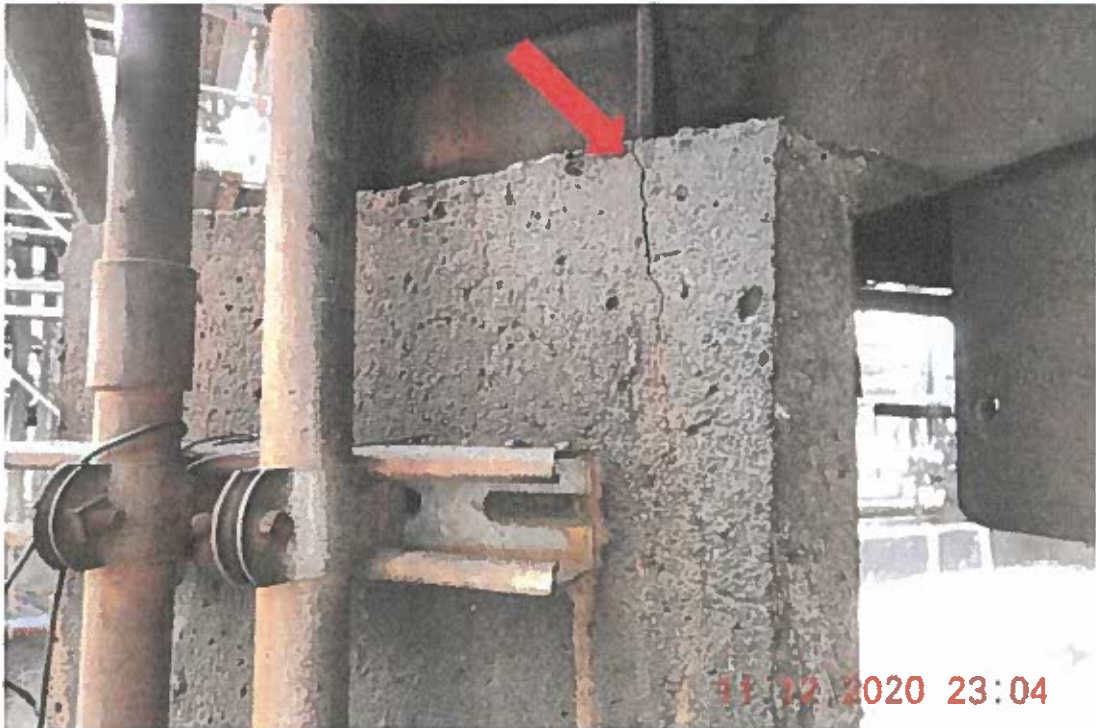
16)

The following sixteen (16) photos show the external condition of the reboiler. Areas of general corrosion were observed on the exterior of the reboiler. A crack in the southeast side of the burner box was observed. Cracks were noted around the bolts of the inspection ports. Light cracks were noted in the concrete pillars of the support legs. Significant cracks and separation in the ladder support welds were noted.

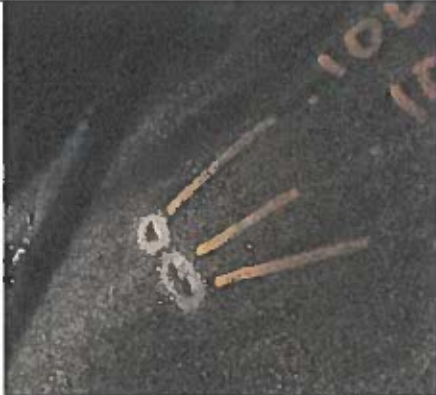
Reference ID: 9

Description: 3x .100" corrosion at N 2 TOC Vapor Outlet shell

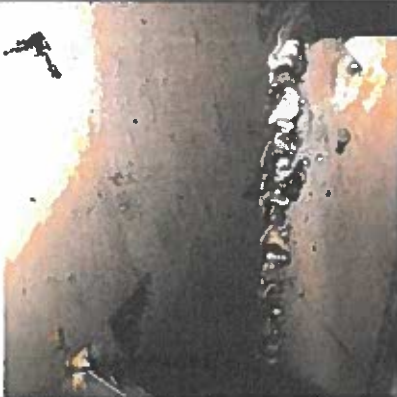
Reference ID: 13

Description: Baffle bracket attachment weld below tray 21. Typical 4 places. Weld quality issues, arc strikes, undercutting, buckshot, etc.

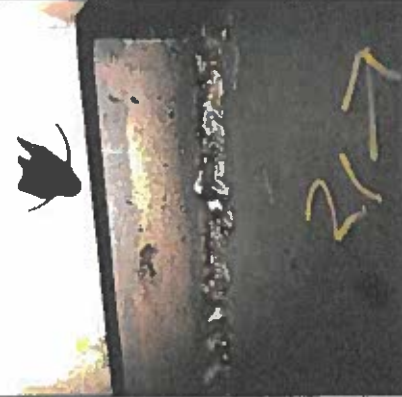
Reference ID: 14

Description: Baffle bracket attachment weld below tray 21. Typical 4 places. Weld quality issues, arc strikes, undercutting, buckshot, etc.

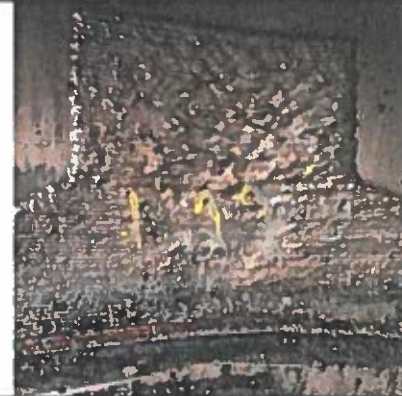
Reference ID: 18

Description: Erosion of weld metal buildup area above tray 22. Unknown depth of erosion.

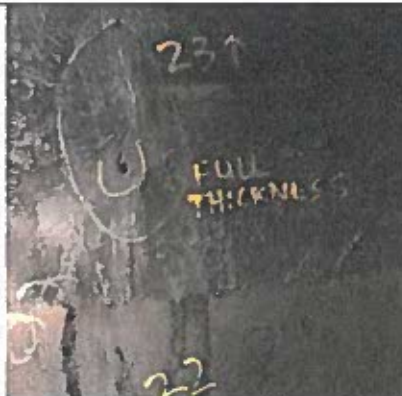
Reference ID: 20

Description: Thru hole above tray 22 @west side. .375" diameter

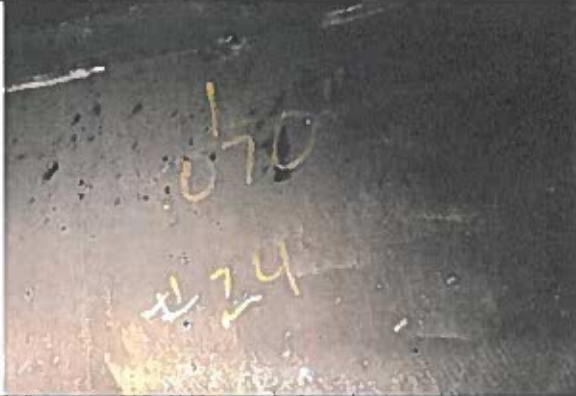
Reference ID: 25

Description: Arc gouged area under tray ring 24. .070 x 1"

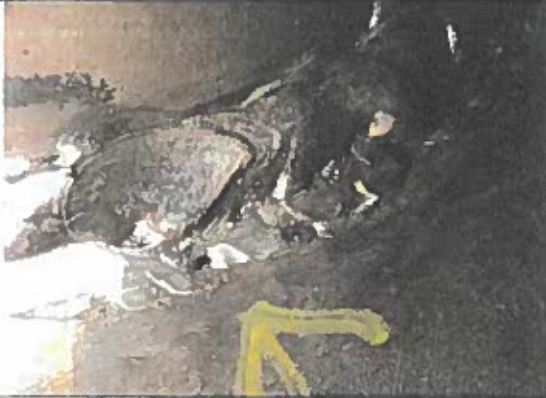
Reference ID: 37

Description: close up view of item 36
